# Las Vegas Wash Long-Term Revegetation Management Plan

November 2019

SOUTHERN NEVADA  
WATER AUTHORITY®

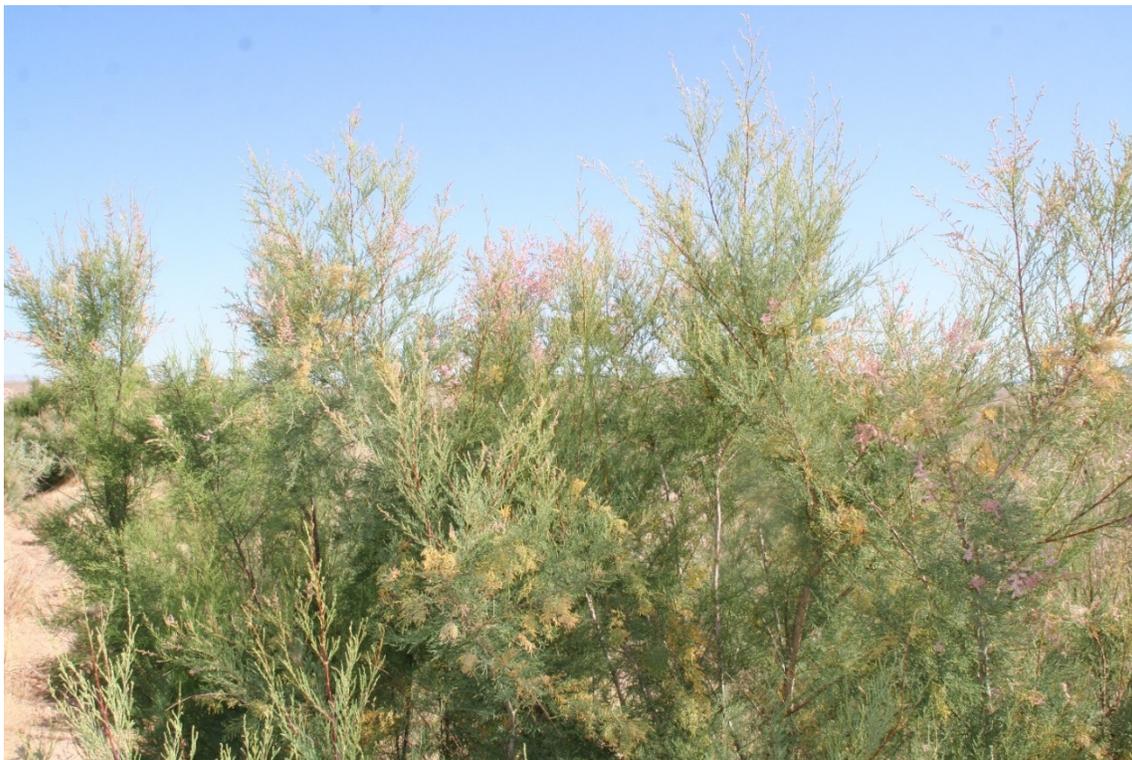
**Figure 2. Salt cedar is a noxious weed that was once the dominant species along the Las Vegas Wash.**

The most prevalent weed species along the Wash prior to the onset of restoration activities was salt cedar. This shrubby non-native tree has invaded many of the waterways of the western United States and has caused substantial ecological degradation. The removal of this species is time consuming and can be expensive. The Wash restoration project has successfully eradicated more than 90% of the salt cedar in the area. Initial removal has typically come from clearing for the construction of erosion control structures. Secondary removal has been an ongoing effort after native plants have been established in revegetation sites. Because there is regular surface water from the Wash, many areas with high groundwater tables, occasional stormwater flows, and initial irrigation water applied to revegetation sites, there is ample opportunity for salt cedar and other weeds to reestablish.

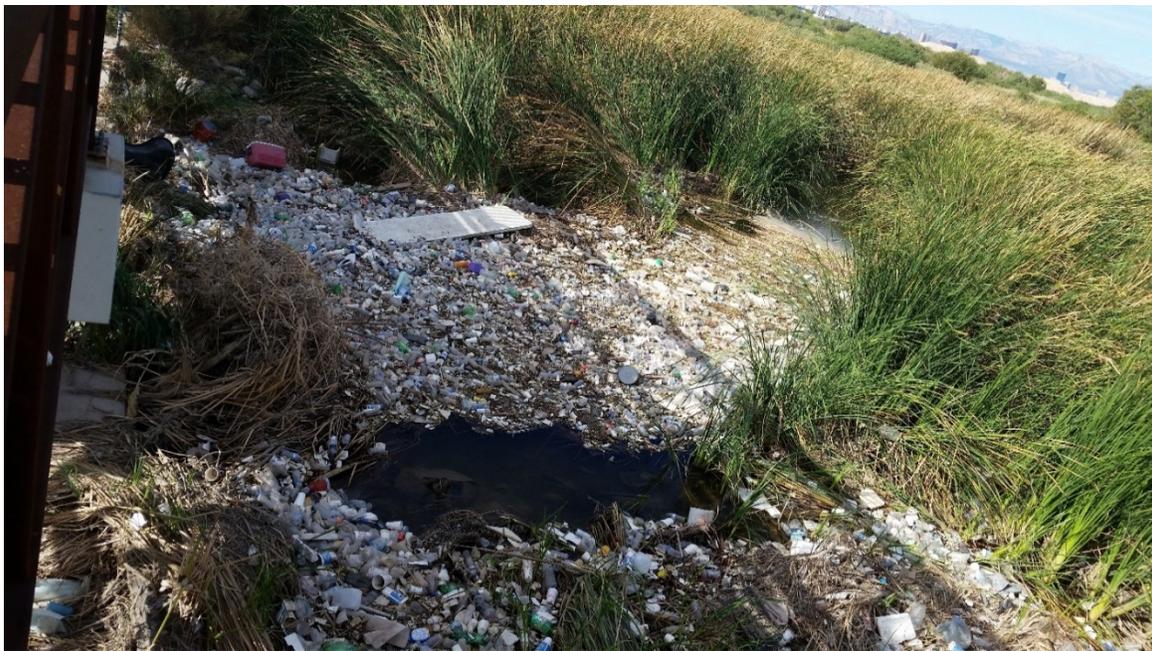
**Figure 3. Trash regularly collects upstream of the Upper Diversion Weir after storm events.**

The third way trash gets into the Wash is much more prevalent, which is during storm events (Figure 3). Trash from throughout the Las Vegas Valley that gets washed into flood channels or other Wash tributaries eventually reaches the Wetlands Park and gets deposited throughout various areas. It is most prominent in riparian areas along the banks of the Wash, but after large storm events can reach far away from the water.

The Upper Diversion Weir, in particular, needs special attention when it comes to the large amount of trash that accumulates after storm events (Figure 3). Initially, trash accumulates in the backwater of the weir. But during larger, longer, or multiple storm events, the water and trash go over the weir and the trash is deposited downstream of the weir as well. Crews need to visit this weir after every storm event to quickly remove as much trash as possible. Additional cleaning will also need to be done throughout the year.

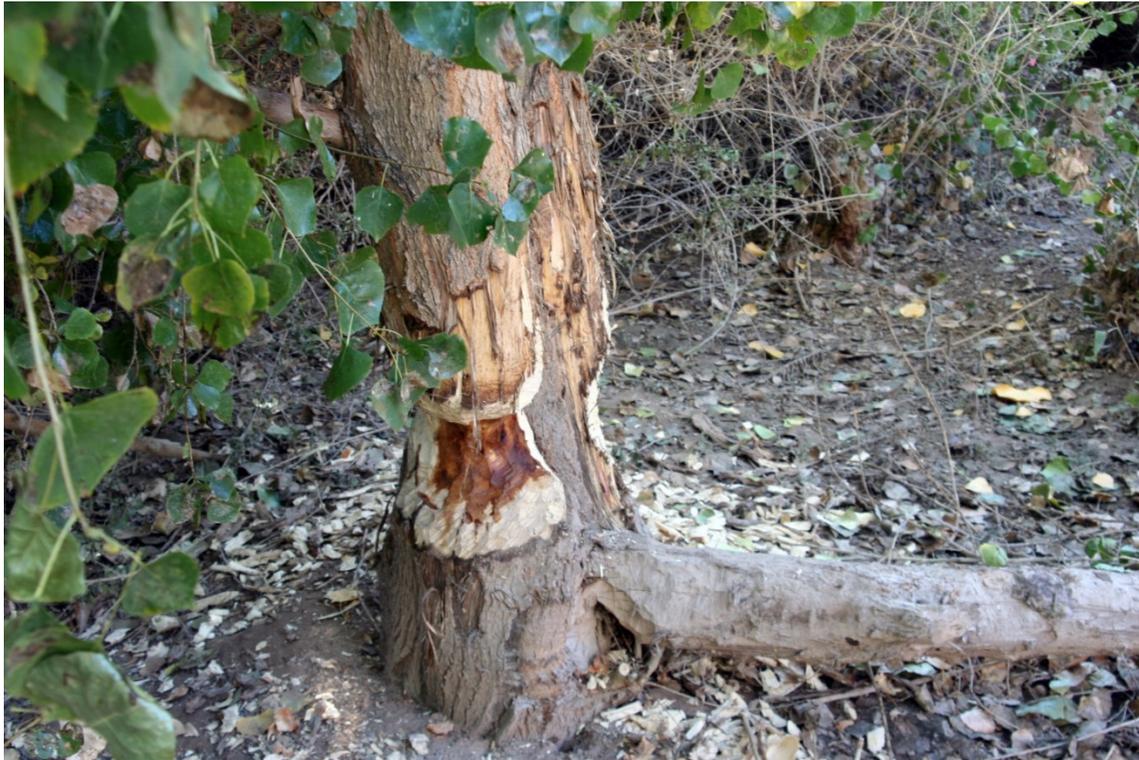
**Figure 4. Beaver damage to a cottonwood tree not protected by fencing.**

Herbivore control is needed in many areas to prevent plants from being eaten by different species of wildlife (Figure 4). Most herbivore control begins during the initial installation of revegetation. This currently consists of fencing to keep herbivores out of revegetated areas or fencing placed around individual plants. Long-term management activities will primarily involve the upkeep of fencing to continue to control herbivory and the removal of fencing that is determined to be no

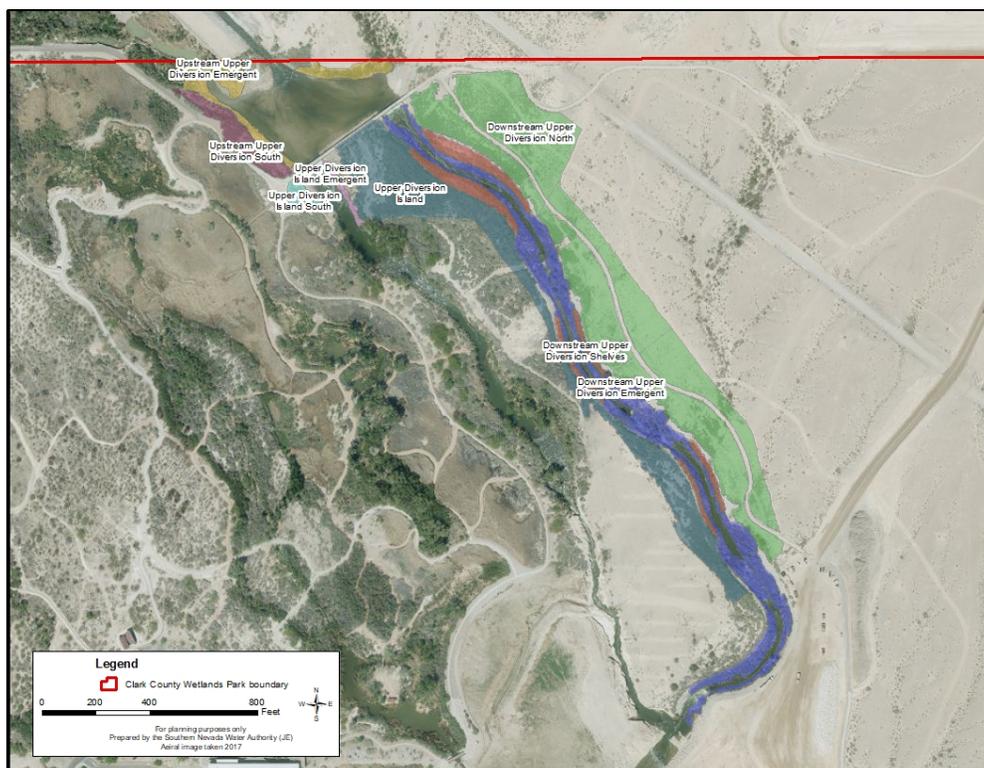
Figure 5. Revegetation sites associated with the Upper Diversion Weir and East Diversion Channel.

Vegetation removal will continue in the backwater behind the weir/bridge. There is also a substantial amount of vegetation including large woody trees that have established on the weirs in the East Diversion Channel. These will likely require regular management to ensure future functionality of the structures.

With the backwater of the weir/bridge to stay clear of vegetation, the remaining areas suitable for wetlands and riparian habitat area are densely vegetated and diverse in species and structure. There are improvements that could be done to the upland habitats. Two revegetation sites were planted as part of a Wash Green-Up in 2008, Downstream Upper Diversion North and Upper Diversion Island (Figure 5). These sites are both successful and densely vegetated. However, both sites are dominated by saltbush. Some mesquite trees were planted and are still present but have not put on much growth. It is recommended that a few hundred cat-claw acacias, which are more drought tolerant than mesquite, be planted throughout the area to diversify the habitat for wildlife use.

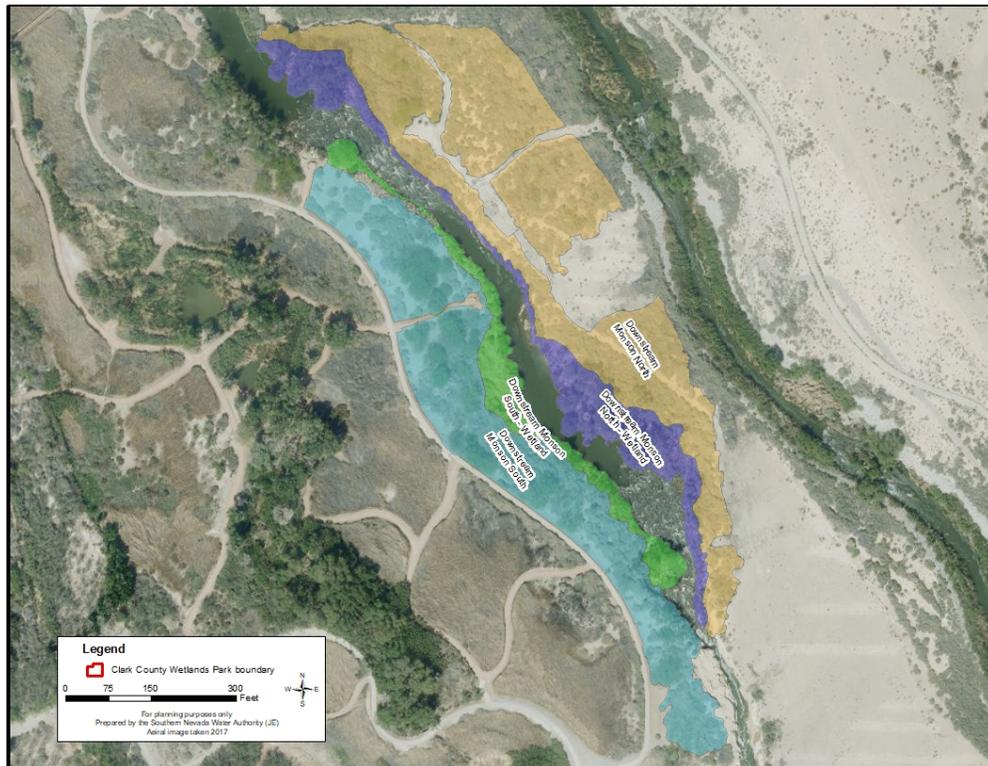
**Figure 6. Revegetation areas associated with the Monson and Visitor Center Weirs.**

now an island between the Wash and the East Diversion Channel (Figure 6), has a large amount of salt cedar. The western side has been more controlled since it is primarily maintained by Clark County and its contractors. The eastern bank is more difficult to access. The Visitor Center Weir was reconstructed and expanded, which also removed some salt cedar, and that project improved the accessibility of the site. These trees should be removed to reduce their potential to spread into downstream sites.

Currently there is good diversity of plant species and structures at these sites. Additional plantings may be appropriate in areas where salt cedar is removed. These would be along the banks, making willows a good choice for most locations.

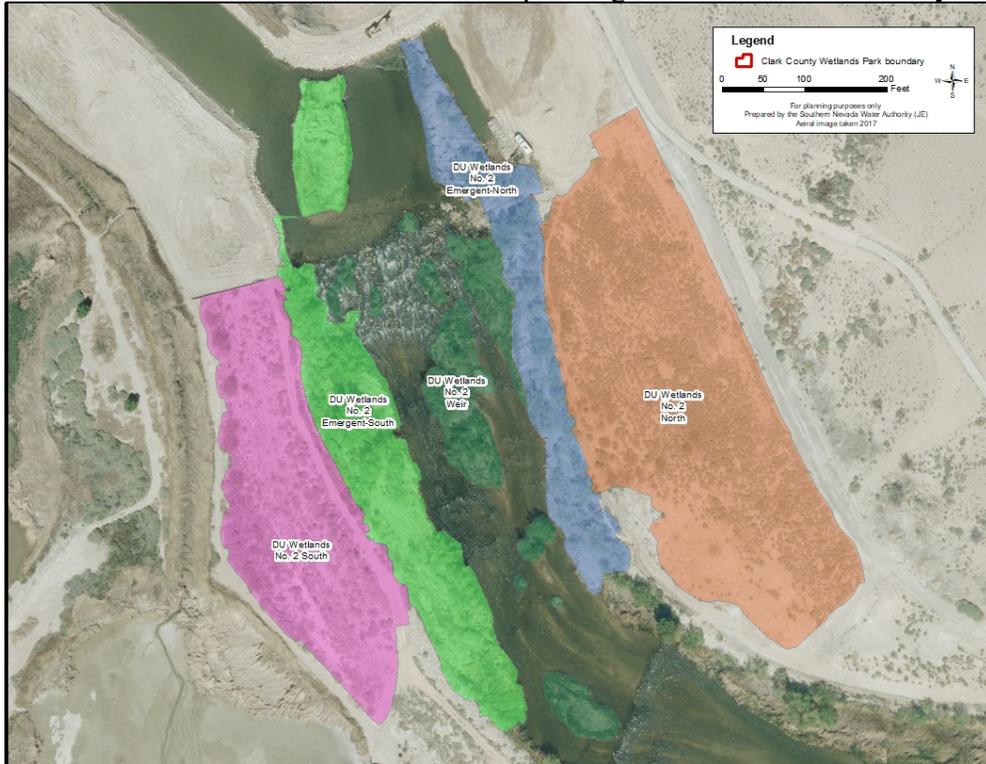
Figure 8. Revegetation areas associated with the DU Wetlands No. 2 Weir.

The upland area on the south side of the DU Wetlands No. 2 Weir has a large amount of bassia on it that needs to be removed and replaced with native plants. In some areas, if the bassia is properly removed, native plants will be able to fill in. If the stands of the weed are large, then additional planting may be necessary to ensure that this or other weeds do not fill back in the space. This weir was covered in vegetation for many years until removed in early 2019. Previously, the vegetation established quickly here. Annual monitoring will be done to determine the rate of establishment in the future and when removal operations will need to be done.

The wetland and riparian areas along the banks at this weir are diverse in terms of numbers of species and plant types including trees, emergents, forbs, and grasses. The two upland revegetation sites are also doing very well in terms of providing potential wildlife habitat, having a diversity of plants. The one potential ecological enhancement project will be when bassia and other weeds are removed, primarily from the southern site. Besides bassia, the site is dominated by honey mesquite and four-wing saltbush. It is recommended that grasses such as alkali sacaton be used to fill in the spaces left by weed removal.

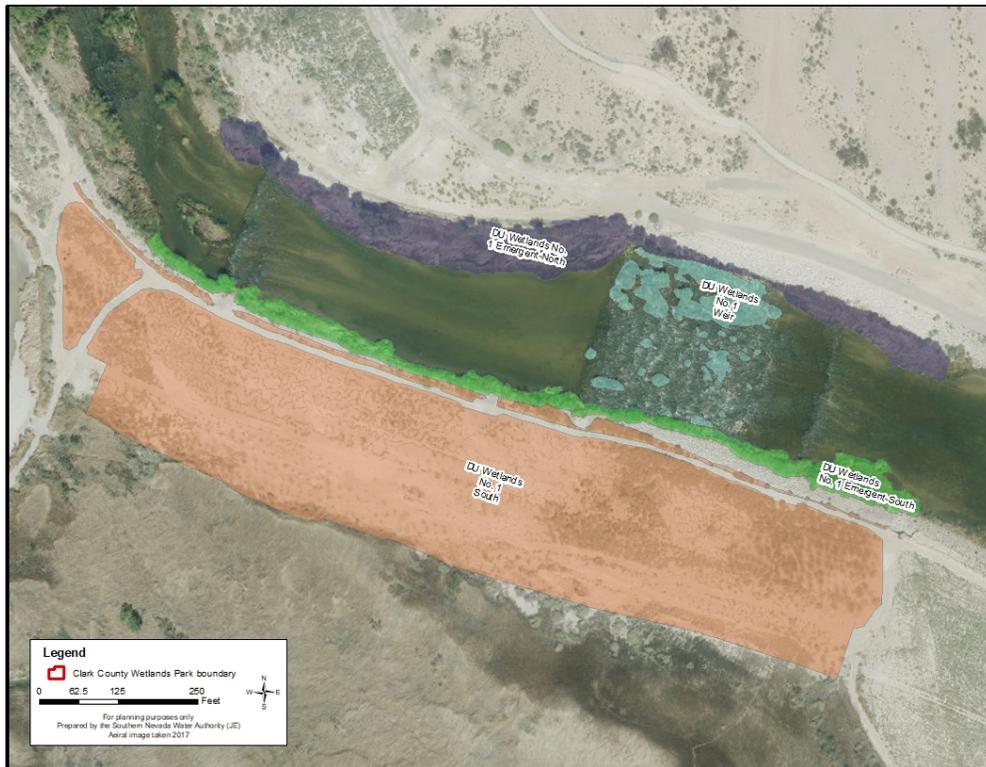
Figure 9. Revegetation areas associated with the DU Wetlands No. 1 Weir.

The only known management issue at the DU Wetlands No. 1 Weir is trees that have established on the weir. These were also removed in early 2019. There were not as many as at DU Wetlands No. 2 Weir, but they will need to be removed in the future as well. Both the wetland and upland revegetation sites at this weir are doing very well. Planted in 2013, there is a diversity of plant species and structures in both areas. There is also a large population of bassia on the southern non-

wetland site measured at 5-25% in 2017. This needs to be removed, but bassia distribution on this site is less concentrated in one area and additional plantings should not be necessary.

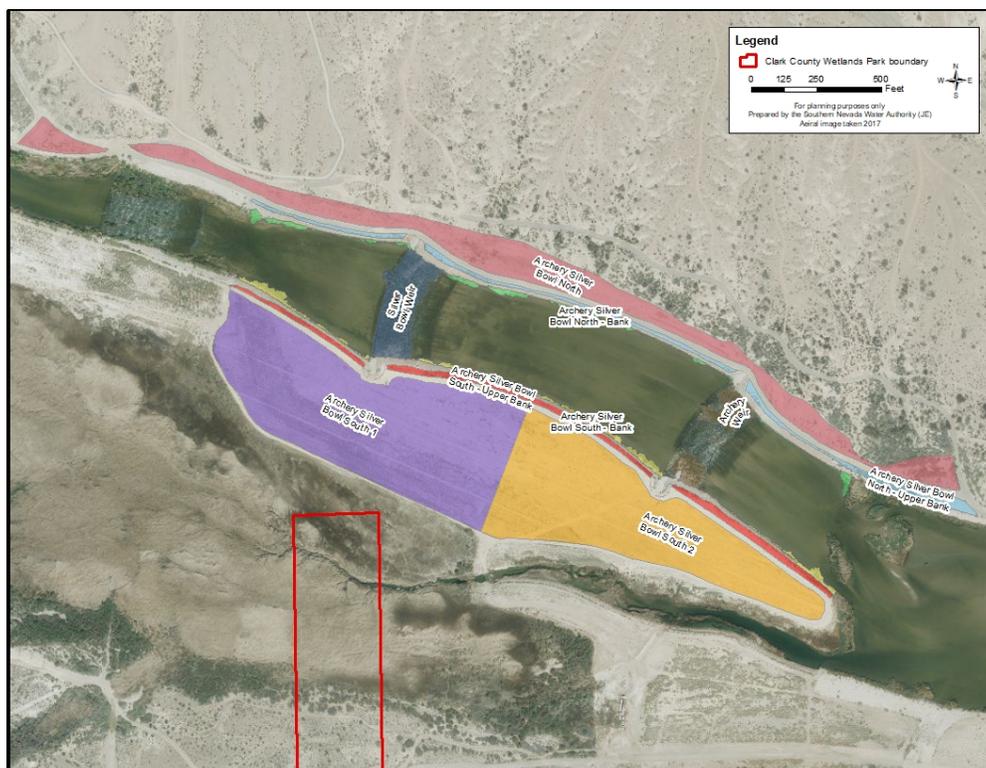
Figure 10. Revegetation areas associated with the Archery and Silver Bowl Weirs.

Like most weirs, these also had trees that established on them that were removed in 2019. Vegetation is expected to reestablish, although the species may differ, and the frequency of removal may change based on the impact to the structure. The two large sites on the south side of these weirs were planted as Wash Green-Ups in 2015 and have very few weeds that have established on them. The site on the north side is narrow but long, about 3,500 feet. This site was has many weeds including Russian thistle and bassia that need removal.

The two south side upland areas had a variety of species planted on them in 2015, but the desert saltbush, which was hydroseeded on the site, is by far the dominant species. Areas should be explored to incorporate trees such as mesquites and cat-claw acacia. Additional shrub types could also be incorporated if suitable areas are identified.

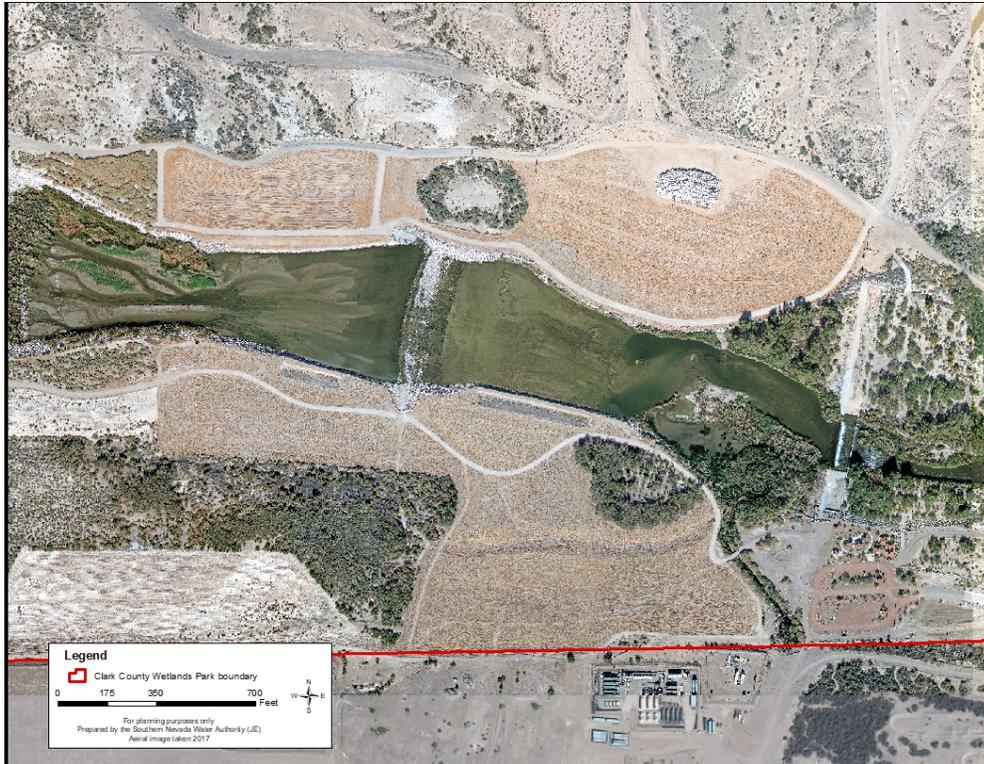
**Figure 12. Areas surrounding the Sunrise Mountain Weir will be revegetated in upcoming years.**

which needs to have vegetation regularly cleared to keep it working properly. The Wetlands Park has a trailhead near the weir and this increased visitation. This results in a minor increase in trash nearby, but to date, this has been minimal. Greater amounts of trash come during storm events and get caught in vegetation downstream of the weir. This has not been addressed to the level needed in the past and should be a higher priority in the long-term management program. Ecologically, most of the Pabco Road Weir sites are also doing very well. Sites have a wide diversity in plant species and structure. There is also a wide variety of wildlife found in these areas, perhaps due to the age of the plants. There are specific activities that could be done to potentially improve the habitat for bird species. Downstream Pabco South and Upstream Pabco North have large stands of Fremont’s cottonwoods and Goodding’s willows which have been known to host migrating willow flycatchers. Improvements in hydrology and understory may improve the habitat for these species on the site. Further examination of these sites needs to be done. One idea is to dig trenches or channels from the Wash into the interior of the site. Another is to dig ponds or pools within the center of the site down to the water table to expose it as surface water under the canopy of the large trees. Planting of a greater density of smaller shrubs, such as sandbar willow (*Salix exigua*) or similar species, is also needed.

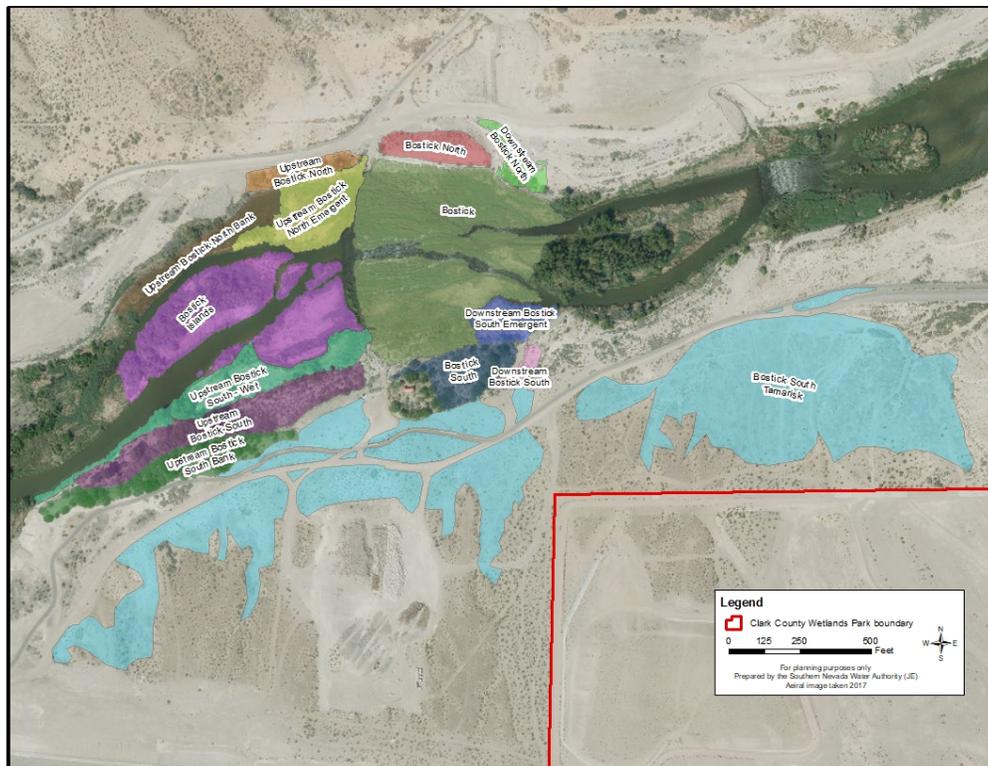
**Figure 15. Revegetation areas associated with the Bostick Weir.**

The Bostick Weir is the largest weir on the Wash and has a lot of revegetation surrounding it both in terms of size as well as habitat types. There have been numerous projects removing trees from the face of the weir, this activity will likely need to continue in the future. There are some salt cedar and other weeds found in the revegetation sites but no large amounts that require special attention. The large Bostick South Tamarisk revegetation site was planted in 2015 after removing about 12 acres of salt cedar. While this site does not currently have salt cedar in considerable

amounts, being that it was dominated by the invasive tree in the past suggests that careful monitoring should take place in the future to identify and treat resprouts before they get too abundant.

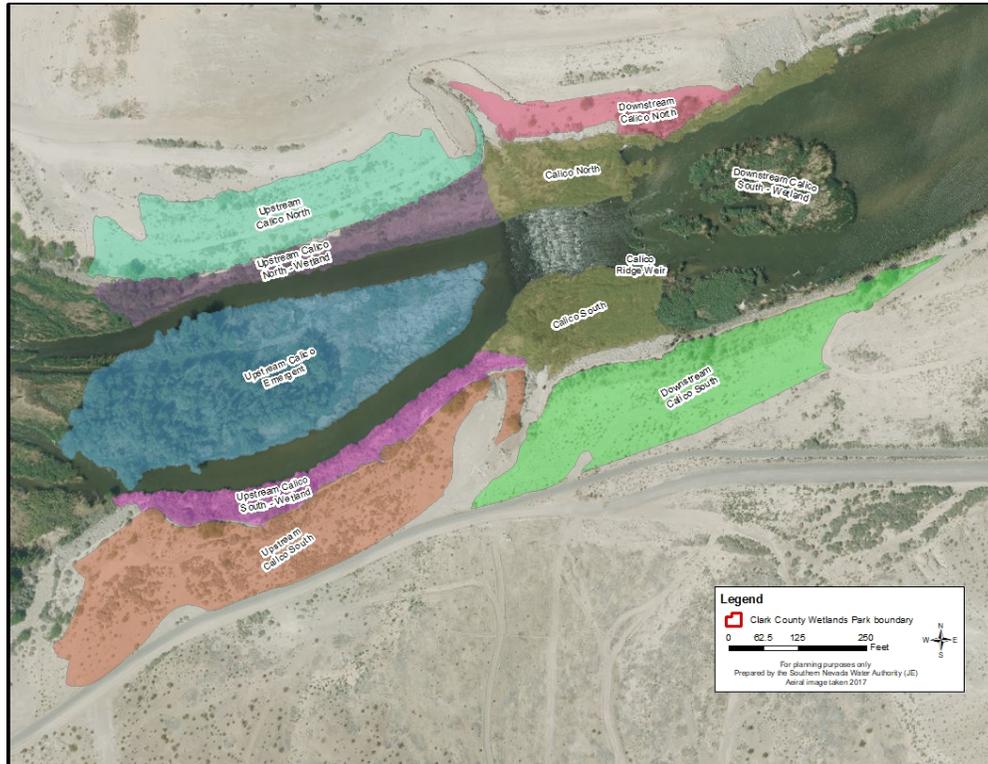
Figure 16. Revegetation areas associated with the Calico Ridge Weir.

The Calico Ridge Weir is a unique style of weir along the Wash being a two-stage weir. The areas of the weir along the banks have accumulated vegetation while the center of the channel has very few plants on it. The bank areas that have vegetation are primarily common reed and are proposed for removal during regular weir management activities. However, since this type of vegetation is flexible in flood events and would not cause overbanking, it is relatively low on the priority list of vegetation removal projects.

The non-wetland areas on the north side of the Wash, planted in 2005, appear to have high survivorship of the plants that were originally planted. However, there has been slow growth of those plants and very little self-establishment of any additional plants. There are a variety of plant

types there with creosote, saltbush, and honey mesquites present. They are concentrated in specific areas and have stunted growth, especially the mesquites. An in-depth survey of the soils will need to be done to determine appropriate plant types and locations of additional plantings needed to improve these sites.

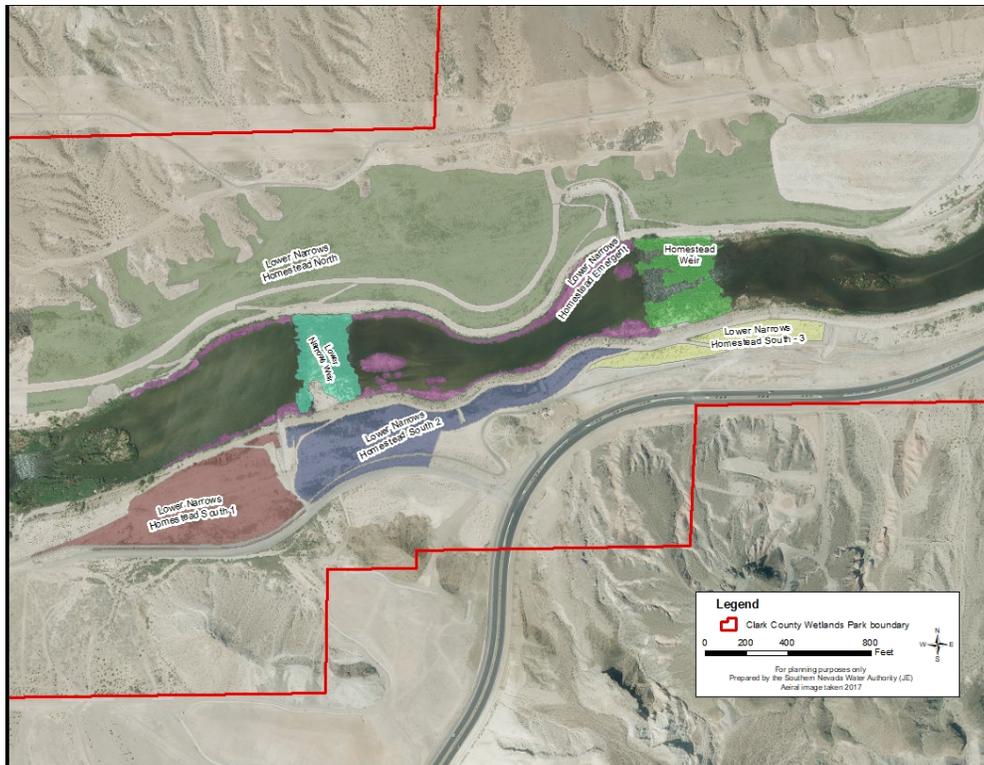
**Figure 17. Revegetation areas associated with the Lower Narrows and Homestead Weirs.**

The bank protection installed for these two weirs on the north and south side were covered with excess soil from the Three Kids Weir project just downstream. It was subsequently planted in 2015 with several types of vegetation. Since this area is both new and adjacent to the water, there is a higher likelihood of weed encroachment, and therefore it will likely need regular treatment until the native vegetation is much more mature.

The upland areas on both the north and south side of the Wash are dominated by saltbush species. These areas could be enhanced by additional plantings of trees such as cat-claw acacia. This would be more appropriate on the areas on the southern side of the Wash. The non-wetland areas on the north side of the Wash are much higher off the water and water table; it is unclear if trees even as xeric as cat-claw acacias would be successful there.

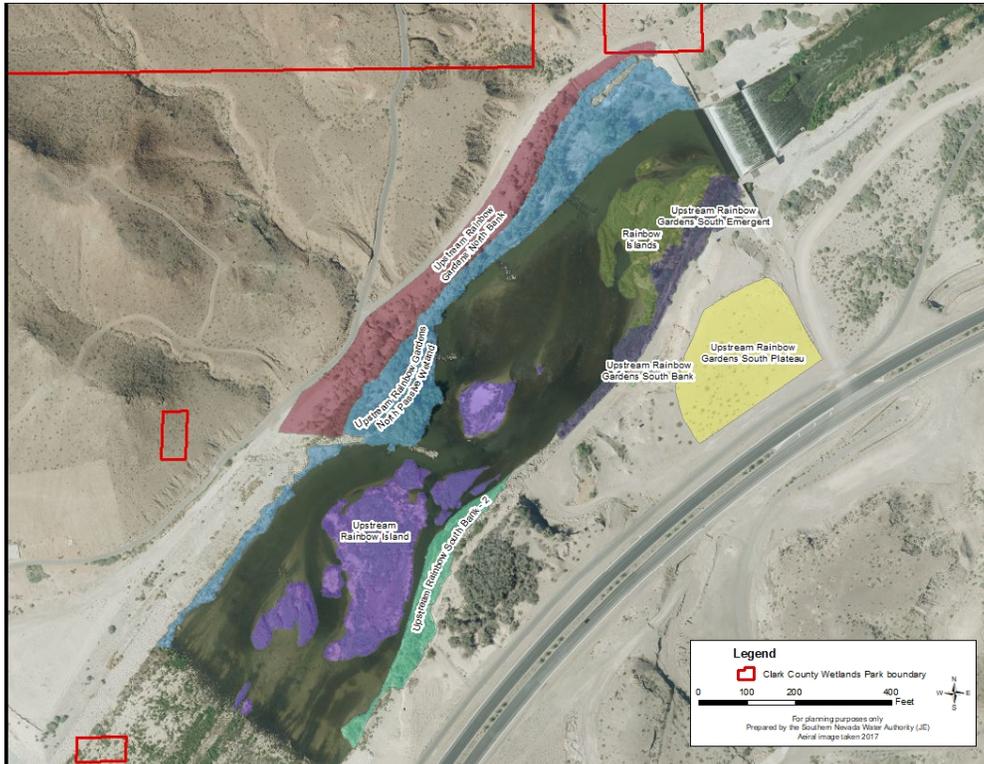
Figure 19. Revegetation areas associated with the Rainbow Gardens Weir.

Most of the revegetation sites at Rainbow Gardens were actively or passively created in 2005, the year the weir was completed. The exception is Upstream Rainbow North Bank, which was hydroseeded in 2010. The weir itself is a concrete structure and therefore vegetation does not grow on it. The vegetation in the channel upstream, however, has been managed in the past to allow flows to hit the weir directly instead of at an angle; this will continue in the future. The last major removal of vegetation from the channel left portions of vegetation along the banks dominated by common reed. Additional plantings of riparian trees, via pole plantings, should be done throughout

the south bank. The north bank has not been managed at all and consists entirely of plants that passively established. This includes salt cedar trees that should be removed and replaced with native riparian species. Additional pole planting and bulrush transplants can be planted along the entire northern bank as well.

The one upland revegetation area on the south side, Upstream Rainbow Gardens South Plateau, should have additional plantings take place. Like many other upland revegetation sites, many of the planted plants are still present but have not grown much. This site primarily consists of creosote bush. A small number of cat-claw acacias could be planted as well as other shrubs to diversify the plant species there. In addition to creating better habitat, this area is now along the Galleria drive and is seen by hundreds of drivers a day. A more attractive area will be beneficial to recreationists using the park as well.

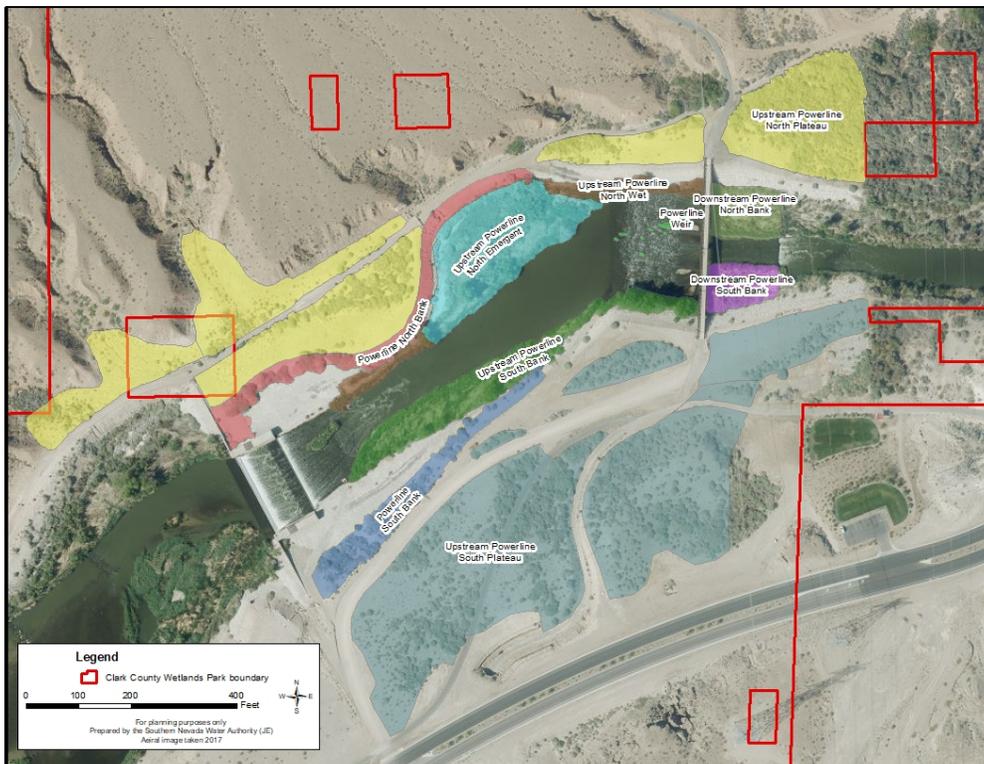
Figure 20. Revegetation areas associated with the Powerline Crossing Weir.

The Powerline Crossing Weir has had vegetation removed from the face in past years and this will likely be a recurring management activity to ensure the proper function of the structure.

There are portions of non-wetland areas on both the north and south side of the weir that are bare or nearly devoid of vegetation. Substantial additional plantings could take place in these areas. The most successful plants at these sites have been saltbushes, so additional plantings should consist of other shrub species or trees to diversify the habitat.

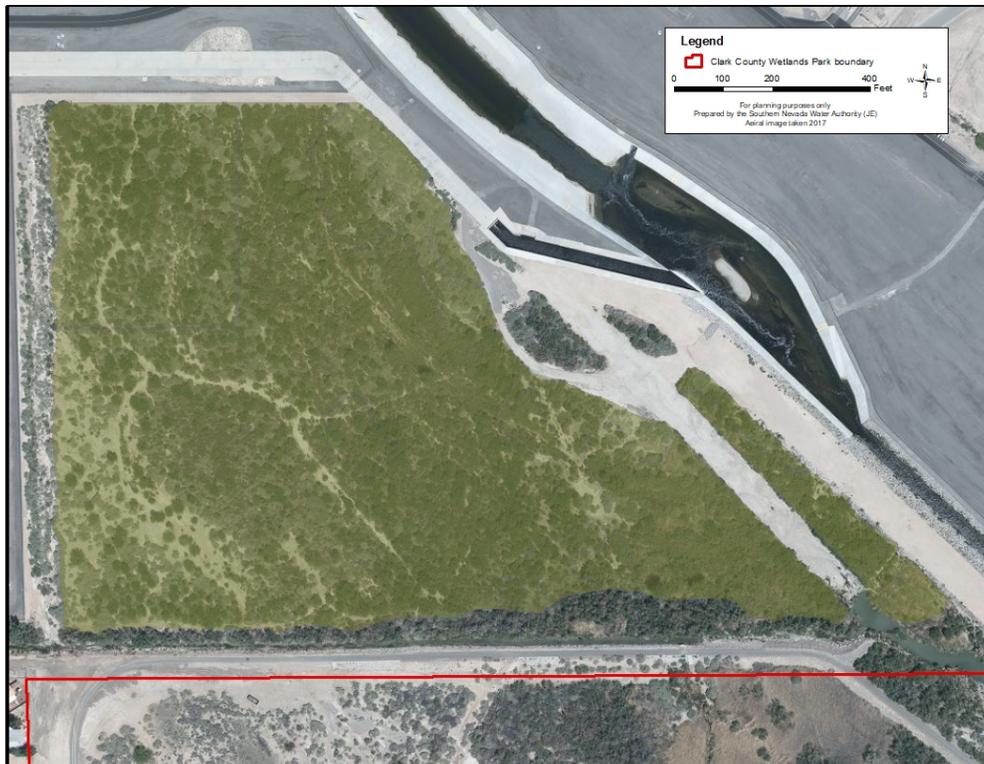
**Figure 21. The revegetation area located at the Clark County Water Reclamation District.**

A 28-acre revegetation project on the Clark County Water Reclamation District property was completed in 2009. The site was very successful with fast growth of planted plants and self-establishment of other native plants. There has also been a lot of establishment from non-native plants including noxious weeds such as salt cedar and tall whitetop. This is the only current management need for the site. The site is upstream of all the other revegetation sites along the Wash and therefore controlling the weeds on this site should reduce efforts needed downstream.

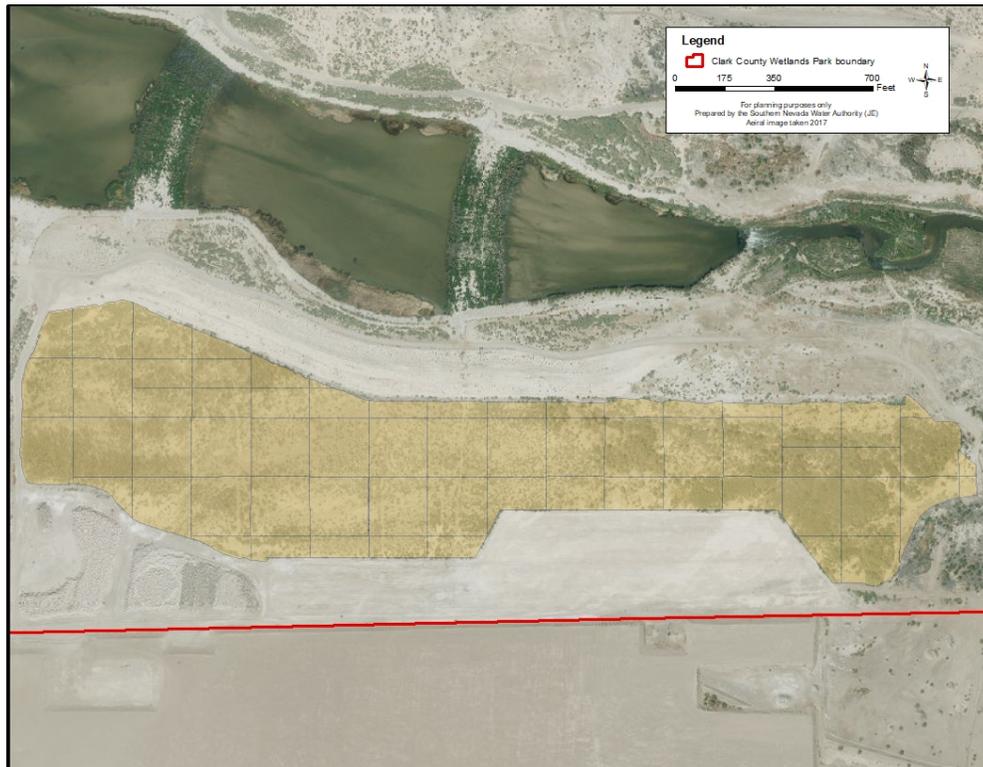
Figure 22. The Site 108 revegetation site.

This large site (just over 40 acres) was planted in 2006 and 2007. The plantings have done very well, and the species and types of plants are quite diverse. The only management need is salt cedar

removal. In the most recent vegetation monitoring, about 3% of the site was covered in salt cedar. Given the low percentage, it should be removed when most cost effective but is not a high priority.

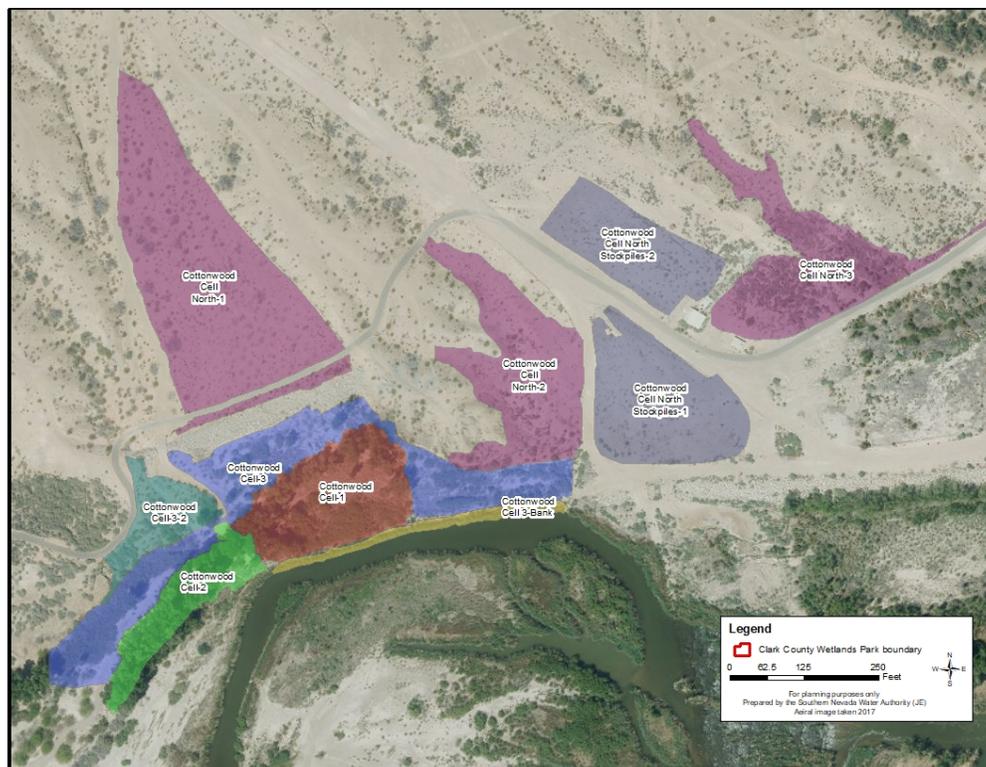
Figure 24. The Cottonwood Cell revegetation areas.

The area known as the cottonwood cells have been planted in various phases and consist of diverse habitat types. The original two cottonwood cells were established as nurseries for cottonwood pole collection for future restoration needs. It was rarely used for this purpose and the trees have grown substantially larger and denser than expected. The cottonwoods in Cottonwood Cell 1, planted in 2002, have been thinned naturally by beavers. Unfortunately, the void they left was primarily filled by johnsongrass, a state-listed noxious weed. While it has already been treated a few times, this may be a recurring management task, to keep it under control. Where these non-natives are removed, additional riparian plants should be planted. Specifically, understory plants to complement the large cottonwoods and Goodding's willows on the site. Cottonwood Cell 2 to the west, planted in 2005, has not had natural or mechanical thinning. The trees are likely to be healthier and the site can develop into a mature habitat if half or more of the cottonwoods are removed. After, like Cottonwood Cell 1, additional understory riparian plantings should take place to diversify and improve the habitat.

The second phase of plantings in this area took place in 2012. The areas planted at that time included additional riparian areas adjacent to the original cottonwood cells, as well as multiple

non-wetland areas. All these plantings did very well with survivorship and have limited weed encroachment. Some sizable portions of these sites were removed with the Historic Lateral Weir expansion project and will be planted again in the future.
