## Las Vegas Wash Vegetation Monitoring Report, 2014

**SOUTHERN NEVADA WATER AUTHORITY  
Las Vegas Wash Project Coordination Team**

**Las Vegas Wash Coordination Committee**

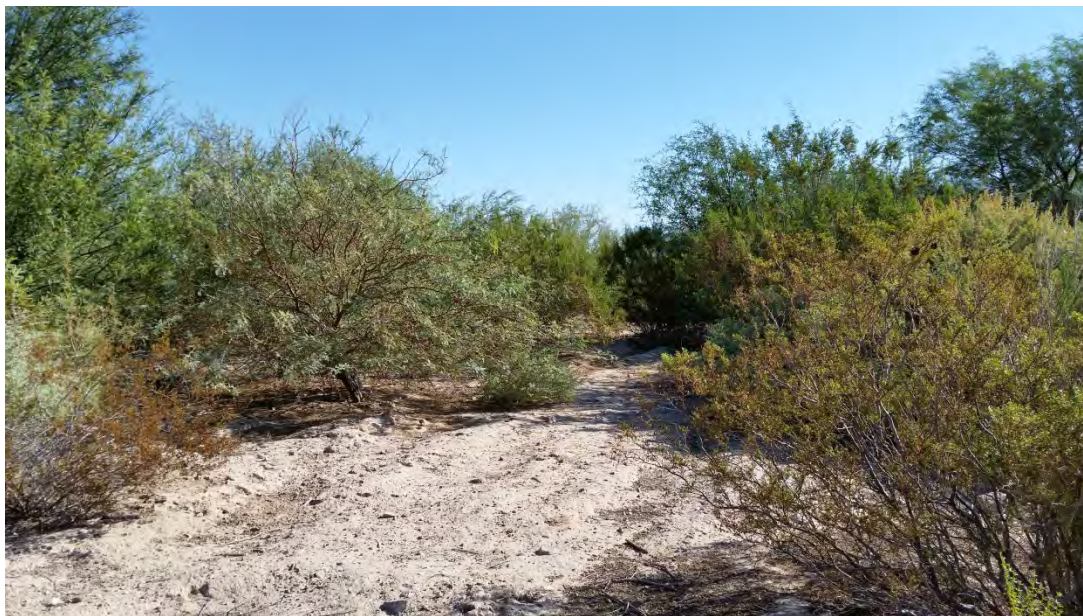
**Figure 4. Mature upland vegetation at Upstream Bostick South Bank in 2014.**

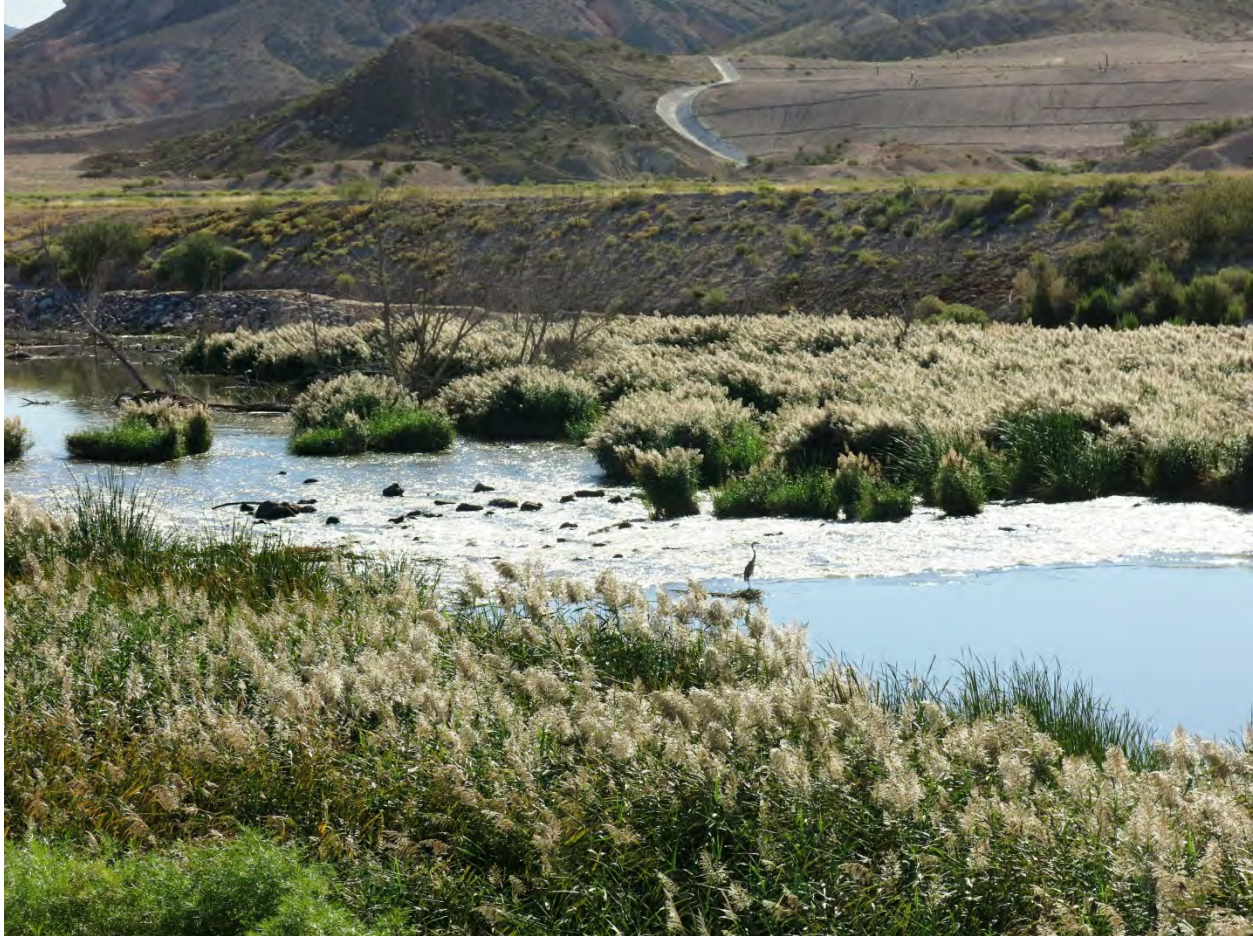
**Figure 6. Common Reed is the dominant vegetation on the Calico Ridge Weir.**

Like Bostick Weir, very little maintenance is done on sites at the Calico Ridge Weir. Also, like Bostick Weir, there are now bike trails and increased visitation to these sites which may require additional maintenance (i.e., increased public use may result in litter or other trash that needs cleaning or intentional/unintentional plant damage). Downstream of the Calico Ridge Weir (Figure 6), are the Lower Narrows and Homestead Weirs and because these areas are newer, they have been recently irrigated; nearby irrigation often increases the spread of weeds. While there has not been any substantial increase in weeds at this time, the sites will be monitored to ensure they do not become a problem.

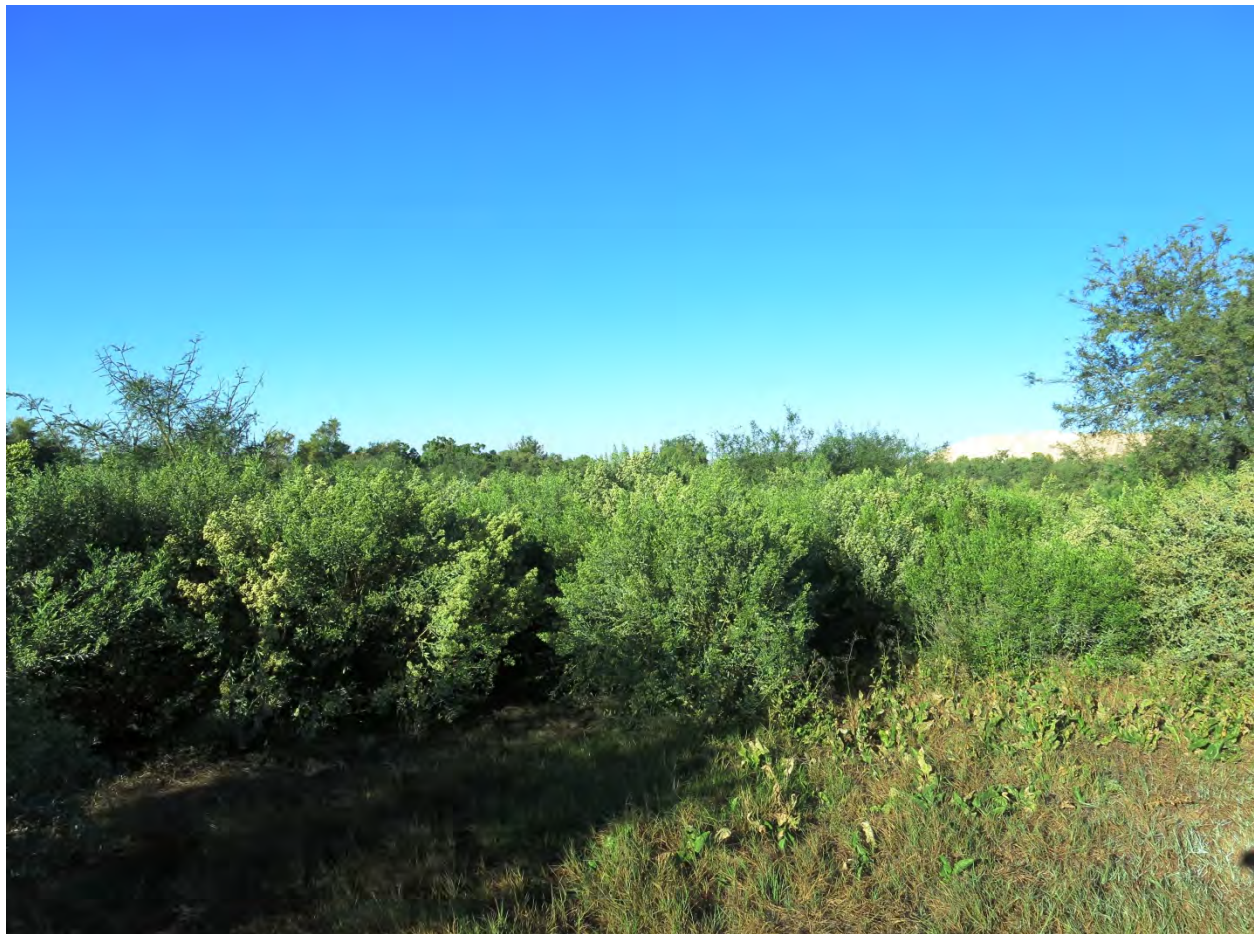
Using ArcGIS, total cover of the site was slightly higher in 2014: 76.8% compared to 72.9% in 2013 (Figure 8). Maintenance activities on this site regularly take place after any substantial rainfall in the Las Vegas Valley because it receives flooding and substantial trash deposition. In 2105, major construction running adjacent to this site will likely impact it and maintenance could result from the disturbance.

**Figure 8. Vegetation at the Clark County Water Reclamation District sites continues to have high total cover in 2014.**

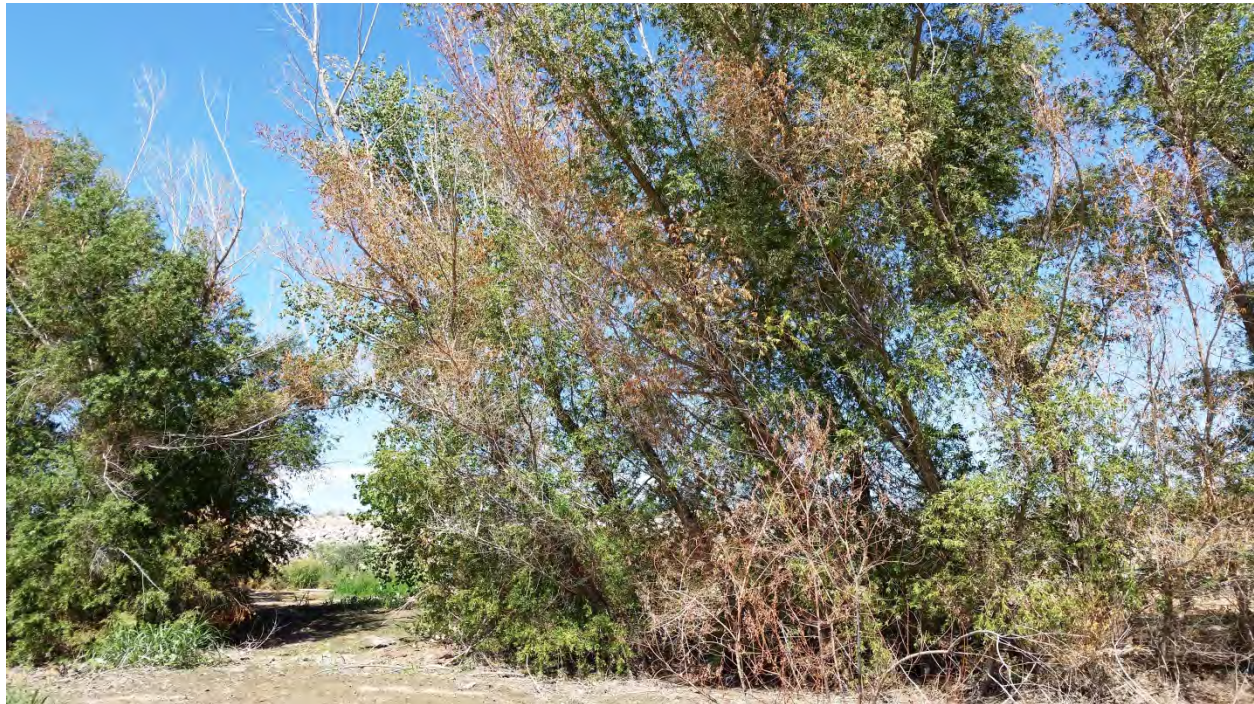
**Figure 10. Some mortality at Cottonwood Cell 1 has reduced the total cover in recent years.**

The natural die off of cottonwood trees in Cottonwood Cell 1 and 2 gives an opportunity to replant the site under the remaining cottonwood trees with a more diverse understory. This will improve the wildlife suitability and the increased spacing between trees should result in better health for those that remain. Cottonwood Cell 2 has not yet experienced the level of die off as Cottonwood Cell 1. It is recommended that the site have some cottonwoods thinned in order to prevent disease transmission. In conjunction, shrubs and other shorter trees should be installed to create various height structures and diversity.

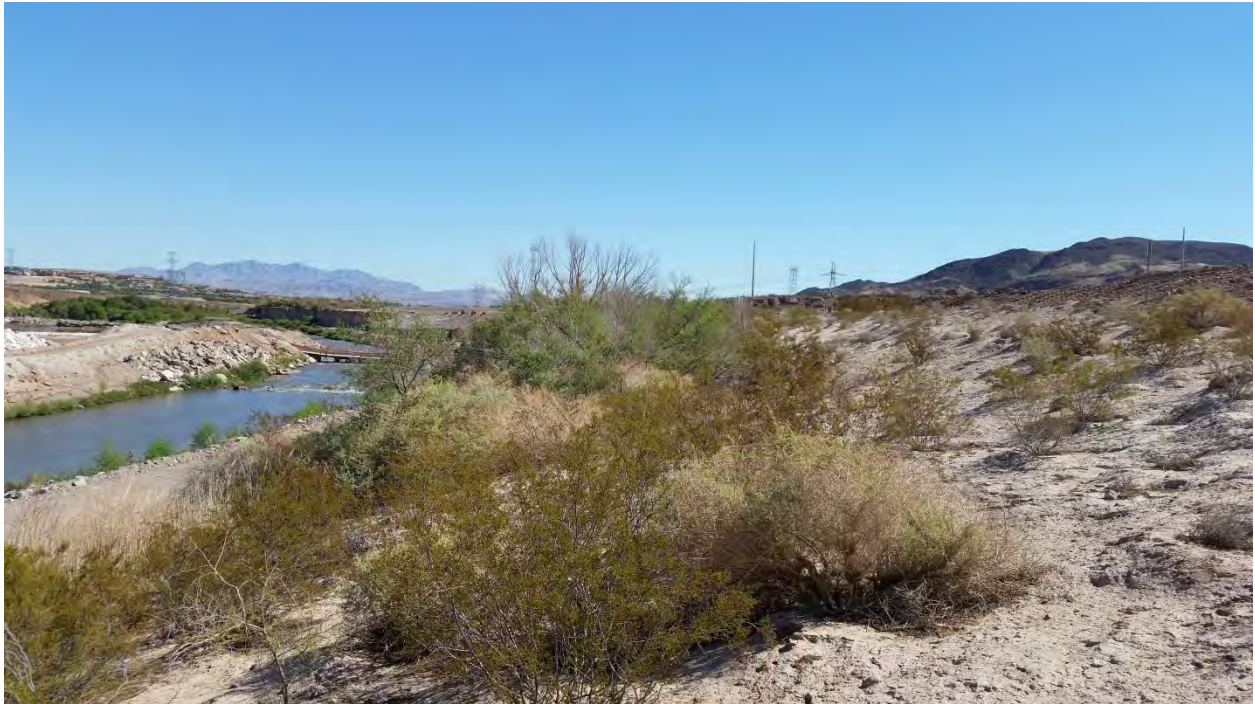
**Figure 12. Creosote bush dominates the Upstream Demonstration South-non-wetland site in 2014.**

Like most mature sites, maintenance activities on the Demonstration Weir have been limited for many years. However, the construction of the adjacent Three Kids Weir and CCWP bike trail (installed adjacent to the non-wetland site) have impacted the site's hydrology and topography. It is expected that additional maintenance activities will be needed in the upcoming years with most being accomplished in conjunction with revegetation of the Three Kids Weir itself.

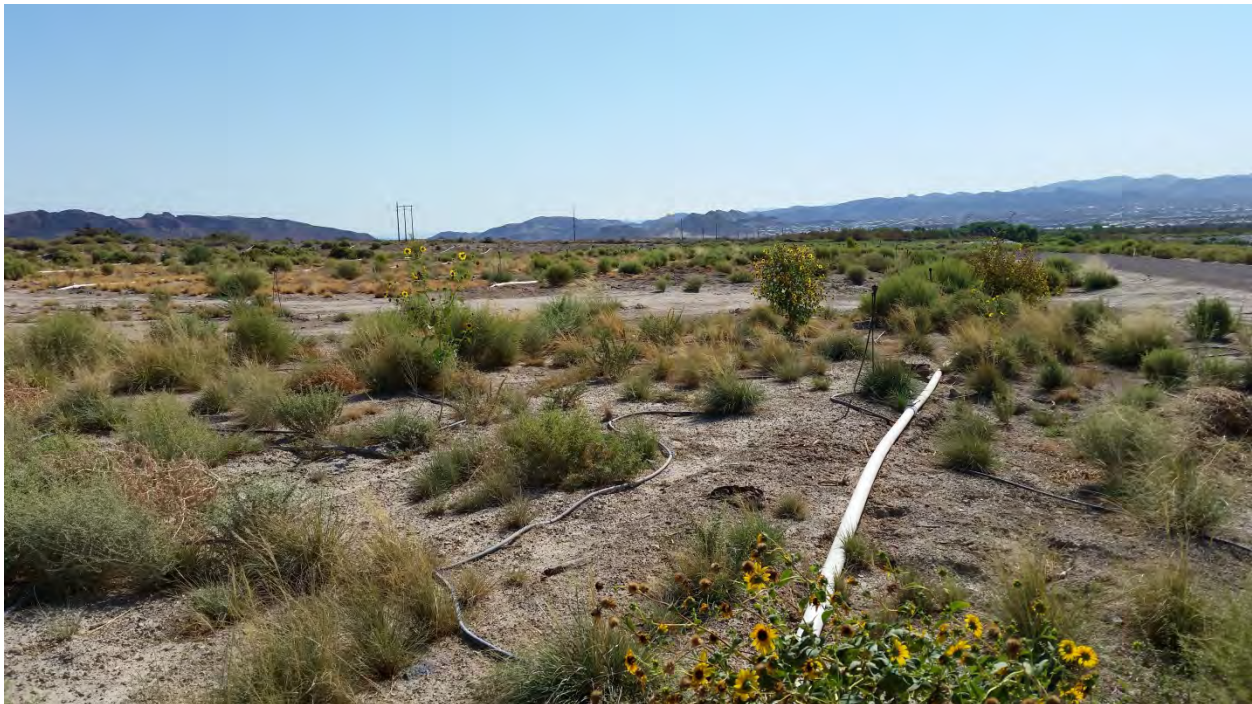
**Figure 14. Diverse vegetation covers the Duck Creek Upper Narrows North revegetation site in 2014.**

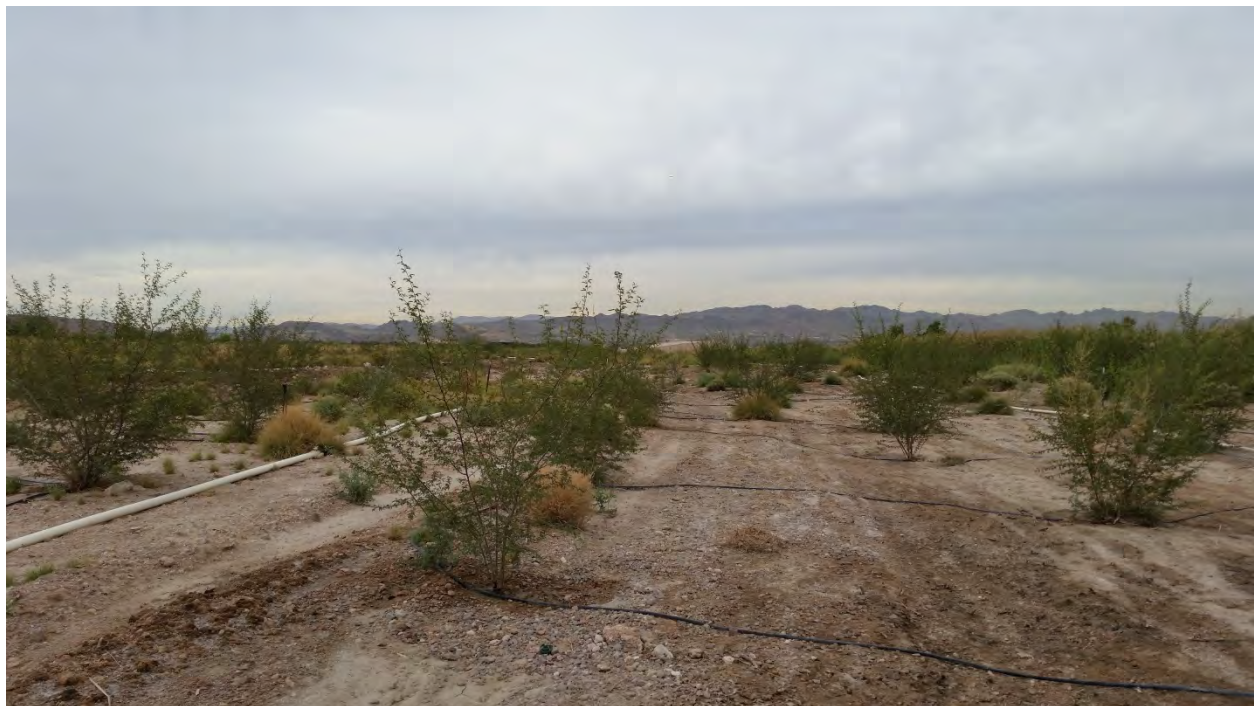
(Figure 16). The upland area north of the DU Wetlands No. 1 Weir was not planted due to its proximity to the construction area near the Archery and Silver Bowl Weirs. These weirs were completed at the end of 2014, and the area will be planted in 2016.

**Figure 16. Screwbean mesquites at DU Wetlands No. 1 South have matured substantially in their first two growing seasons.**

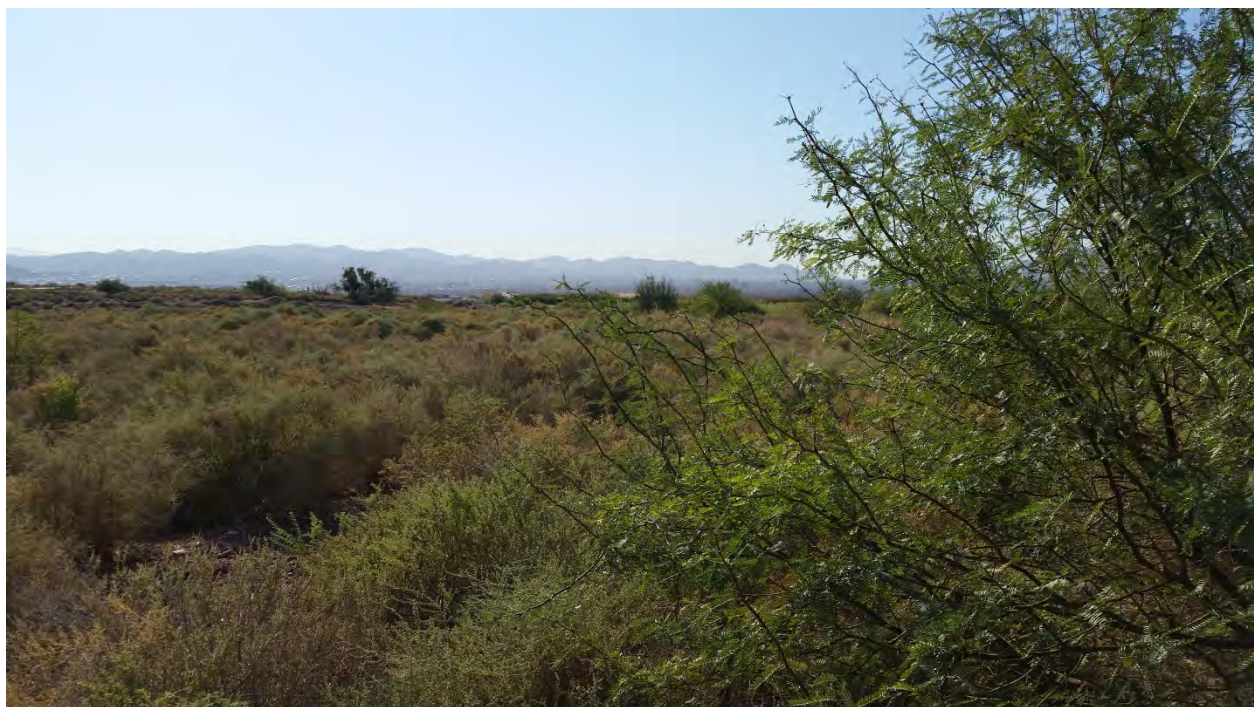
**Figure 17. Desert saltbush and honey mesquite dominated the DU Wetlands No. 2 North revegetation site in 2014.**

Once sites reach the fourth or fifth growing season as these have, there is minimal regular maintenance involved. These sites also have very little traffic from park visitors, limiting disturbance. The only exception in upcoming years is the removal of a small patch of Russian knapweed that was discovered in 2013 and has grown to 2.5% of the site's cover in 2014.

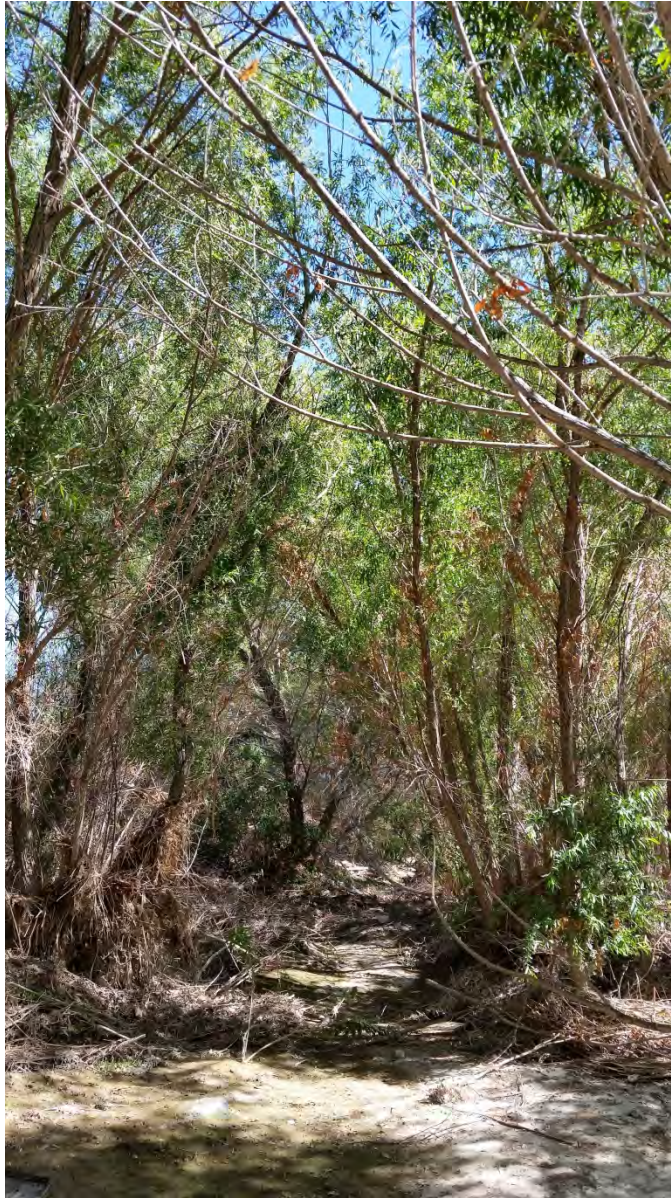
**Figure 20. Upstream Historic Lateral North South has naturally formed channels as a result of flooding events.**

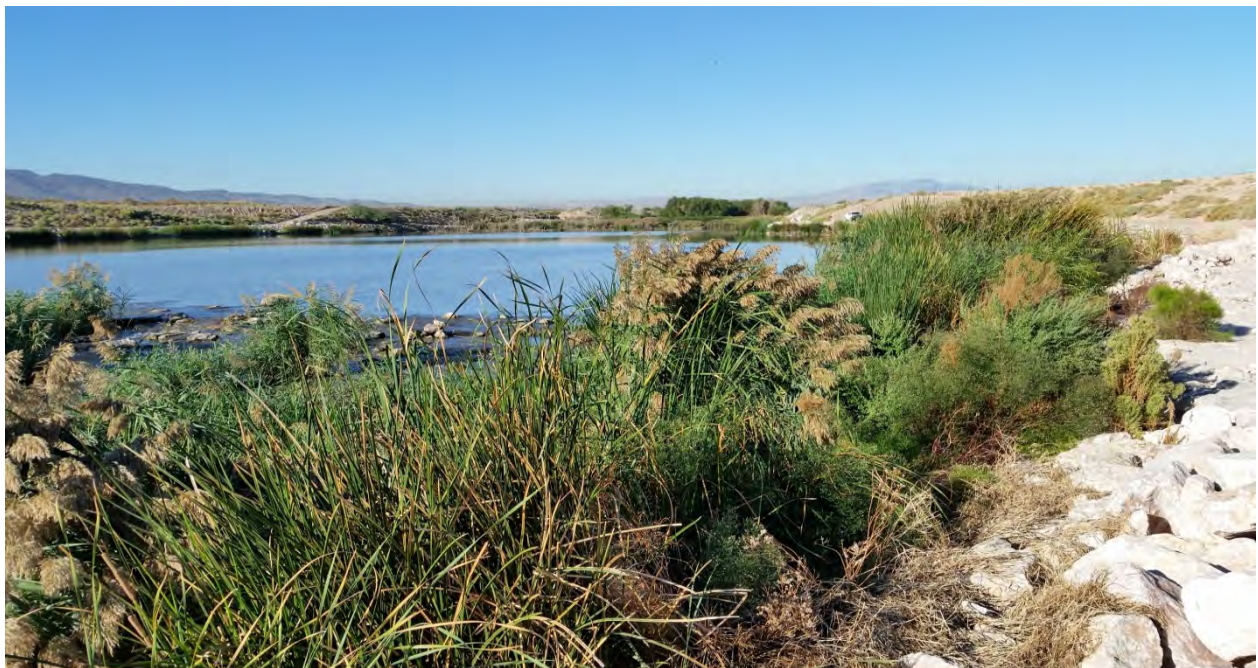
**Figure 21. Lower Narrows Homestead Emergent has dense vegetation lining the banks of the Vegas Wash.**

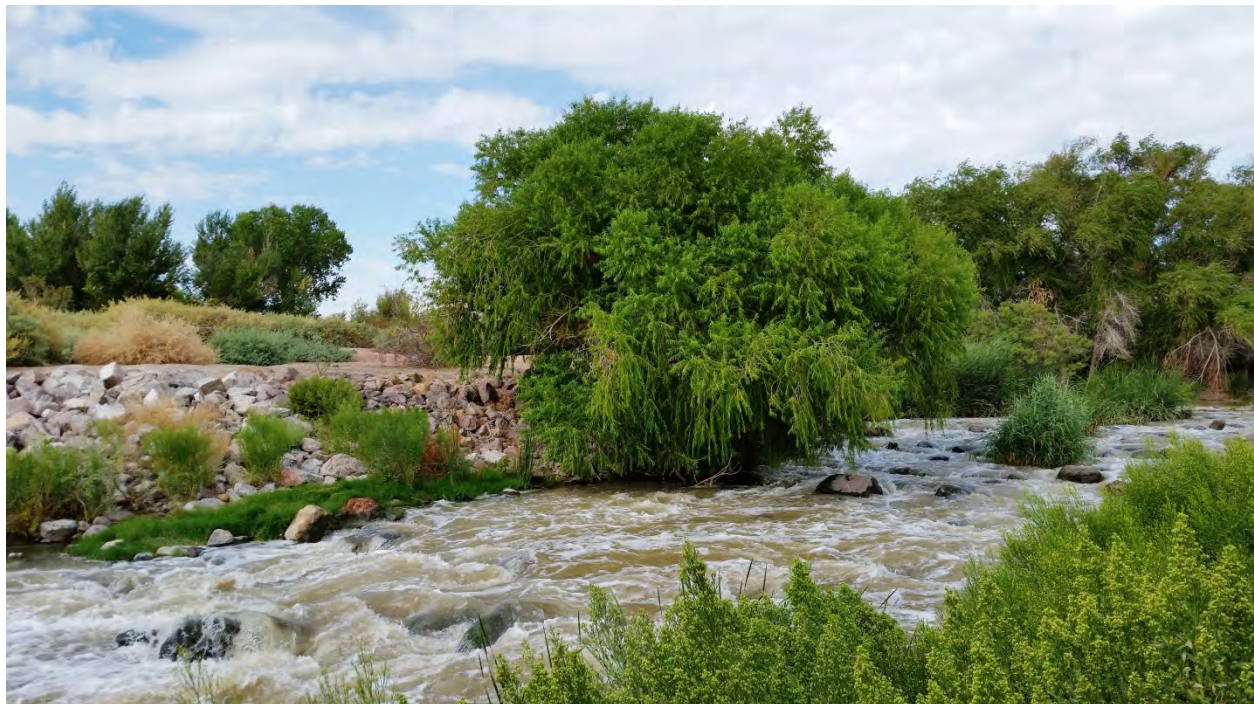
**Figure 23. A large Goodding's willow grows on the bank of the Las Vegas Wash at the Downstream Monson North-wetland revegetation site in 2014.**

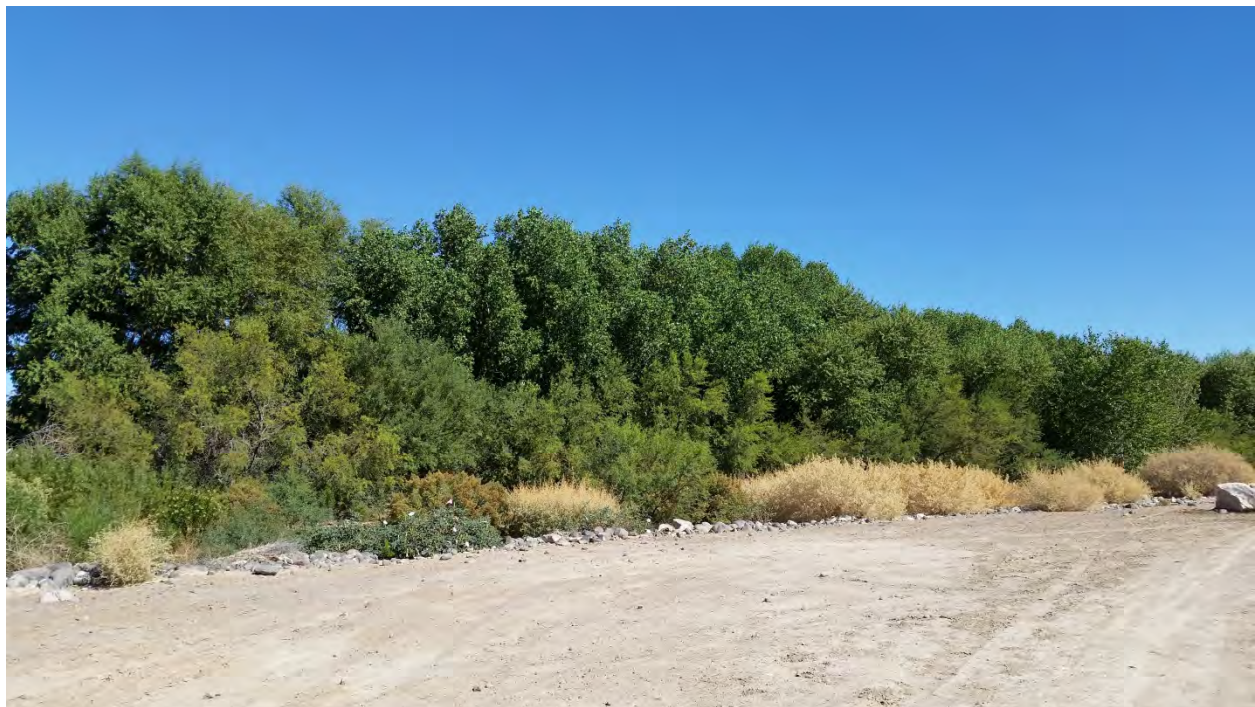
**Figure 25. Upstream Pabco South Lower Plateau was removed in 2014 for maintenance and preparation for the upcoming Sunrise Mountain Weir construction.**

Both older and newer sites have required little maintenance in the past few years. Success of the revegetation on newer sites has limited the required irrigation. Weed encroachment is frequently associated with the level of irrigation applied; therefore, irrigation is ceased as soon as possible after native plants have been established. After monitoring concluded in 2014, the CCWP trail was installed adjacent to many of these sites and currently terminates at the Pabco Road Trailhead, which will bring many more visitors to the area. Also, construction activities in preparation for the Sunrise Mountain Weir has removed Upstream Pabco South Lower Plateau (UPSLP), a component of Upstream Pabco South (Figure 25). When construction is complete, the Wash channel will extend southward to the previous southern boundary of the UPSLP and the altered hydrology will definitely effect the surrounding vegetation.

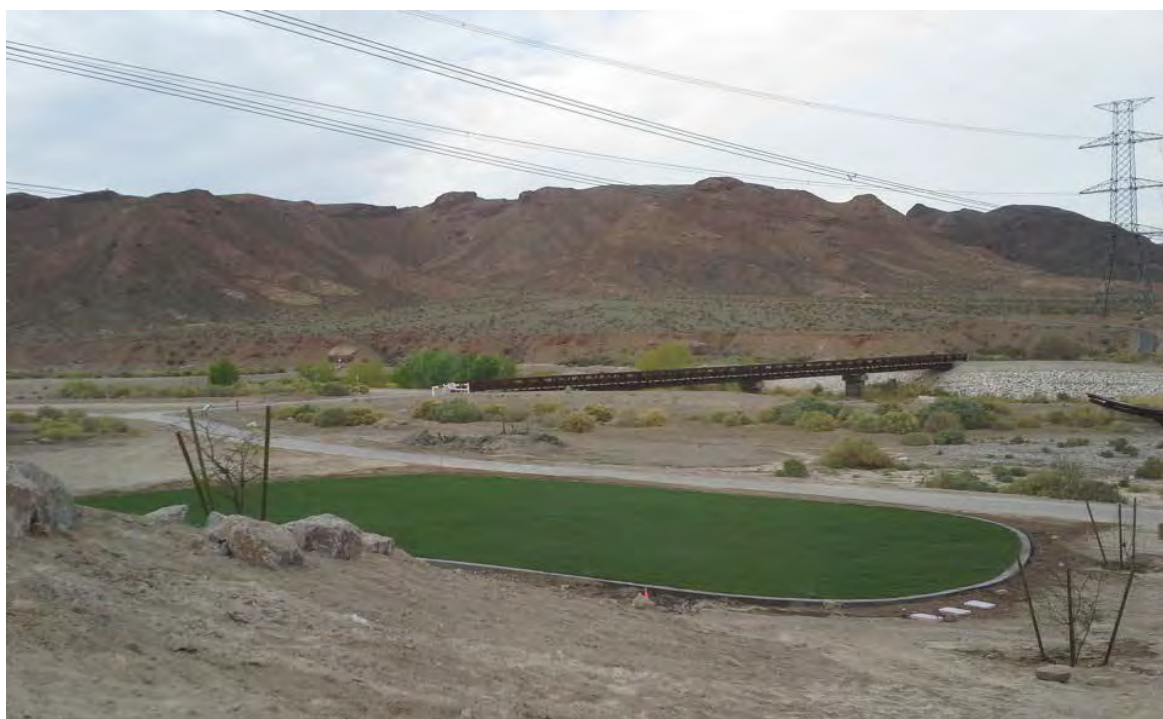
**Figure 28. The new city of Henderson Park near the Powerline Crossing Weir.**

Only two of the nine revegetation sites at the Powerline Crossing Weir were monitored in the field for all plant attributes in 2014: Upstream Powerline North Bank and Upstream Powerline North Emergent (Figure 27; Table 15). They were all in their eighth growing season and have very mature vegetation. The required minor maintenance activities in the past year included clean-up of debris resulting from construction of a nearby park in the City of Henderson (Figure 28). With the CCWP trail system now connected to the bridge associated with the weir, along with the proximity to the City of Henderson's new park, it is expected that this area will see more visitation in upcoming years which may lead to additional maintenance needs.

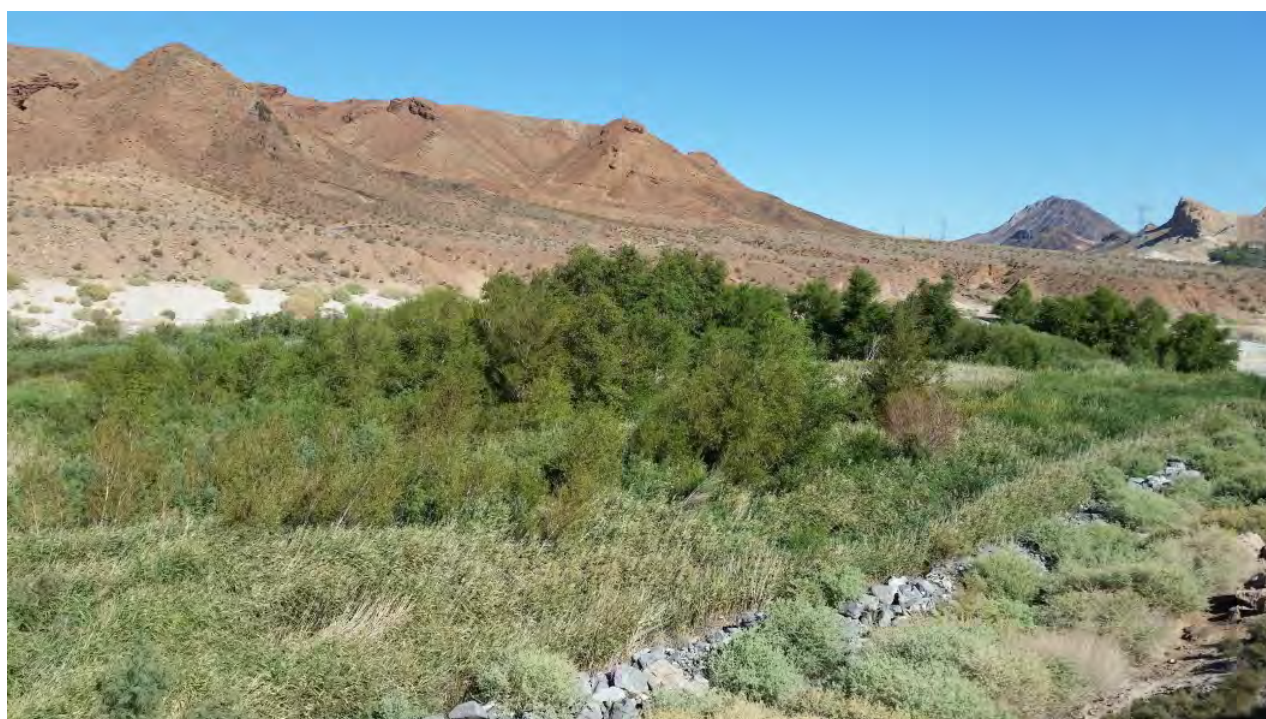
**Figure 30. Large Goodding's willow trees filled the Rainbow Islands revegetation site in 2014.**

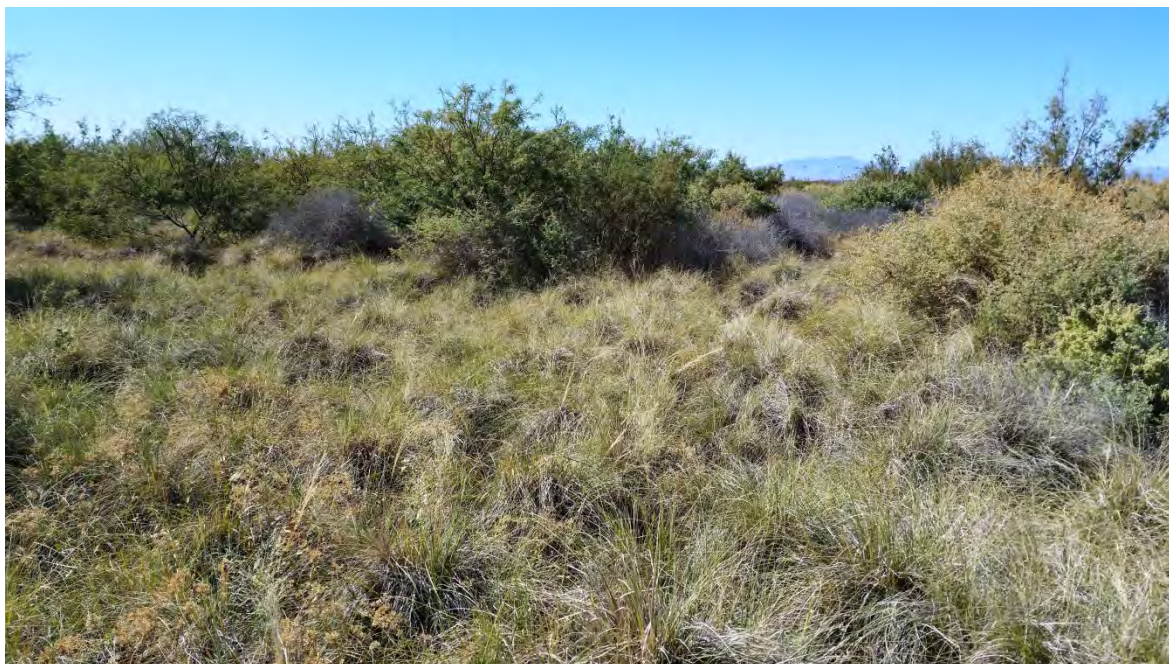
**Figure 31. Alkali sacaton had filled in as a dense groundcover over much of Site 108 in 2014.**

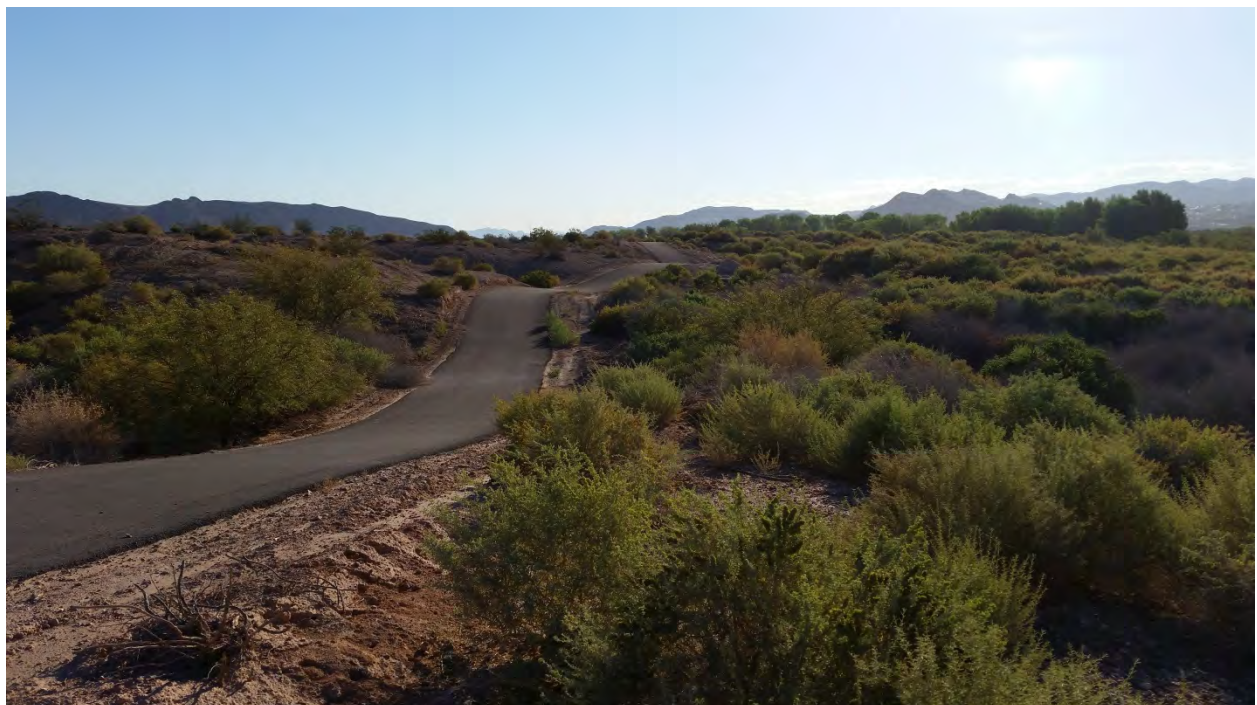
**Figure 33. The Clark County Wetlands Park trail bisects much of Site 111.**

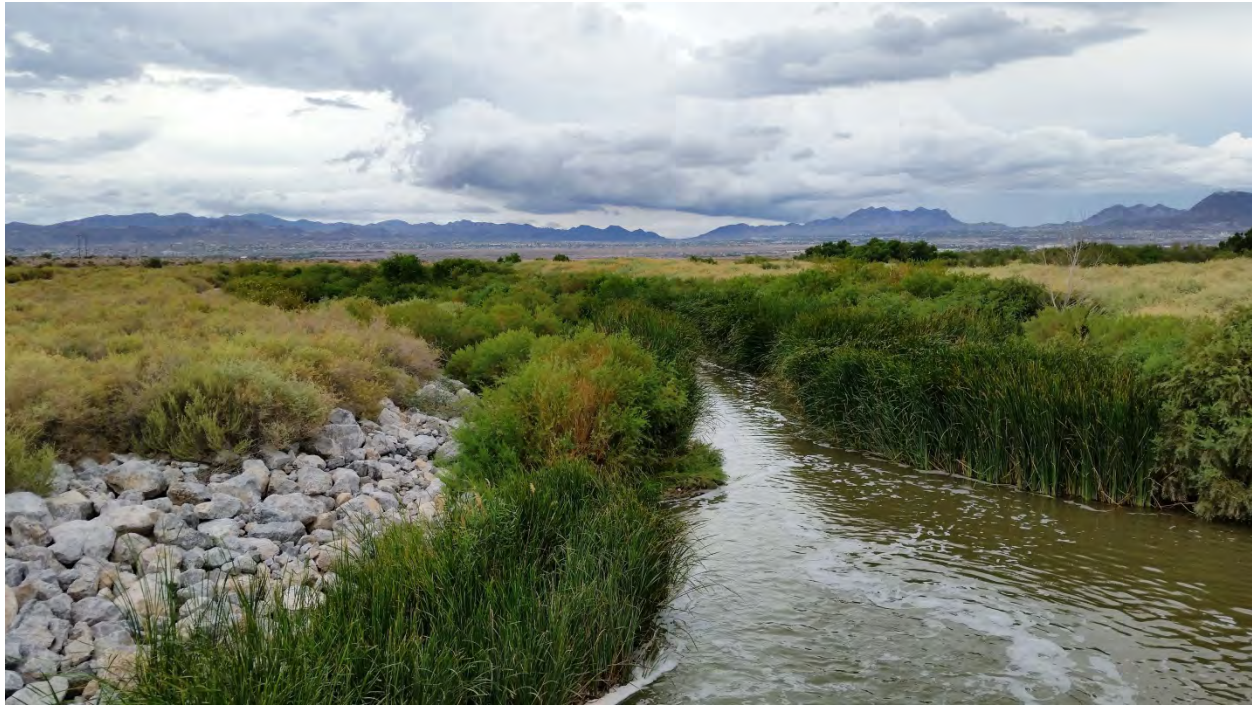
**Figure 36. Both non-wetland and wetland revegetation sites at the Upper Diversion Weir were densely vegetated with mature plants in 2014.**
