## Las Vegas Wash Vegetation Monitoring Report, 2015

**SOUTHERN NEVADA WATER AUTHORITY  
Las Vegas Wash Project Coordination Team**

**Las Vegas Wash Coordination Committee**

**December 2016**

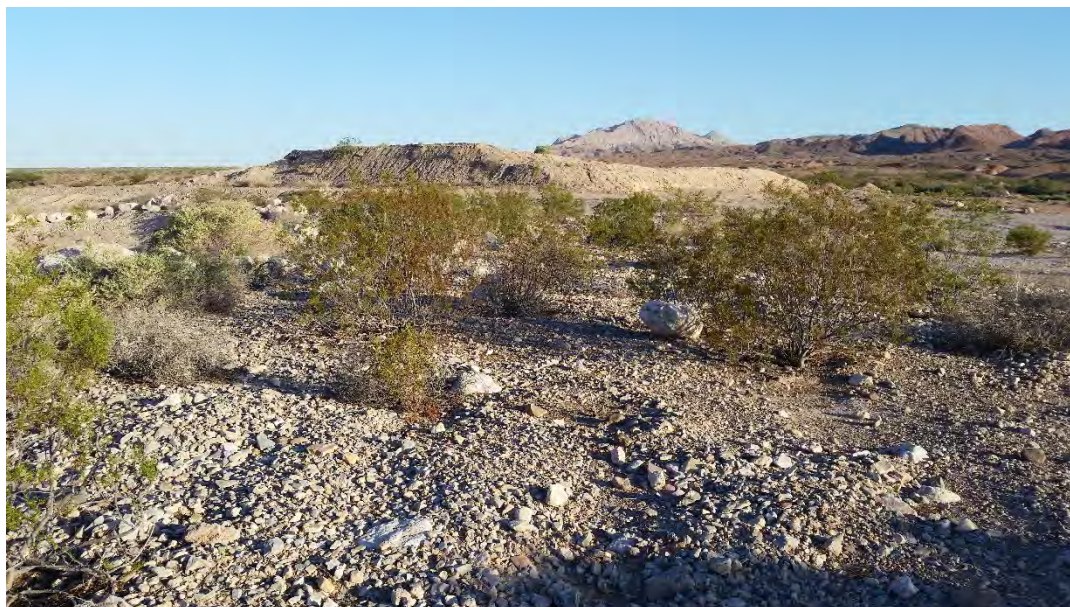
**Figure 3. Creosote bush dominate the Upstream Bostick North revegetation site in 2015.**

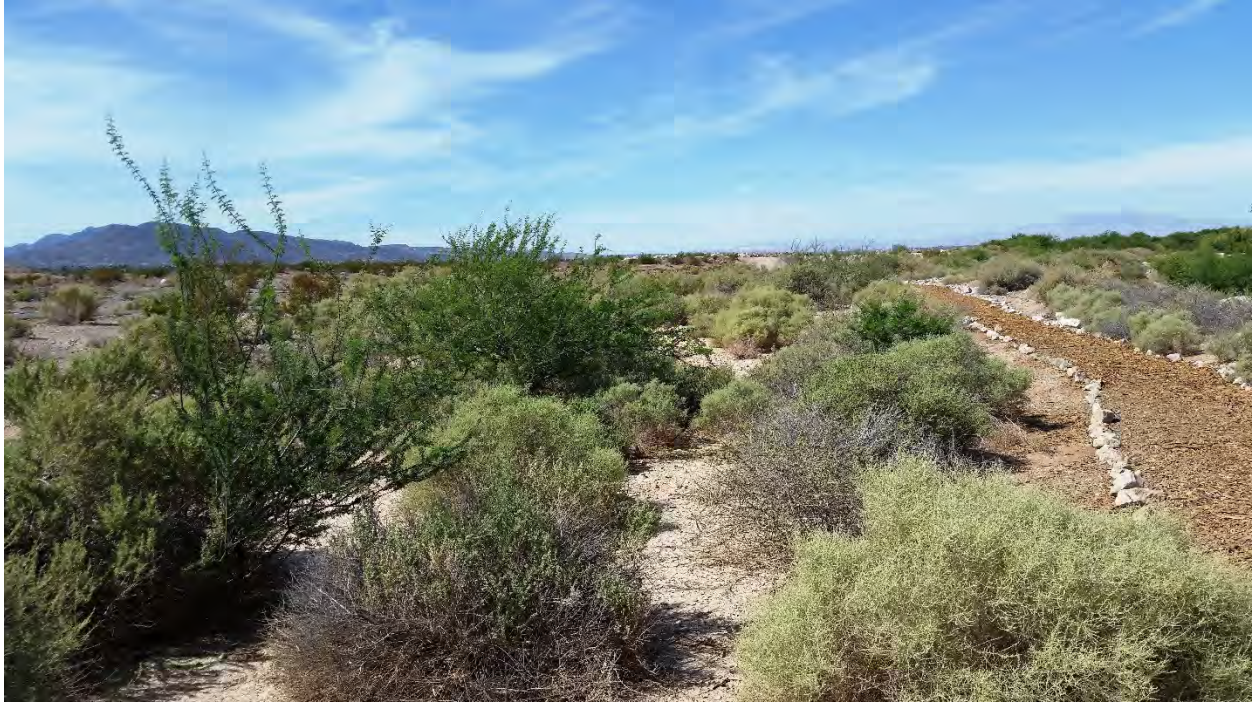
**Figure 6. Desert saltbush and cat-claw acacia are prominent in the Upstream Calico North non-wetland revegetation site in 2015.**

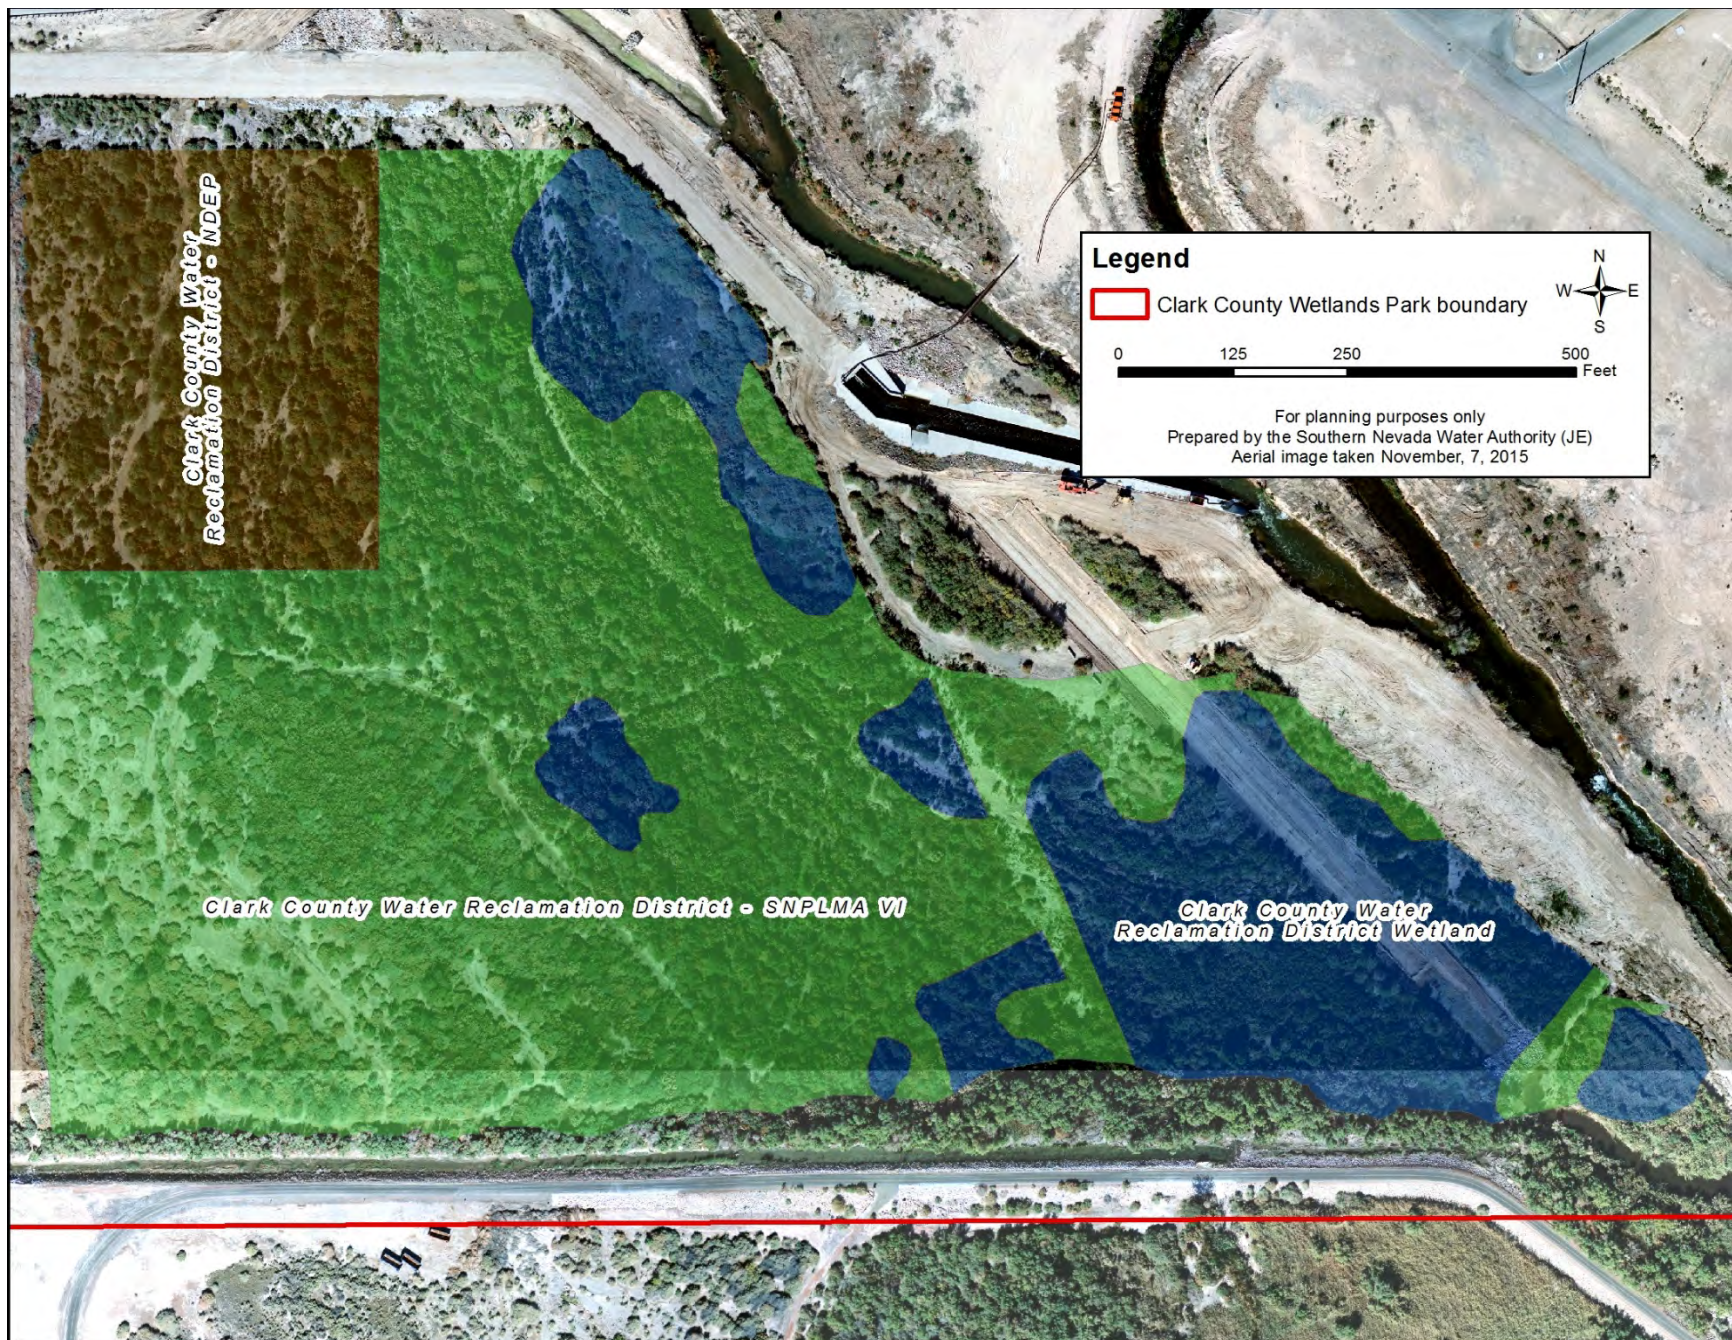
**Figure 7. Aerial photograph of the 2015 delineated Clark County Water Reclamation District revegetation sites.**

The site located at the CCWRD was monitored in 2015, its sixth year, in the field after exclusively using ArcGIS in 2014 (Figure 7; Table 5). It is made up of 29 semi-equivalent monitoring areas in terms of size categorized into wetland and non-wetland. The site as a whole as well as the separate wetland and non-wetland components all had lower total cover in 2015 as compared to 2014. This is likely due to the use of ArcGIS in 2014. There are many areas that are difficult to maneuver around in within this site as well as densely vegetated in some parts of monitoring areas while less dense in others. This makes it difficult in the field to make accurate assessments of the total cover. That being said, most areas were very similar to the measurements of ArcGIS as well as the previous in field measurements in 2013.

The percentage of cover in terms of noxious weeds has increased over the past few growing seasons. It is now over 10% of the site as a whole and over 13% in the wetland monitoring areas. The increase can mostly be attributed to the increase in tamarisk on the site. There is still a stand of tamarisk on the southern border of the site along Monson channel, kept in place for security concerns. In addition, up to the time of the 2015 monitoring there was a stand of tamarisk to the

west of the revegetation site as well. This stand was removed as part of the current construction project. These two stands likely resulted in the reestablishment of tamarisk on the site which dominated the site prior to 2010. As noted in previous reports, the shallow groundwater table as well as often the presence of surface water makes this site easy for self-germination of all types of plants.

Soon after 2015 monitoring concluded, a major construction project commence on the CCWRD property adjacent to this revegetation site. The Wash channel will be lined through the CCWRD property. There are known immediate impacts due to having to clear some vegetation to make room for construction. There are also likely unknown impacts such as how the lining will impact groundwater levels and flooding impacts. It is unknown if the project will allow for field monitoring in 2016 to determine the impacts.

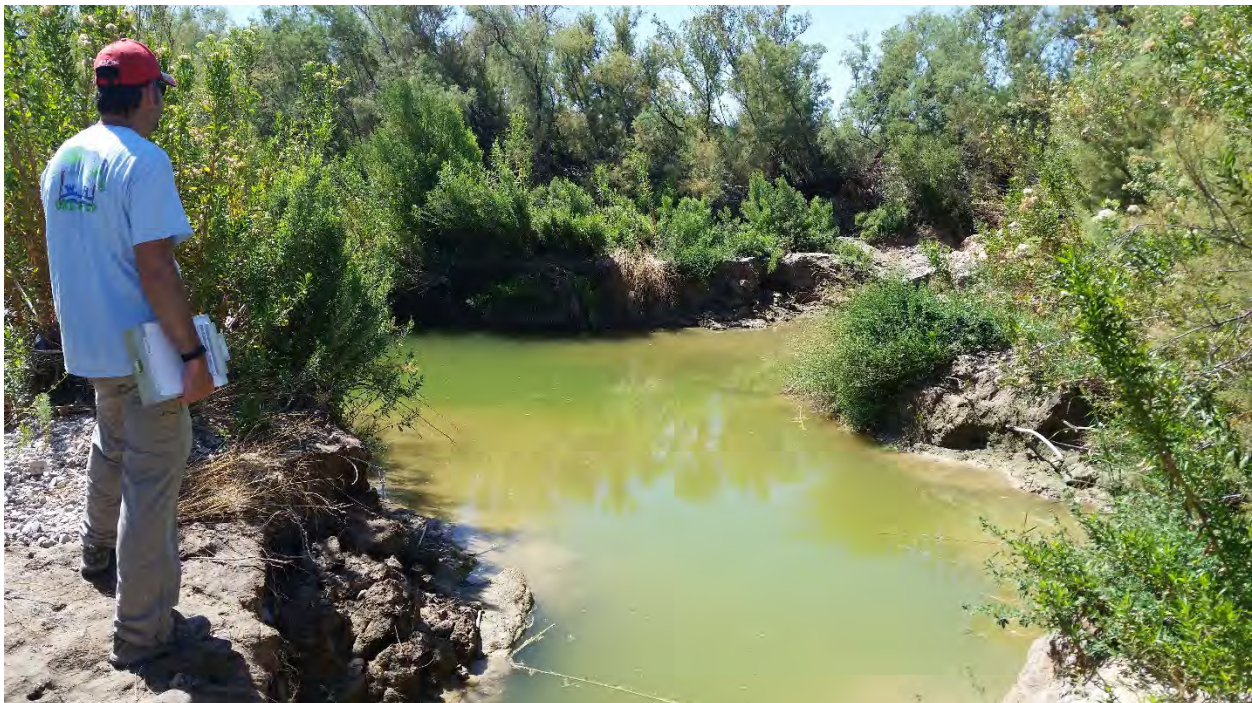
**Figure 8. Erosion reveals how shallow the groundwater is at the Clark County Water Reclamation District revegetation site in 2015.**

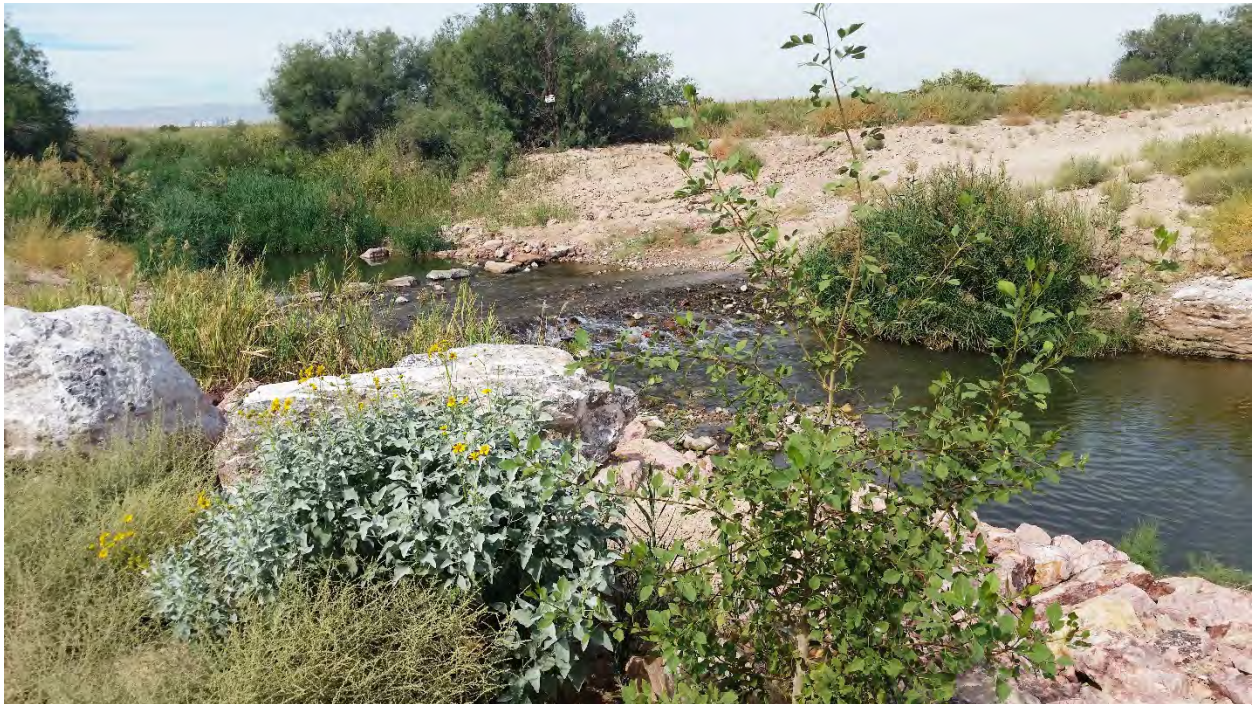
**Figure 13. Established vegetation at the Duck Creek Upper Narrows South 2 revegetation site along the banks of the Duck Creek Channel in 2015.**

The two newest actively planted sites are on pace with most Wash revegetation sites in terms of species richness and total cover. Survivorship however, was lower than average on both sites. DCUNS2 had 72.3% survivorship and DCUNS3 had 51.7%. The average for most sites in the past years was closer to 80%. It is difficult to determine what the cause of the low survivorship is, the majority of plants found to be dead during monitoring were not able to be identified. This is common during survivorship measuring since most distinguishing characteristics are no longer visible. But the plants were found in basins dug for plants and often had drip irrigation emitters nearby. Despite the concern with survivorship, those that made it to monitoring time were growing well and there are few noxious weeds to be concerned with (Table 8). Therefore further monitoring will be needed to ensure ultimate success of these sites.

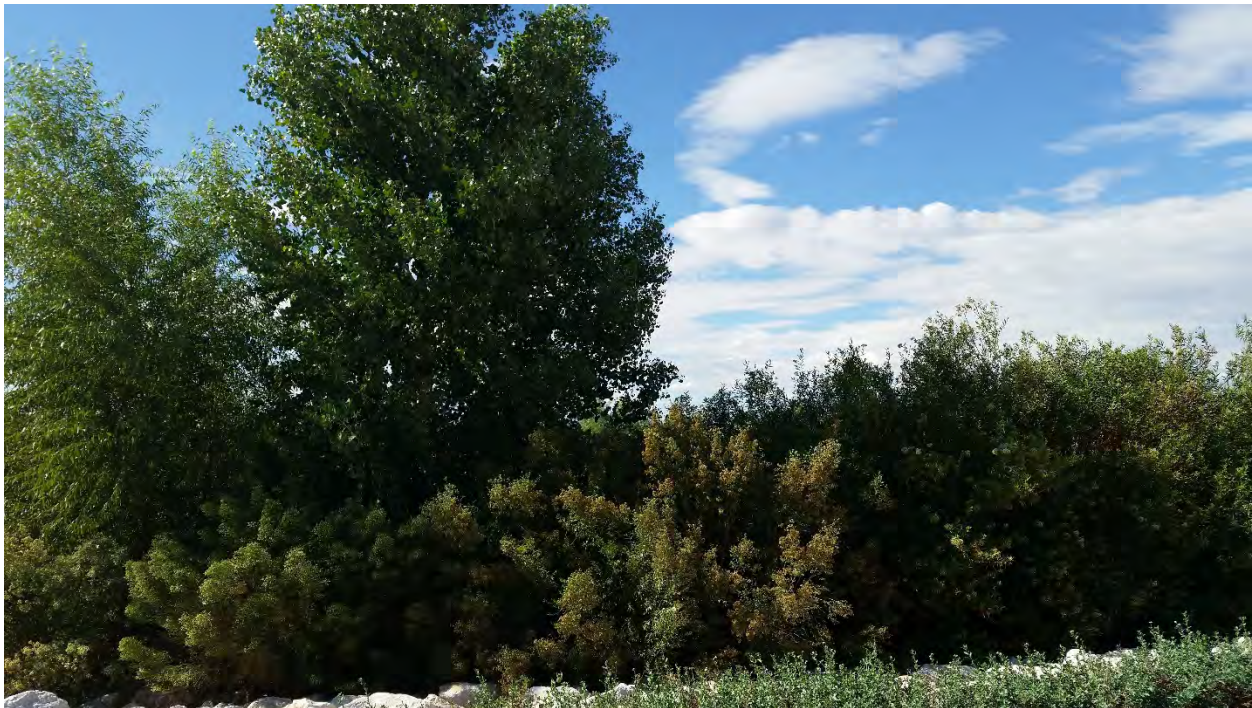
**Figure 15. Mature riparian vegetation along the banks of the Wash at the DU Wetlands No. 1 North revegetation site in 2015.**

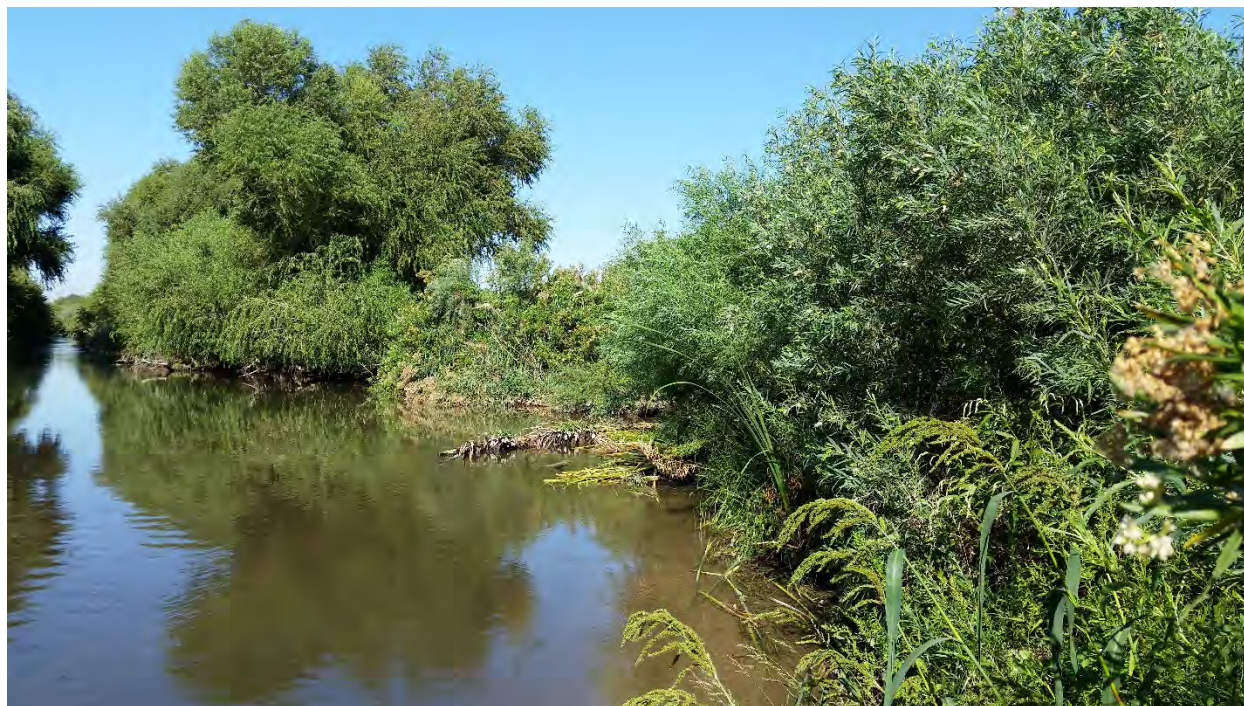
**Figure 17. Upstream Historic Lateral North - Wetland has very dense riparian and wetland vegetation in 2015.**

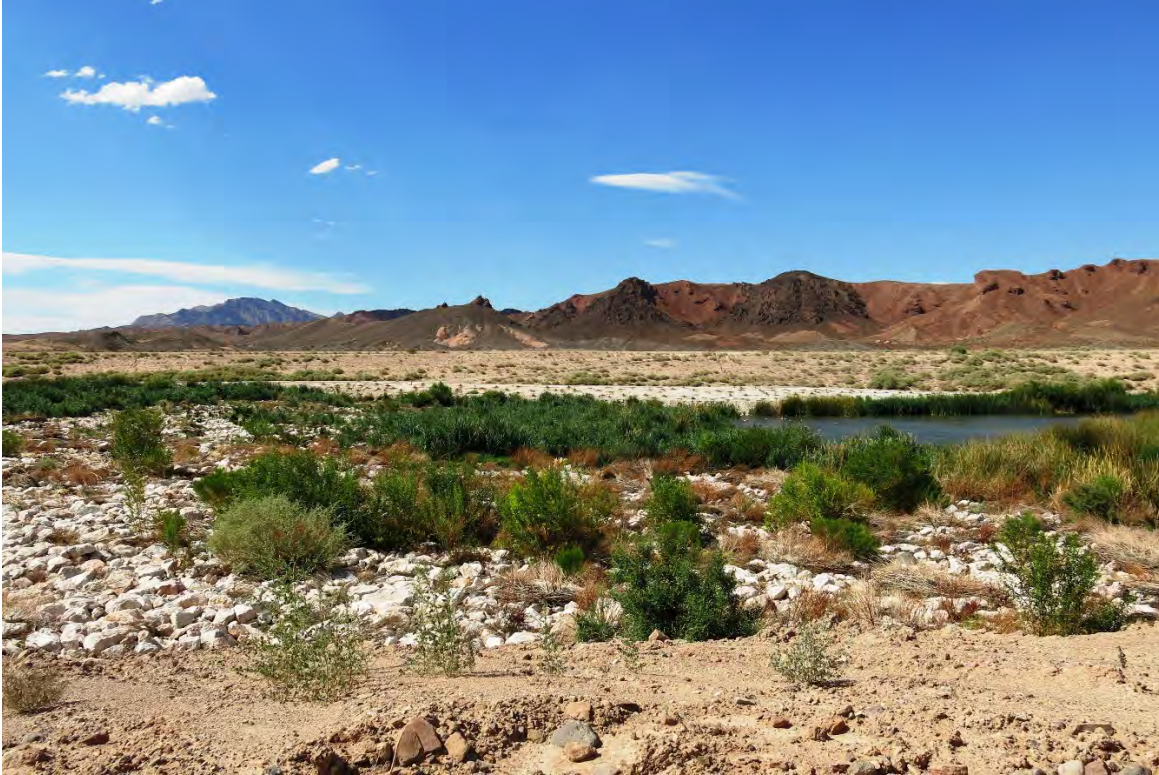
**Figure 19.** The Homestead Weir had nearly four and a half acres of vegetation established on it in 2015.

This part of the Wash was one of the most incised and as a result, the upland areas are 30 or more feet off the floodplain of the Wash. This results in the areas being very dry and will likely not see very high plant cover. Both Lower Narrows Homestead South 1 and 2 have 50-75% total cover with the vast majority of it coming from a single species, four-wing saltbush (*Atriplex canescens* var. *canescens*). Some additional plantings will take place in 2016 and 2017 to increase diversity on the sites. With the harsh conditions better understood, appropriate plant material will be more likely to succeed.

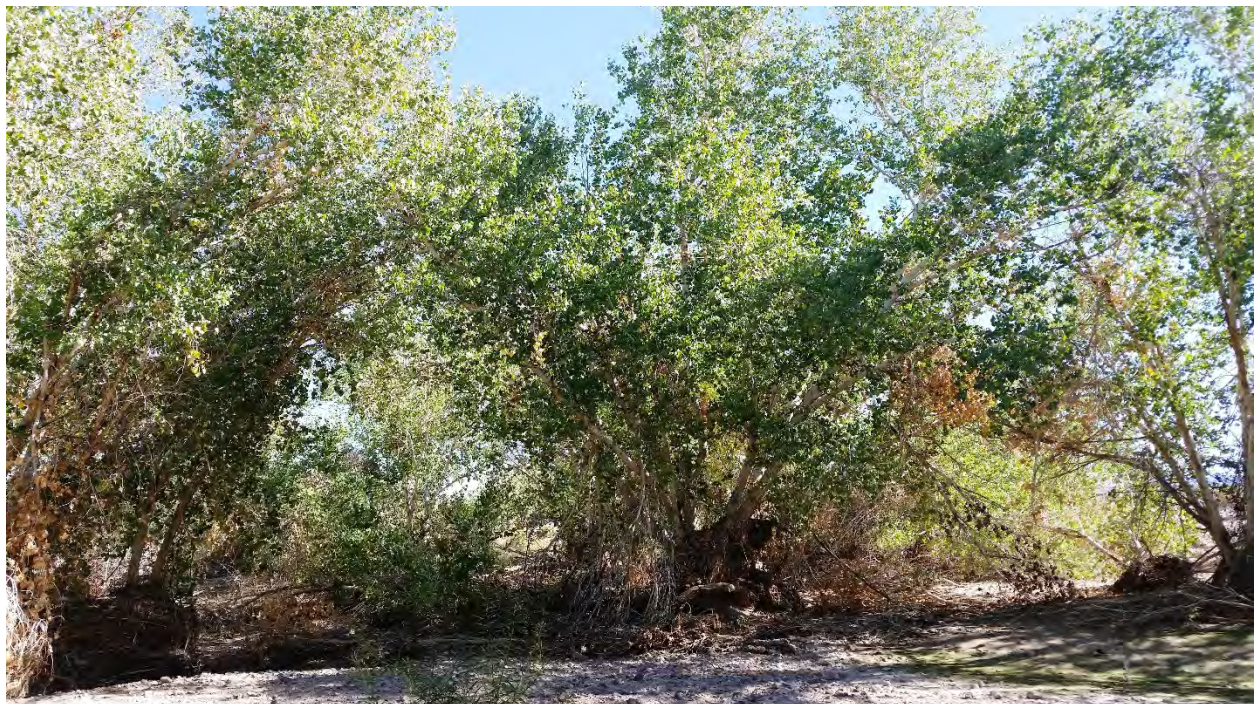
**Figure 22. Mature cottonwood trees fill the Downstream Pabco South revegetation site in 2015.**

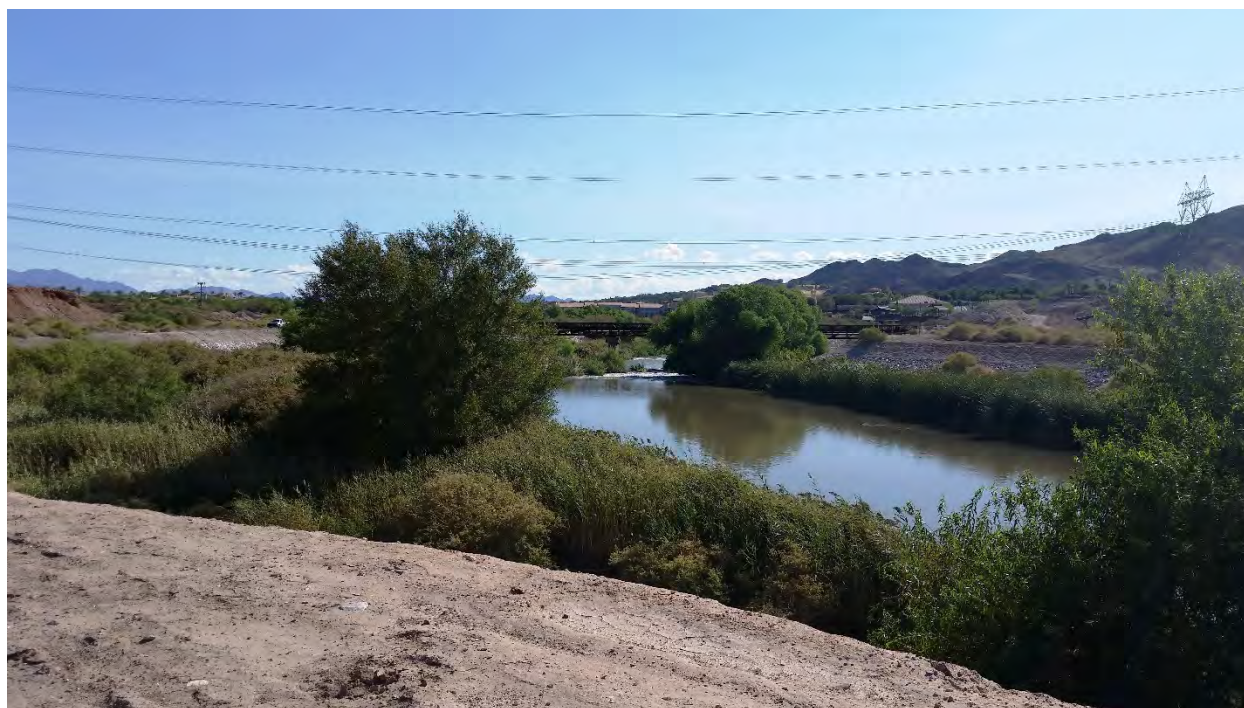
**Figure 25. Riparian and wetland revegetation sites at the Powerline Crossing Weir have varied structure in 2015.**
