Las Vegas Wash Vegetation Monitoring Report, 2024

SOUTHERN NEVADA WATER AUTHORITY Las Vegas Wash Project Coordination Team

Las Vegas Wash Coordination Committee

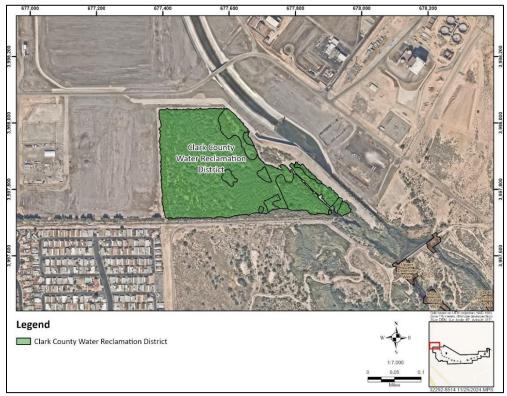
Figure 3. Aerial photograph of the previous Clark County Water Reclamation District revegetation site boundary.

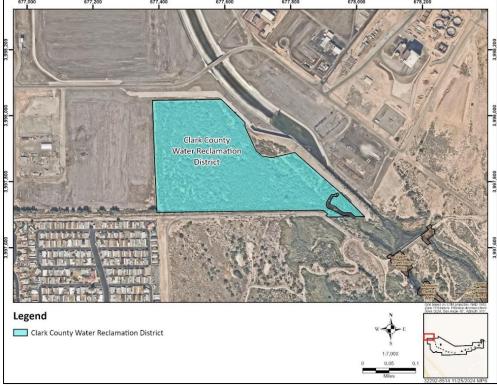
Figure 4. Aerial photograph of the new Clark County Water Reclamation District revegetation site boundary.

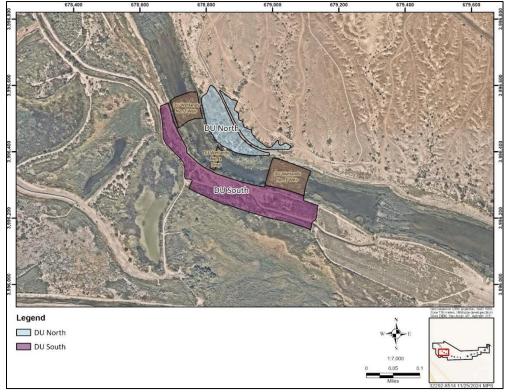
Figure 10. Aerial photograph of the new DU Wetlands No. 2 and No. 1 weirs revegetation site boundaries.

DU Wetlands No. 1 Tamarisk, DU Wetlands No. 2 North and part of Archery and Silver Bowl North (ASBN) were combined to create DU North (DUN, Figure 10). DUN was the only site monitored in the field in 2024 (Table 7). It had a total cover class range of 50–75% and 13 species were identified. The calculated WPI was 3.59 which classifies the site as a non-wetland. Combining DU Wetlands No. 2 South and DU Wetlands No. 1 South created DU South (DUS). DUS is scheduled to be monitored in the field in the fall of 2025, with the remaining sites being monitored in the field in 2026. Using aerial imagery and LiDAR data, these sites' vegetative cover ranged from 34.12% to 61.07% (Table 7).

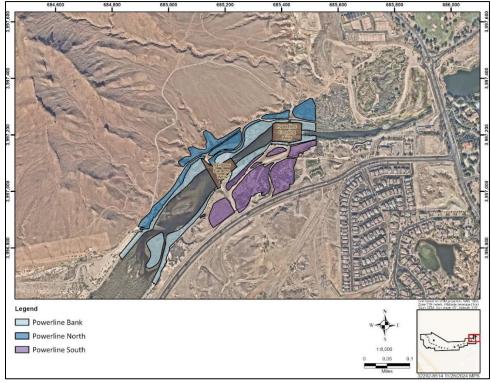
Figure 34. Aerial imagery of the new Rainbow Gardens and Powerline Crossing weirs revegetation site boundaries.

Powerline North (PLN) was created by merging Upstream Rainbow North Bank, Upstream Powerline North Plateau and Upstream Powerline North Bank. This site was monitored in the field along with Powerline South (PLS) in 2024 (Figure 34). PLS includes what was previously known

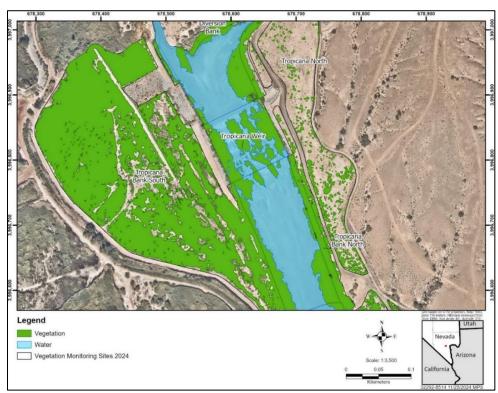
Figure 36. An example of what the total vegetative cover results looks like using aerial imagery and Light Detection and Ranging (LiDAR) data at the Tropicana Weir revegetation sites.

Using high-resolution (resolution = 3 inches per pixel) aerial imagery and Light Detection and Ranging (LiDAR; resolution = 1 foot per pixel) data (Singleton 2024), a vegetative cover map of the Wash was created. Aerial imagery is acquired on a biennial basis between May and June and LiDAR data is acquired on an as-needed basis both during leaf-on conditions. Upon receiving the aerial imagery and LiDAR data, the LiDAR point cloud data was processed into a canopy height model and then joined with the aerial imagery. A supervised classification was subsequently performed to map trees, shrubs and grasses along the Wash. The results are polygons representing each tree, shrub and grass (Figure 36). Finally, area calculations were performed in ArcGIS Pro based on the fraction of vegetative cover per total site area. Utilizing this method will save time since analysis can now be calculated collectively for all sites as opposed to individually per site.

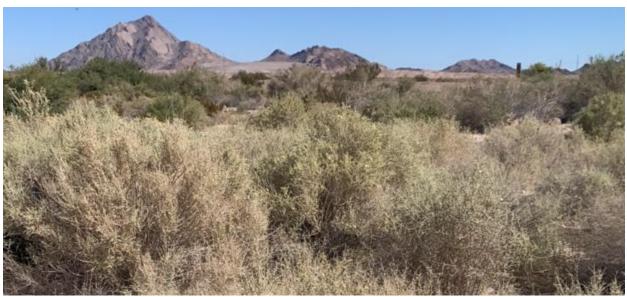
Figure 38. A photo of the vegetative landscape at Archery and Silver Bowl North.

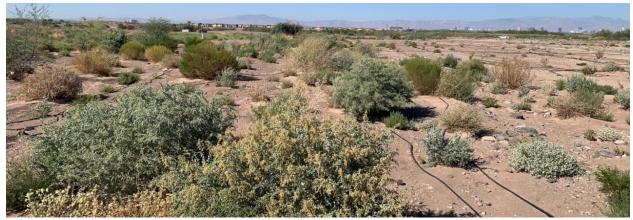
Figure 39. Some of the vegetative species found at Sunrise Mountain South-2.

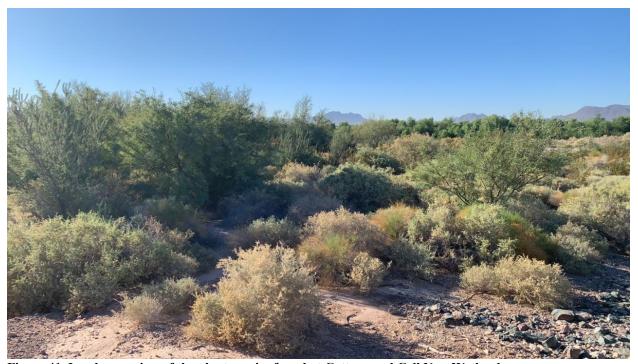
that had a total cover class range of 25–50% and WPI of 4.08. CCW is a 2.55-acre site that had a cover class range of 50–75% and WPI of 2.24 (Table 16). Due to its low total cover, CCNW is a possible candidate for enhancement under the RMP.

Figure 41. Landscape view of the plant species found at Cottonwood Cell Non-Wetland.

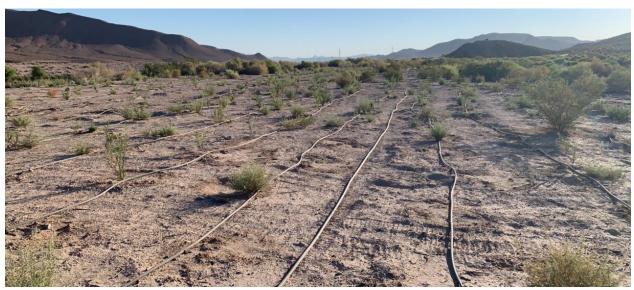
Figure 42. The spring 2024 Green-Up site filled with new plants and irrigation for watering. 3.16 Rainbow Gardens and Powerline Crossing Weirs

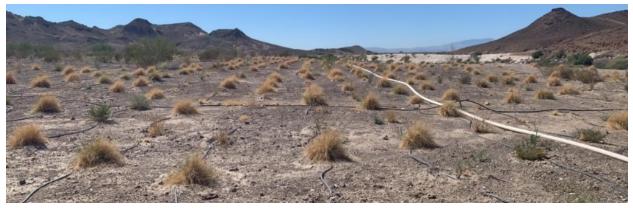
Figure 43. Bundles of alkali sacaton and other native species planted during the spring 2023 Green-Up event. 3.17 Waterway
