## Las Vegas Wash Vegetation Monitoring Report, 2025

**SOUTHERN NEVADA WATER AUTHORITY  
Las Vegas Wash Project Coordination Team**

**July 2025**

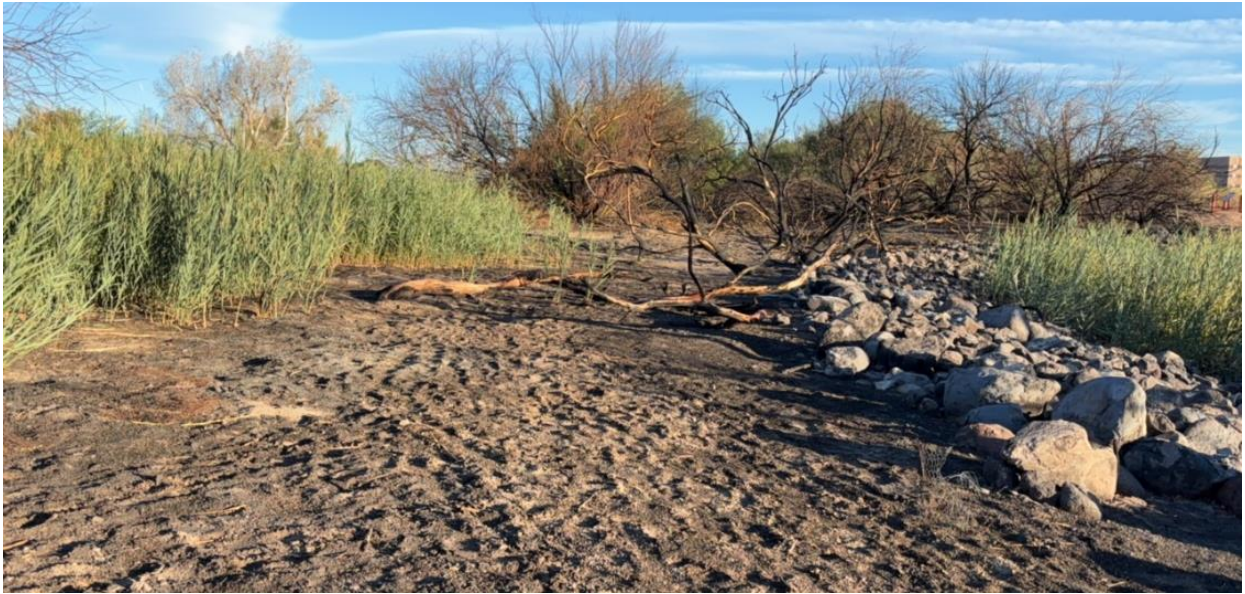
**Figure 8.** The aftermath of a fire that burned parts of the Upper Diversion South site on March 31, 2025.

UDS had relatively high species diversity with 10 species identified but a total vegetative cover range of only 25–50% (Table 7). On March 31, a fire broke out in the area and burned an estimated 5–15% of this site (Figure 8). With the help of high wind speeds, this same fire jumped across the Wash channel and burned an estimated 50% of UDI-2 (Figure 9). With both sites having relatively low vegetative cover ranges and the damage caused by the recent fire, these sites are now good candidates for enhancement under the RMP.

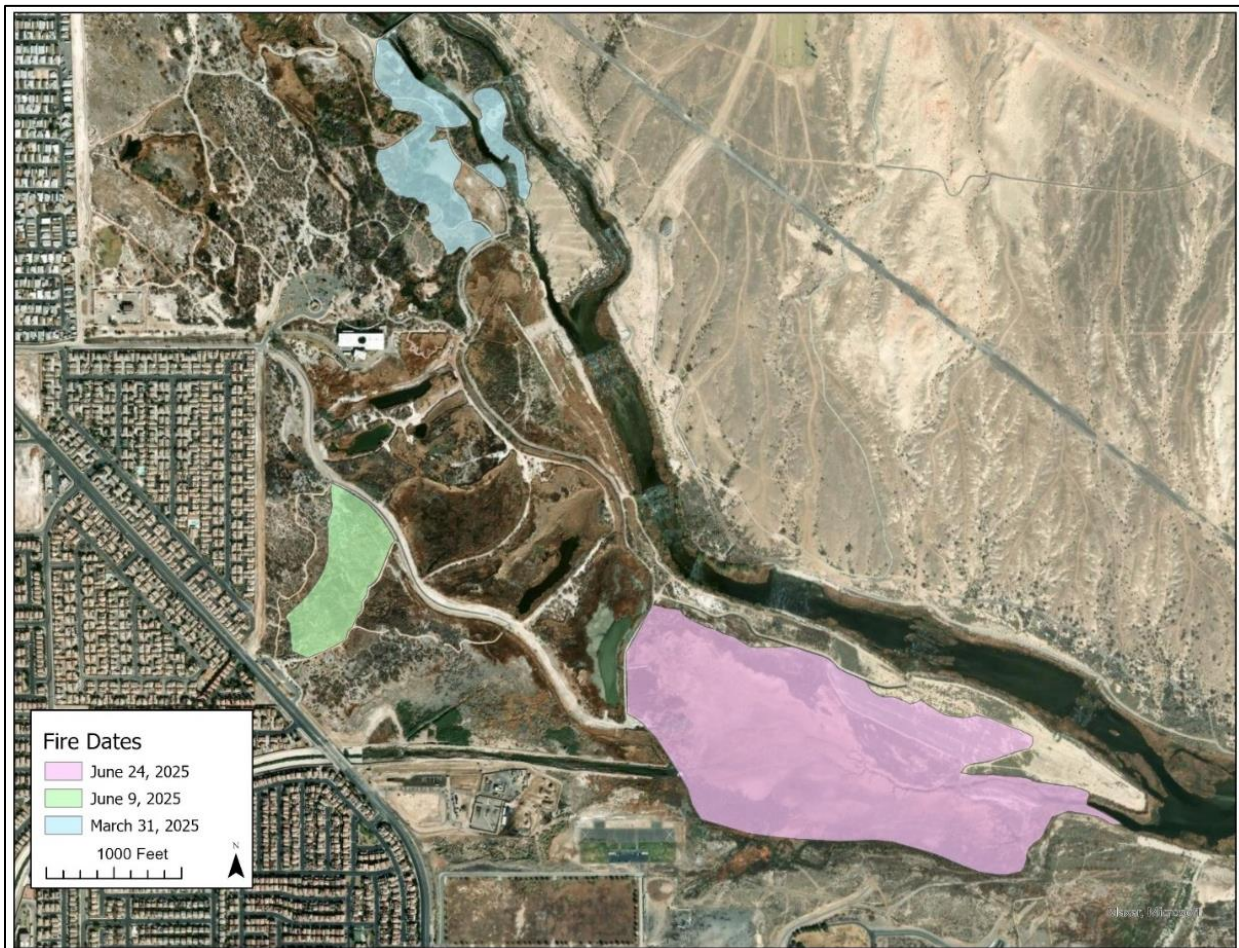
**Figure 9.** The locations of three fires that occurred within the Clark County Wetlands Park in 2025.

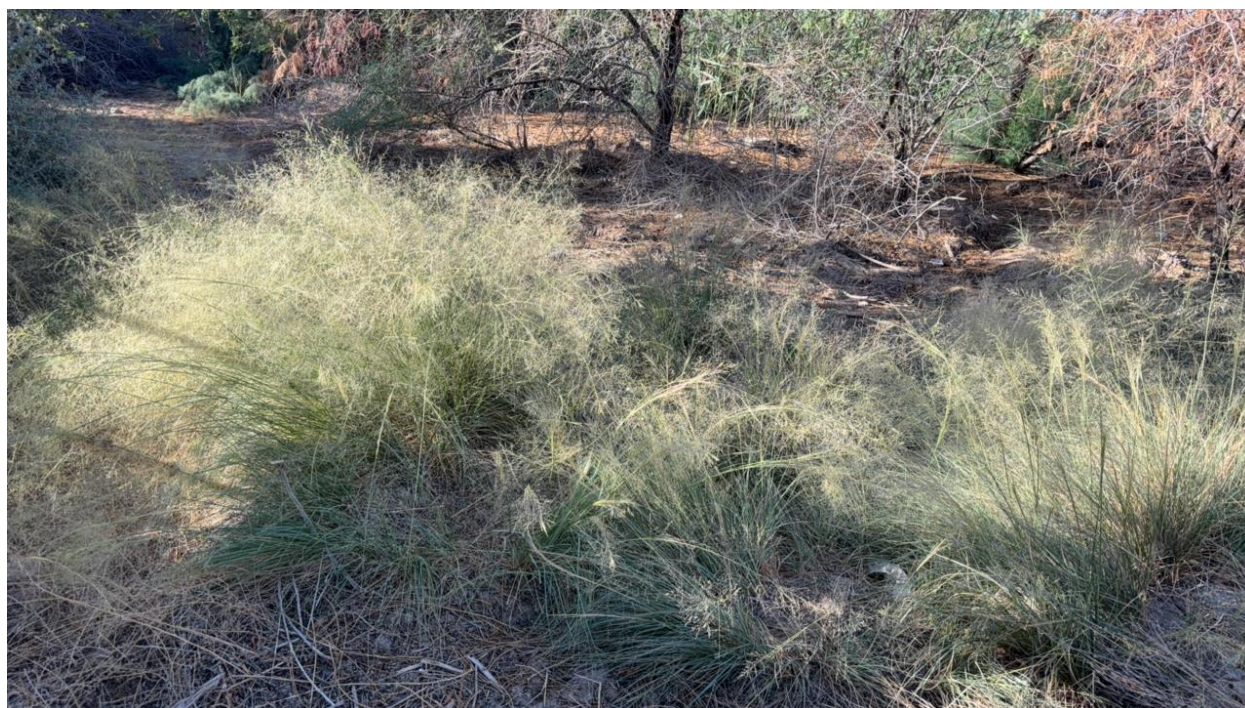
**Figure 11. Alkali sacaton identified at the DU South site during field monitoring.**

DU South (DUS) was the only site monitored in the field in 2025 (Figure 11, Table 9). It had a total cover class range of 50–75% and 16 species were identified, including alkali sacaton (*Sporobolus airoides*; Figure 12). The calculated WPI was 3.36 which classifies the site as a non-wetland. Three of the four remaining sites will be monitored in the field in 2026. Using aerial imagery and LiDAR data, vegetative cover for the four sites ranged from 14.52% to 73.12% in 2025 (Table 9).

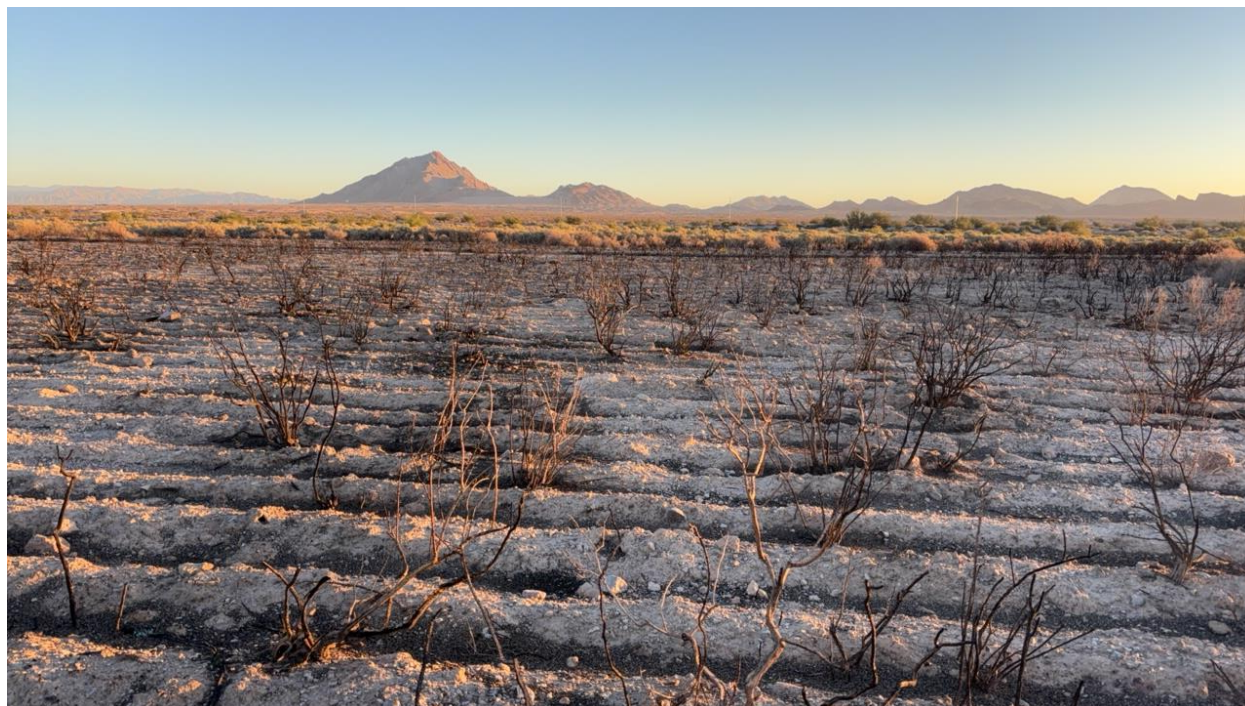
**Figure 14. Archery and Silver Bowl South after a fire moved through the area on June 24, 2025.**

The 21.76-acre Archery and Silver Bowl South (ASBS; Figure 13) site had a 3.93 WPI calculated from the four species identified during field monitoring, making the site a non-wetland (Table 10). On June 24, a fire broke out in the area that burned an estimated 25–50% of this site (Figure 14). As a result, ASBS is a good candidate for enhancement under the RMP. The remaining five sites' vegetative cover was calculated using aerial imagery and LiDAR data. Results ranged from 58.70% for Archery Weir (AW) up to 93.37% for Archery and Silver Bowl Bank North (ASBBN). Both weirs experienced very minor changes in vegetative cover over the year. AW saw a decrease, from 60.47% in 2024, and Silver Bowl Weir (SBW) saw a 1.4% increase (Table 10).

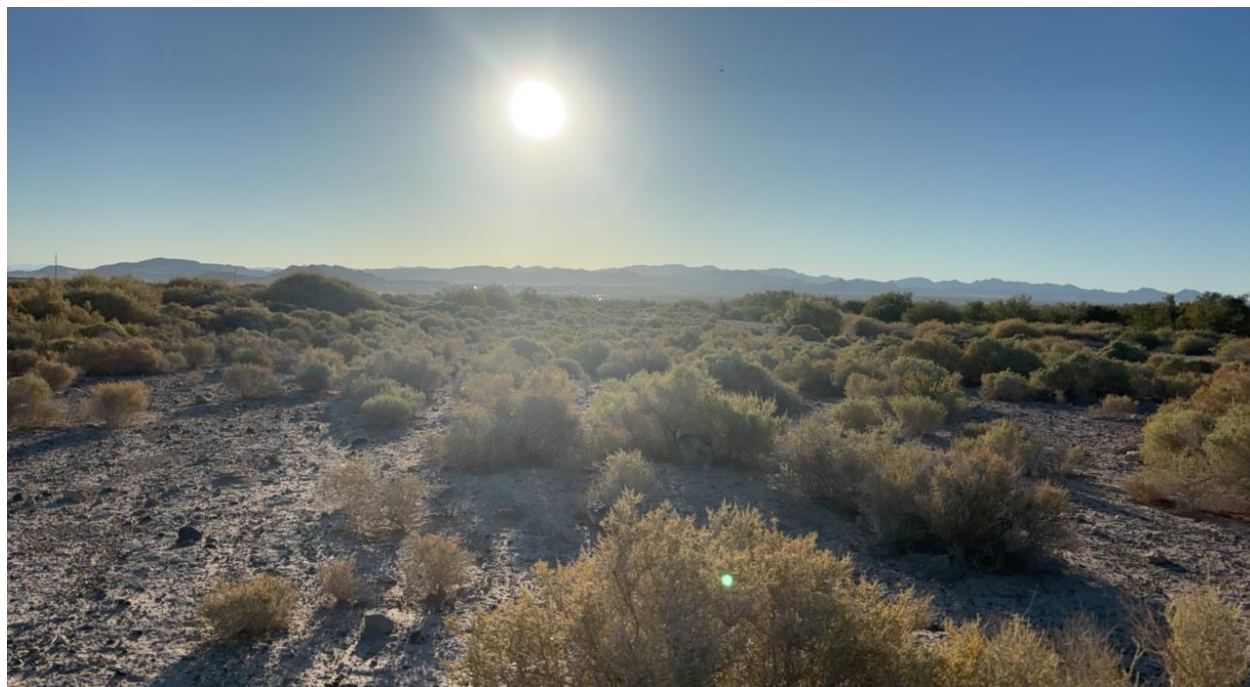
**Figure 16. Landscape view of Upper Narrows South revegetation site.**

UNS, a 33.99-acre site (Figure 15), was field monitored in 2025 and, due to its large size, required a second TMS. The cover class range of 73.8% was calculated by taking the weighted average from both surveys (Table 11). Although more than half of this site is comprised of desert saltbush (*Atriplex polycarpa*), it remains quite diverse with 20 species identified (Figure 16).

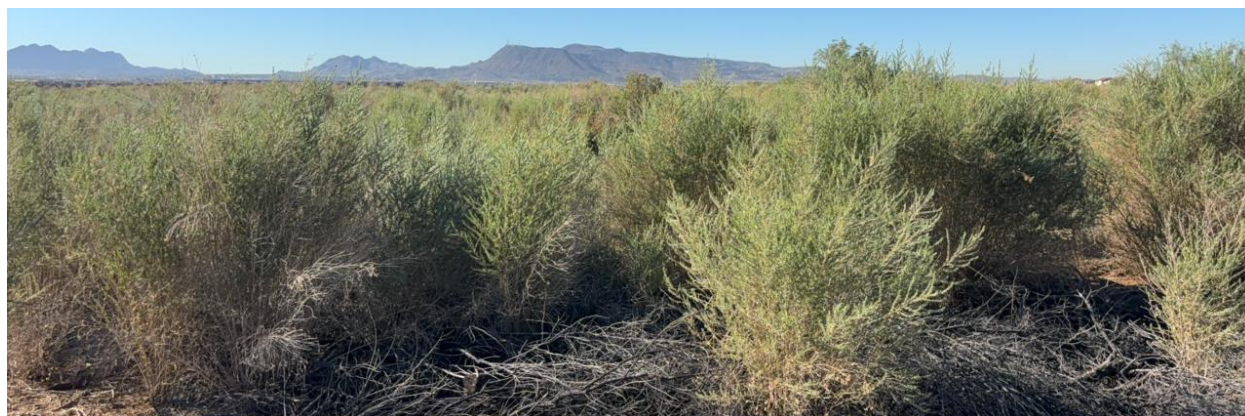
**Figure 18. Arrowweed making the SNPLMA IV site inaccessible during surveys.**

The only site designated as a wetland was SNPLMA IV. The site was mostly inaccessible and therefore, the data presented in Table 12 represent only the species that were visible from the perimeter of the site (Figure 18). Encampments and excessive amounts of trash were documented during field surveys at all four sites (Figure 19). Although encampments will likely continue to be a problem, trash removal should occur.

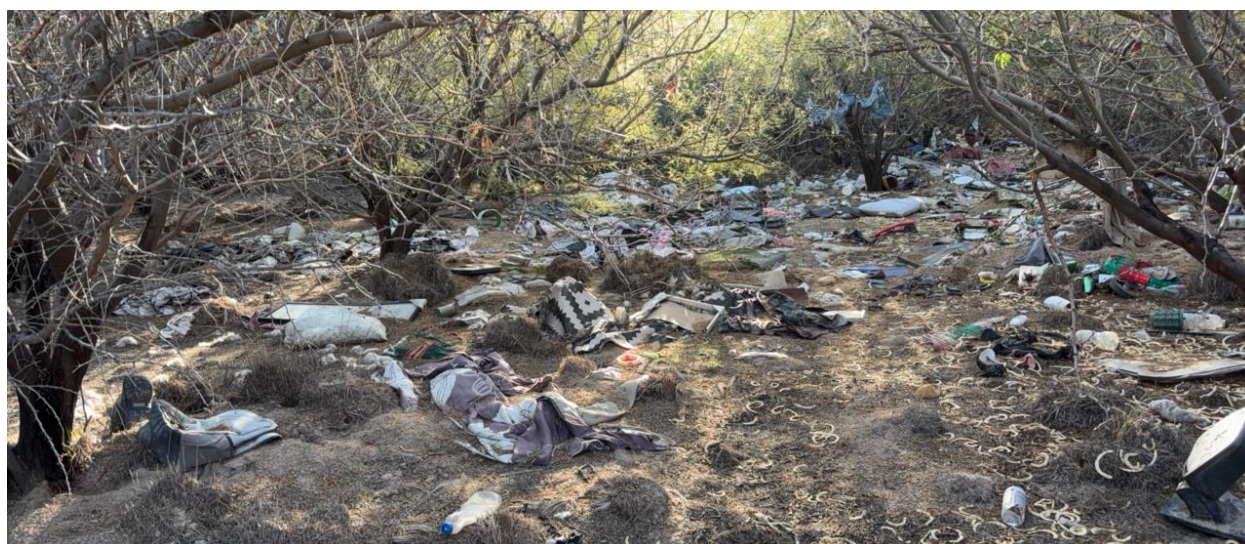
**Figure 19. Trash found at the NDSP site during field monitoring in 2025.**

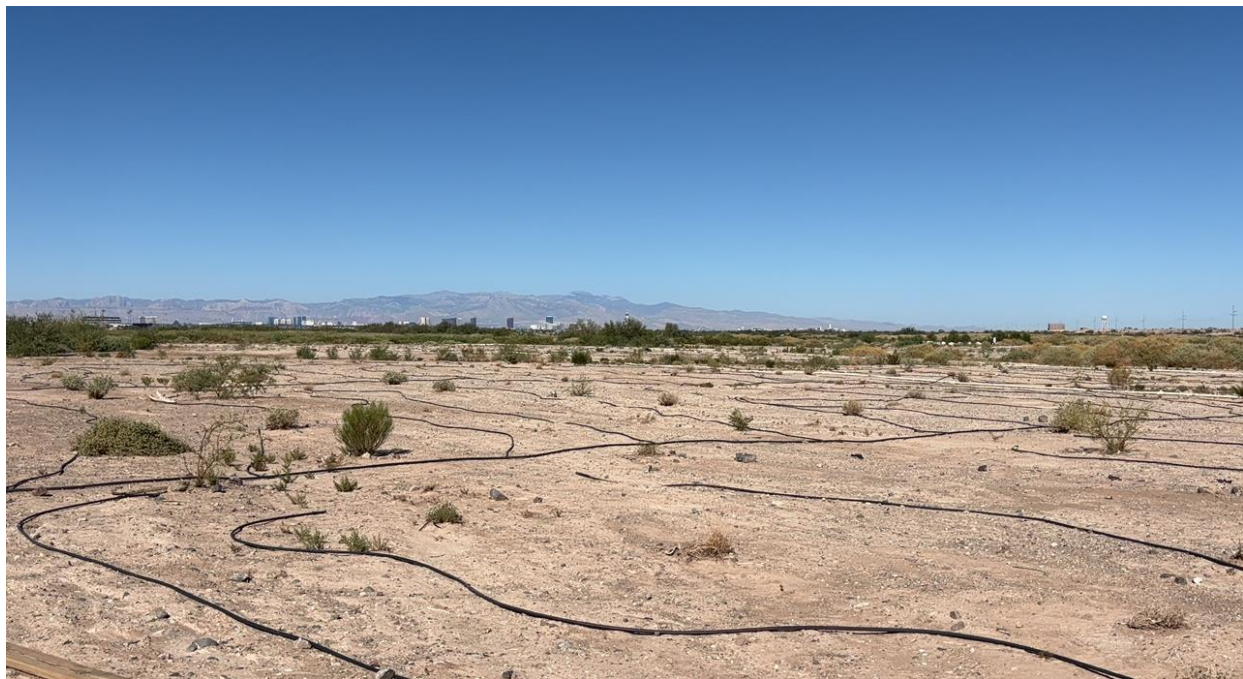
**Figure 21. Bare ground throughout SMS-2 will be planted during the 2026 Green-Up.**

Three of the four sites near Sunrise Mountain Weir were monitored in the field in 2025 (Figure 20, Table 12). Sunrise Mountain North (SMN), Sunrise Mountain South-1 (SMS-1) and Sunrise Mountain South-2 (SMS-2) were all grant funded and within their first five growing seasons. SMS-1 completed its fifth consecutive monitoring season in 2025, and moving forward, this site will be monitored every third year like other sites (Table 12). Both SMN and SMS-2 will complete their required five years of field surveys with the 2026 monitoring season. However, the 2026 Wash Green-Up location is SMS-2, and since this planting is not grant funded, the site will follow the recommendations in this report and be monitored annually for two years. Originally planted in the fall of 2021, SMS-2 recorded a cover class range of 25–50% during field monitoring. The goal of the 2026 Green-Up is to enhance the site by adding plants to areas of bare ground (Figure 21).

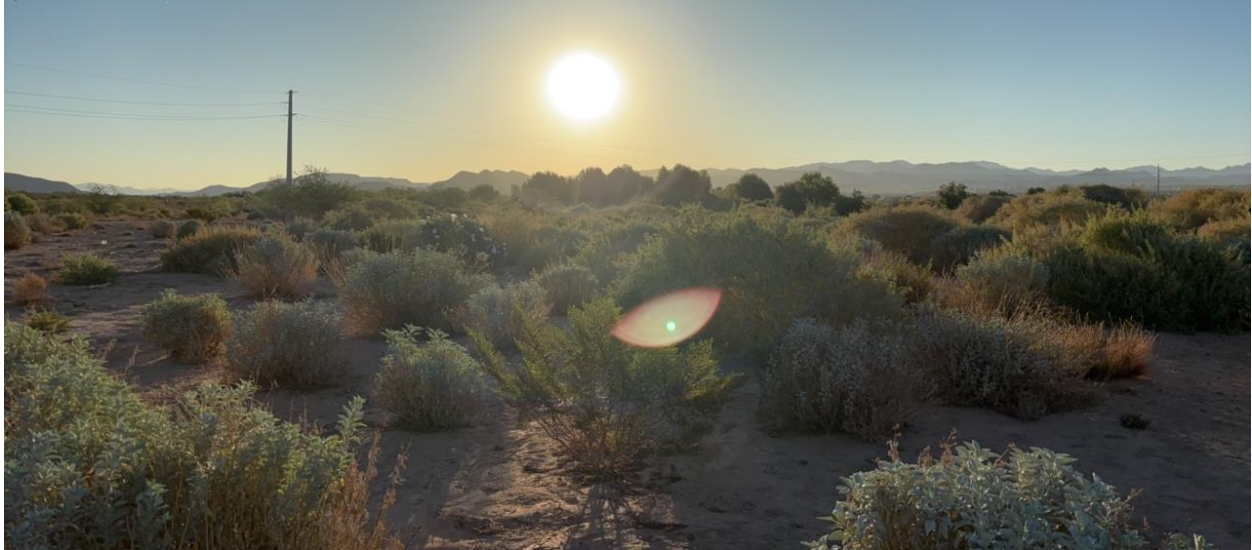
**Figure 22. Vegetative cover at Sunrise Mountain North.**

SMN increased in cover class range from 25–50% in 2024 to 50–75% in 2025 (Table 12, Figure 22). This is likely due to plant growth. SMS-1 also saw an increase in cover, going from 5–25% in 2024 to 25–50% in 2025 (Table 13). Both quailbush and brittlebush (*Encelia farinosa*) contributed to these changes, increasing by 34.5% and 12%, respectively.

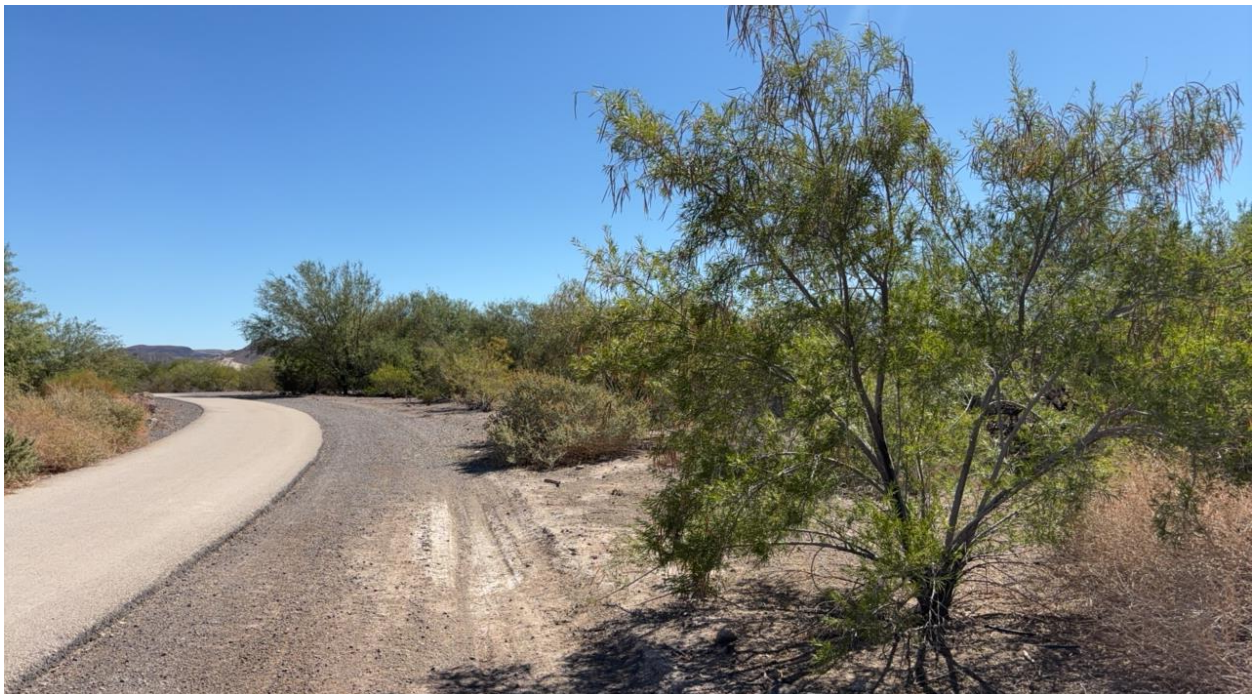
**Figure 23. A paved walking trail runs alongside the northern border of Pabco South revegetation site.**

The new Pabco South (PS; Figures 23 and 24) site is 12.52 acres and had a 3.82 WPI calculated from the 19 species identified during field monitoring, making it a non-wetland (Table 13). The remaining three sites, Pabco North Bank (PNB), Pabco South Bank (PSB) and Pabco Weir (PW, formerly PRW for Pabco Road Weir), will be monitored in the field in 2026 (Figure 24). The vegetative cover using aerial imagery and LiDAR data ranged from 22.82% for PW to 73.71% for PNB (Table 14).

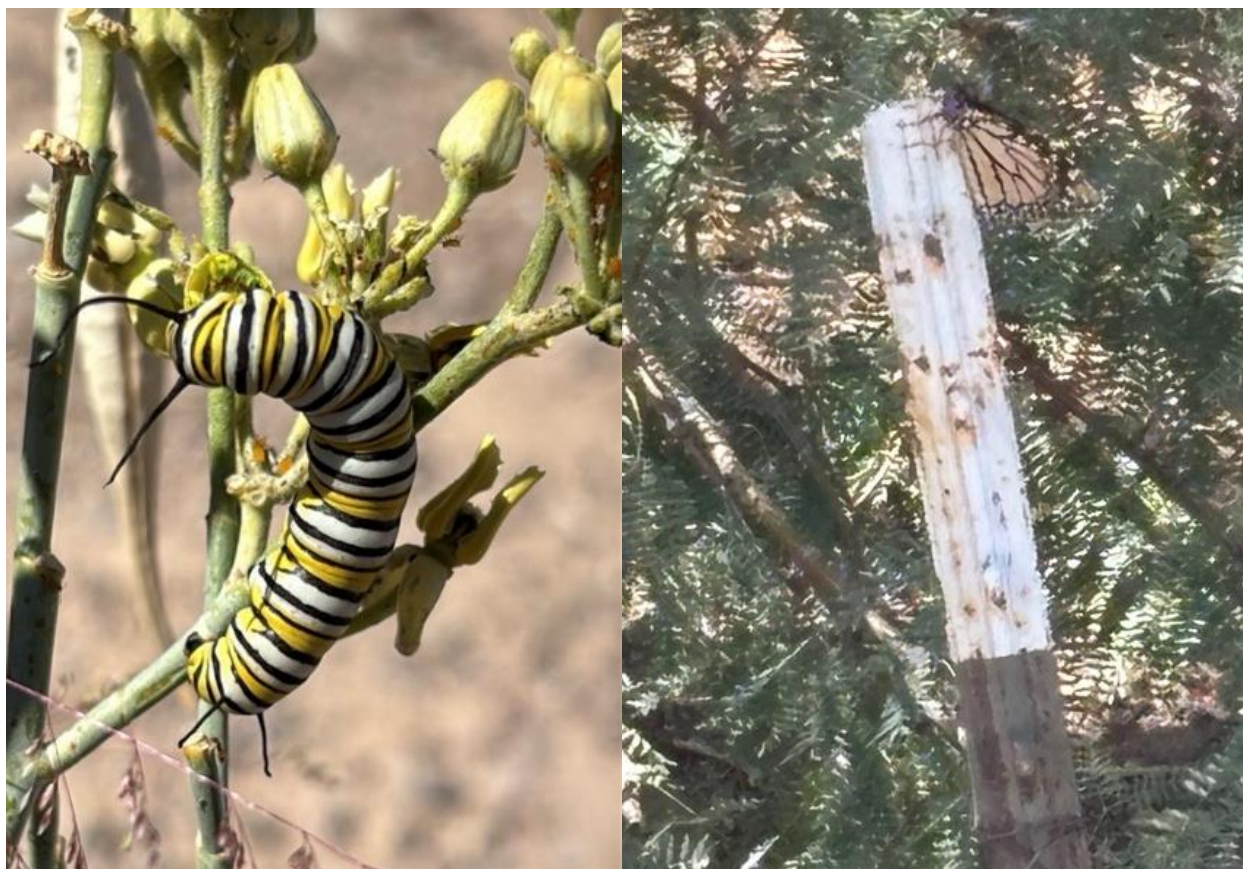
Figure 27. A monarch caterpillar and butterfly seen at the Historic Lateral South revegetation site.

Previously designated as two revegetation areas, Historic Lateral Weir and Historic Lateral Weir Expansion have now been combined. Historic Lateral South (HLS) is a 15.10-acre site (Figure 26) that was monitored in the field in 2025. Results indicate that the site has both good species diversity and vegetative cover (Table 16). With a WPI of 4.16, this site's wetland designation is non-wetland. In 2020, 1,500 native plants were installed by a Girl Scout group, including 50 rush milkweed (*Asclepias subulata*). This species has been growing well, and on October 7, staff identified a monarch caterpillar on one of the milkweed plants and an adult monarch butterfly in the area (Figure 27).

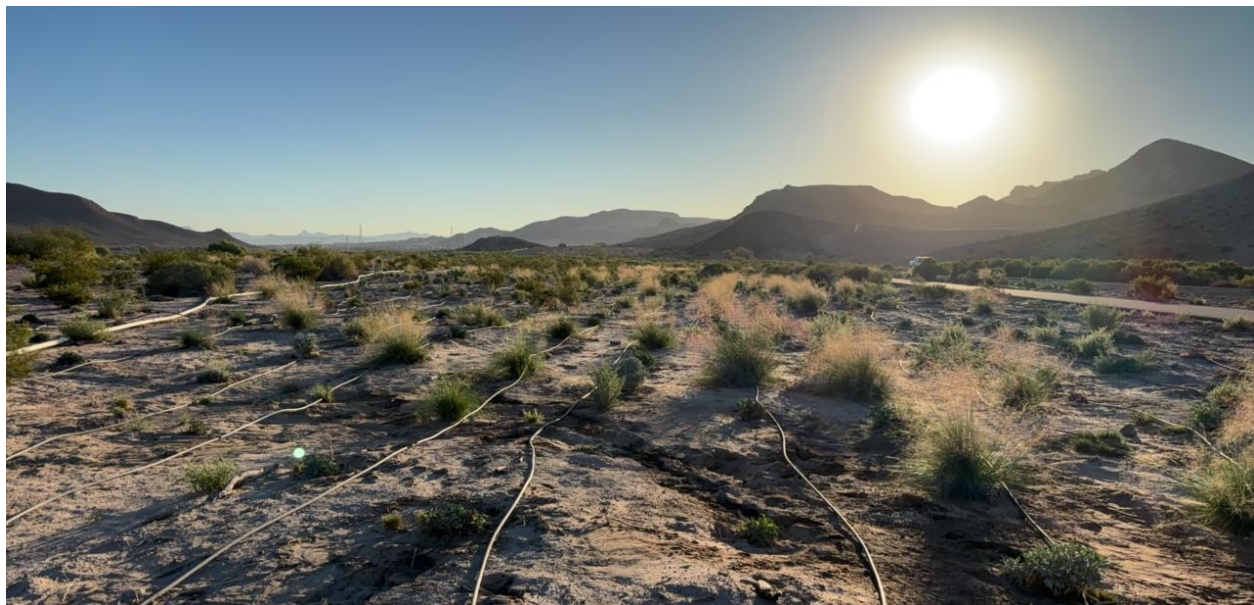
**Figure 31. The spring 2025 Green-Up site filled with new plants and irrigation for watering.**

The 2025 spring Wash Green-Up site, known as Lower Narrows South Green-Up 2025 (LNSGU25) is adjacent to Lower Narrows South Green-Up 2024 (LNSGU24; Figures 31 and 32). Three sites were monitored in the field in 2025 including both Green-Up locations and Lower Narrows South (LNS; Table 19).

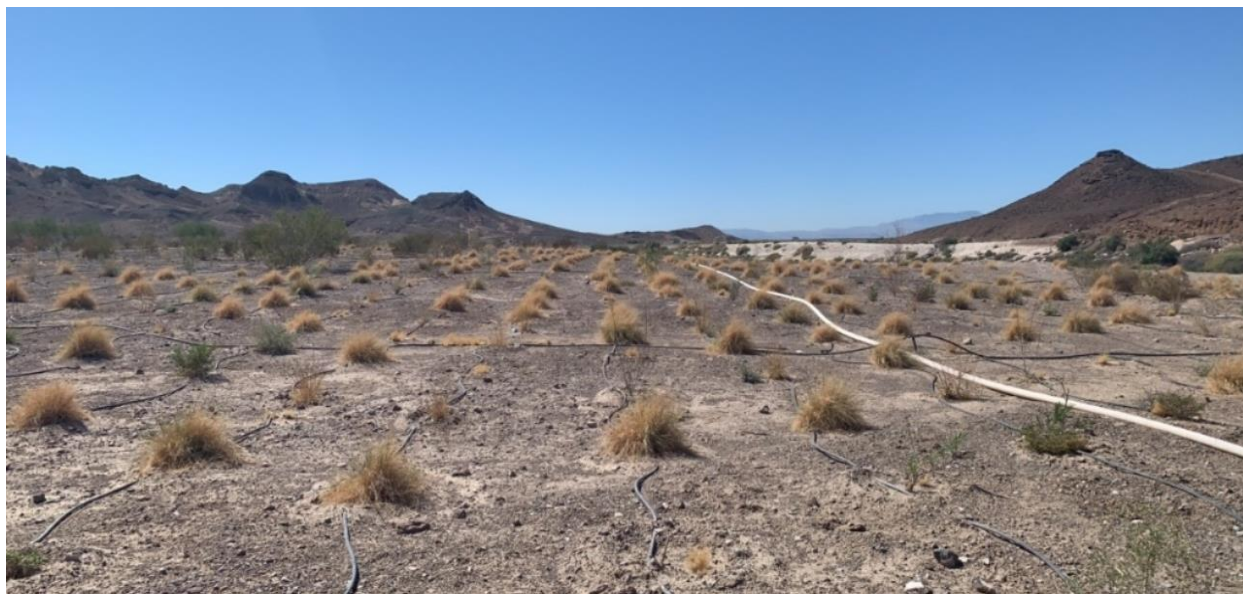
**Figure 33. Alkali sacaton and other native species planted during the spring 2023 Green-Up.**

Powerline South (PLS) includes what was previously known as Upstream Rainbow South Plateau, and it was the first site planted for enhancement under the RMP, during the spring 2023 Green-Up (Figures 33 and 34). One of the species planted during this event was alkali sacaton. Data suggests that this species does not do well when planted in upland areas; only a few green leaves remained on each plant and its cover decreased from 5–25% in 2024 to 1–5% in 2025 (Table 20, Figure 34). PLS has seen an increase in vegetative cover from 25–50% to 50–75%, likely due to Green-Up plant growth. This site received a WPI of 3.62, remaining a non-wetland. Lantow (2025) suggested PLN was a good candidate for enhancement because it had low vegetative cover and only two species. Using aerial imagery and LiDAR data, the vegetative cover for PLN was 38.61% (Table 20), continuing to indicate that the site would benefit from additional planting.

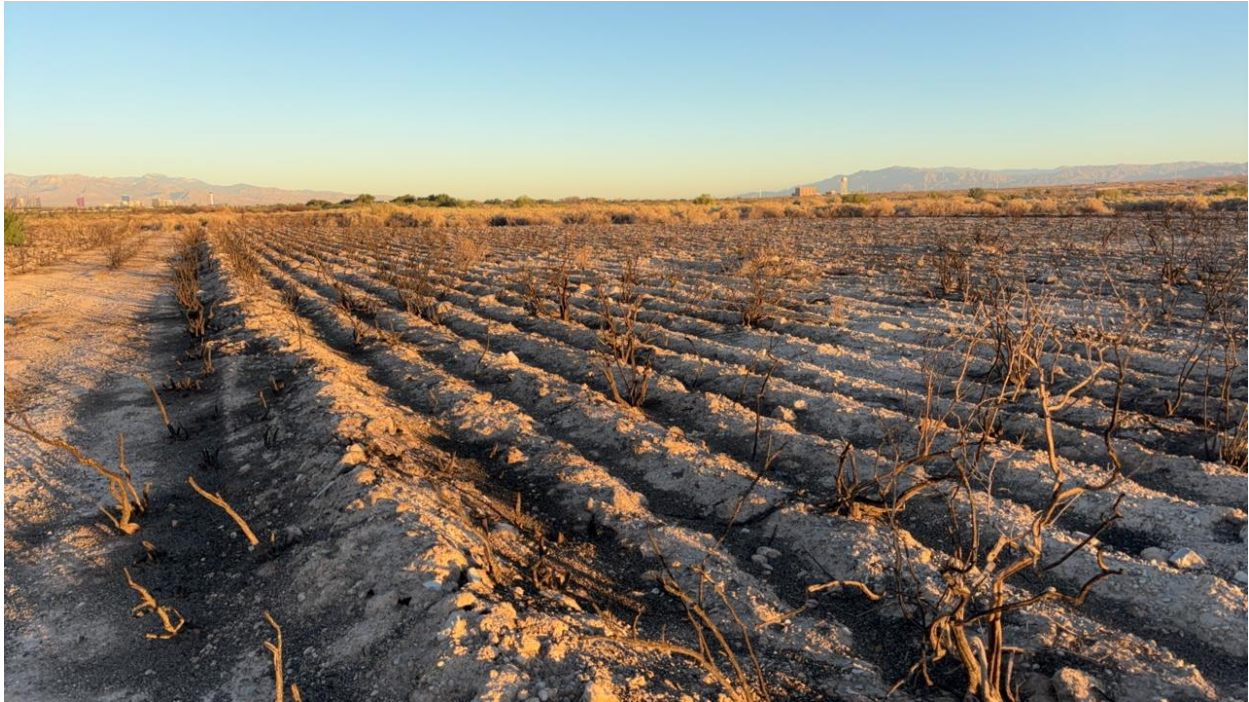
**Figure 34. The aftermath of the June 24, 2025, fire that burned an estimated 25–50% of Archery and Silver Bowl South revegetation site.**

Three of the 20 field monitored sites are good candidates for enhancement (Table 22). Human-caused fires are the main reason they qualify (Figure 35). UNNS, UNSF and HLES will not be monitored in the field until initial or additional plantings occur at each site but also qualify for enhancement (Table 22). The NDEP revegetation site in Site 108 qualified for targeted invasive and other undesirable species removal. This list will likely change annually and will be used to guide future revegetation efforts along the Wash.
