Las Vegas Wash Coordination Committee

Pittman Wash Pilot Wetlands Final Grant Report

**Pittman Wash Pilot Wetlands
Final Grant Report**

September 2007

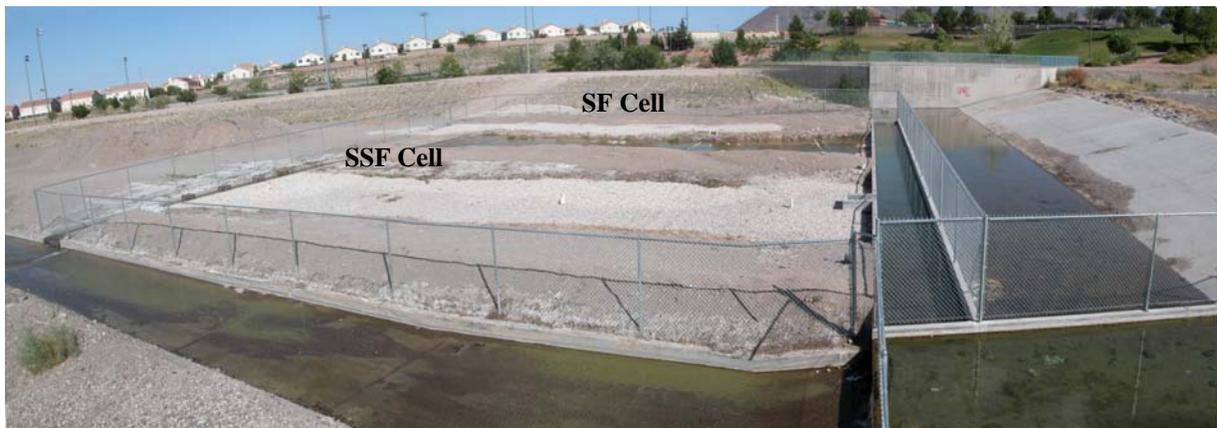
Figure 1: June 16, 2005, site overview looking southeast with the SSF cell in the foreground and the SF cell beyond it.

The pilot project, as fully constructed, covers approximately 0.3 acres of the floodplain immediately adjacent to the dry weather flow channel. There are two 0.06 acre cells, one with a surface flow (SF) regime, and another with a subsurface flow (SSF) regime (Figure 1). The SF cell has alternating open water zones (depth of 2-3 feet) and bulrush-vegetated beds. The SSF cell is filled with 0.75 inch gravel, and the entire surface is planted with bulrush. Three species of bulrush, *Schoenoplectus californicus*, *S. acutus*, and *S. americanus*, are planted in alternating bands in each wetland cell. Both cells are lined with four inches of clay to keep groundwater from influencing wetland water chemistry. Earth berms border the cells and another berm separates the cells. A ditch runs along the southeast border of the site.

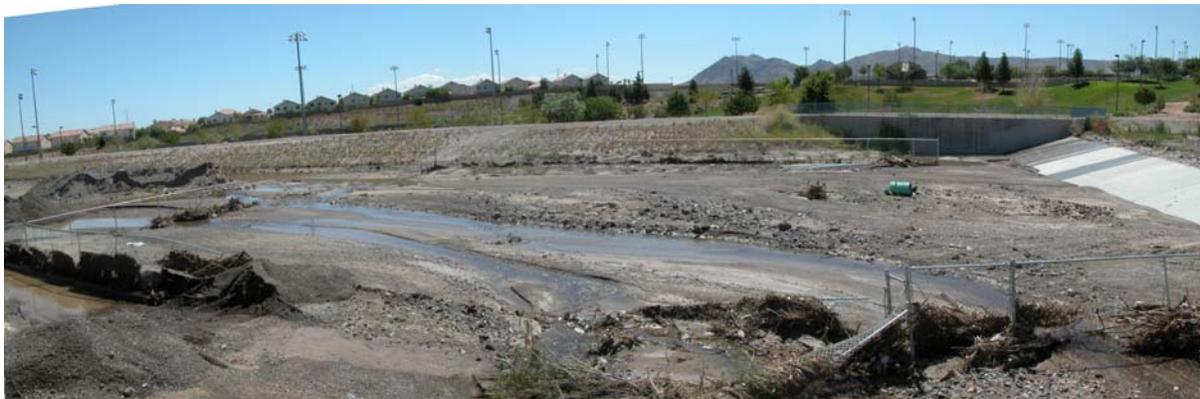
Figure 2: Storm damage caused by the August 14, 2005, flood event. The image was taken from the same overlook as Figure 1. Sediment, storm debris and surface flows cover what should be the SSF cell in the foreground.

The pilot project weathered its first storm events on July 24 and 27, 2005, receiving minor damage. The fence was damaged on the upstream side; the posts were bent horizontally and the fence was covered in debris. A layer of fine sediment was deposited over the site, partially filling in the first pond of the SF cell. Before the site could be repaired, another storm struck that caused significantly greater damage. The August 14 storm dropped 1.89 inches of rain at the gauge upstream of the site. The resulting flows deposited a large volume of sediment on the site, including several boulders more than a foot in diameter. The sediment ranged from 6 inches to nearly two feet deep, filling in the SF cell and the inflow and outflow channels and altering hydrology so that flows were diverted across the SSF cell and the SF cell was dry (Figure 2). A portion of the fence was gone, ripped out by the torrential flows.

Following the August storm, the site required extensive maintenance. Our restoration contractor, Native Resources, began excavating the site in September. They had just finished clearing flood deposits and restoring wetland flows when another storm struck on October 18, 2005, that caused impacts similar to the August 14 event. Less than two days after the site's more than \$13,000 restoration was completed, the pilot project once again needed extensive work.

The series of storms from July through October highlighted the disadvantages of the site's location at the base of a slope in the center of a flood control channel. As nothing could be done to move the project, we examined the design to determine whether there was a way to modify the site to reduce flood damage. We determined that the height of the concrete walls bordering the site on the upstream (southwest) and dry weather channel (northwest) sides needed to be raised. The 2.5 and 1.25 foot walls, respectively, easily allowed storm flows to breach and scour over the site.

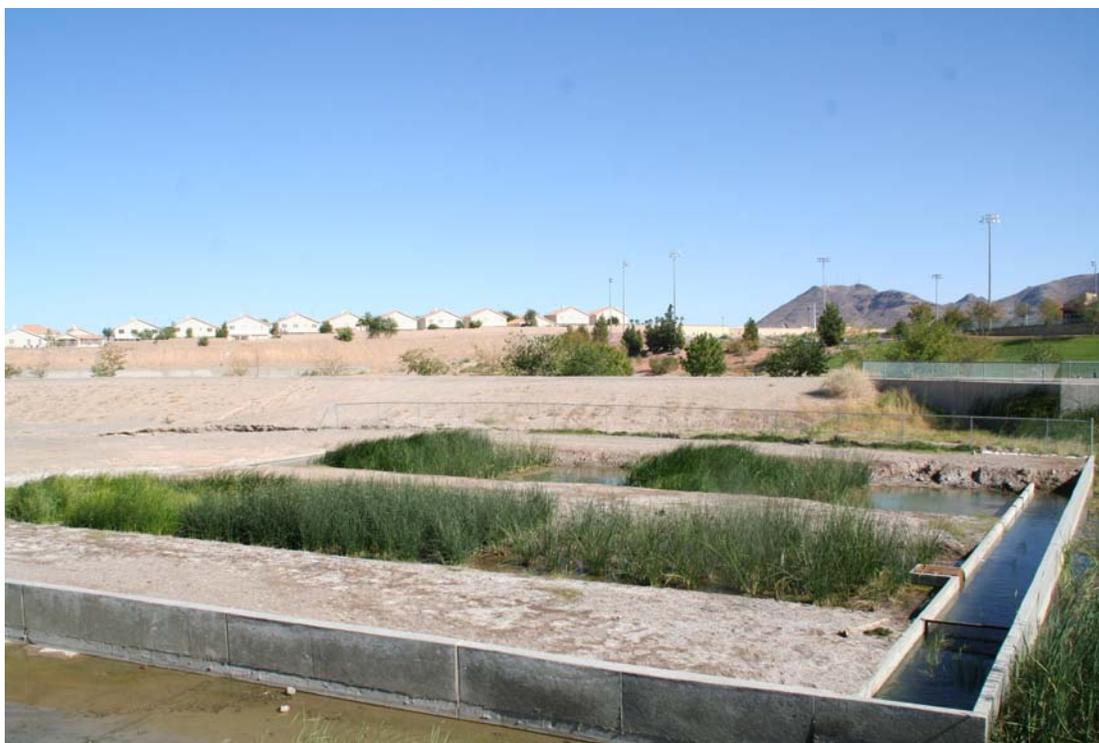
Figure 3: October 12, 2006 site overview looking southeast with the SSF cell in the foreground. Note the standing water visible in the SSF cell.

Once we were assured that the site was better protected against storms, we were able to concentrate on another challenge: saturation and standing water in the SSF cell (Figure 3).

Storm-deposited sediments had filled the interstices between the gravel and were preventing flows from moving through the cell. The bulrush was thriving in the cell as a result of the standing water and fine sediments, but the hydrology was not functioning as a SSF regime should. To address this challenge, in December 2006, Native Resources: removed the plants and

gravel from the cell; replaced the perforated pipe that carries water into and out of the cell; placed a layer of permeable cloth over the pipe to protect it from sedimentation; refilled the cell with clean gravel; and replanted the bulrush. In addition, blow out pipes were connected to the perforated pipes so that they could be easily cleared of sediments following storms events.

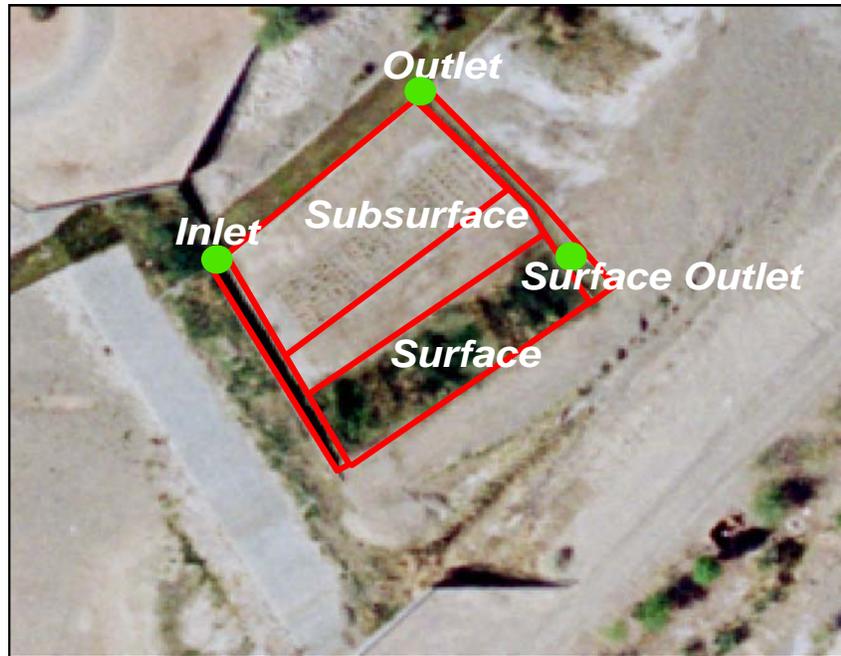
Figure 4: Water quality sampling locations.

As a pilot project, the Pittman Wash wetlands were built to demonstrate whether constructed wetlands could improve the water quality of urban runoff. Thus, monitoring was conducted to assess the changes in water quality caused by the system. The Pittman Wash wetlands were sampled at three locations (Figure 4): the inlet, the surface flow outlet (surface outlet), and the outlet. Water samples were collected each month beginning in February 2007, and analyzed for nutrients, cations/anions, and metals. During each sampling event field parameters, including pH, dissolved oxygen, conductance, and temperature, were recorded using a Hydrolab multi-

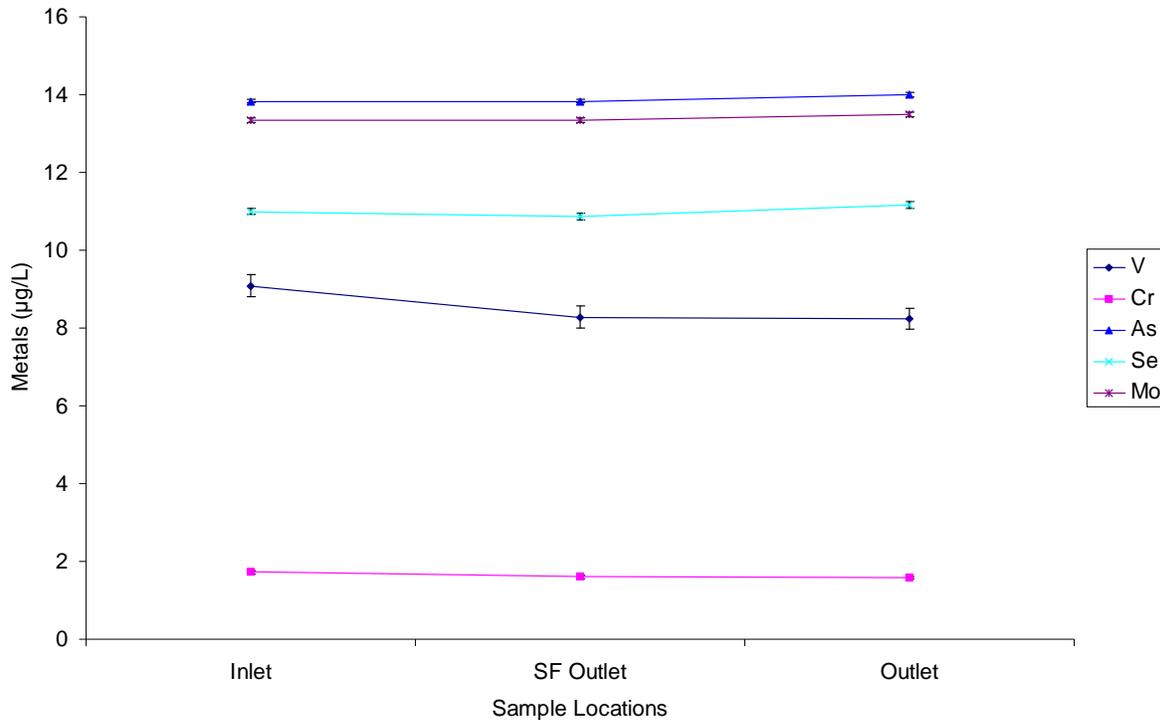
Figure 5: Average metal concentrations at the three sample locations of the Pittman Wash wetlands.

Nitrate was the only nutrient detected consistently in the Pittman Wash wetlands with ranges from eight to ten mg/L from all three locations over six months. Nitrate values remained consistent through the six months of sampling with very little variation between sites or sampling events. V, Cr, As, Se, and Mo were the only metals regularly detected. Sources of these metals are commonly from geologic units (rocks and minerals) and the combustion of fossil fuels. Concentrations remained similar between the inlet and the outlet over the six months of sampling, indicating a consistent flow of these metals through the system. Figure 5 shows the six month averages for all consistently detected metals for the inlet, surface outlet, and outlet. The figure reinforces the similarities in metal concentrations at each sample location and the similarities over the sampling period. These data indicate that the Pittman Wash wetlands currently play a limited role in reducing the metals or nitrate in the system. The continued establishment and maturation of emergent vegetation within the site may help increase the removal efficiency of metals and nutrients.
