**TECHNICAL SERVICE CENTER  
Denver, Colorado**

**Technical Memorandum No. 8220-03-09**

**WATER QUALITY and PLANT GROWTH  
EVALUATIONS of the FLOATING ISLANDS  
in LAS VEGAS BAY,  
LAKE MEAD, NEVADA**

U.S. Department of the Interior  
Bureau of Reclamation

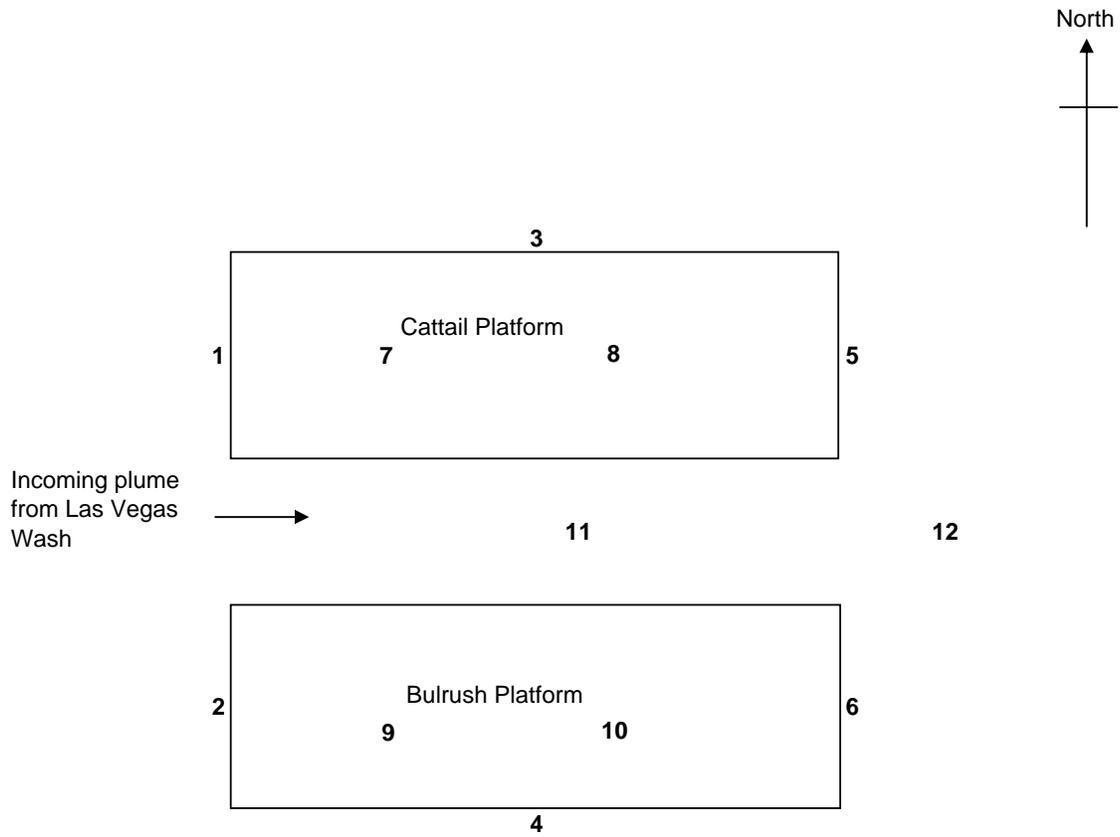
**Figure 3.**

Water sampling and monitoring stations and their number designations.

Sampling locations for the May and June tests were the same. Water samples collected for nutrient analysis and physicochemical data were collected upstream of both floating platforms, under each platform in two different areas, to the sides of each of the platforms and downstream of the floating platforms. Figure 3 is a schematic of this sampling scheme, with a designated number, for each of the sampling locations.

islands for most of the May test (Table 1). It is helpful to use Figure 3 and Tables 1 and 2, along with the nutrient analysis and the water quality information to understand the sampling locations and the direction of flow as well as the shifting of the incoming plume during the May and June tests because conditions changed every sampling date.

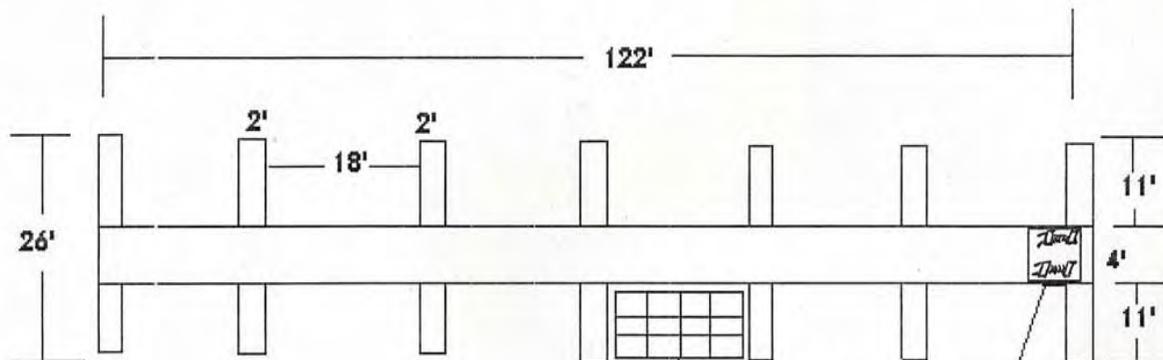
Figure 4. Two floating platforms were constructed. Each had a length of 122 feet and a width of 26 feet. The main walkway was 4 feet wide and side finger walkways were 2 feet wide.

Twelve vegetated pallets composed one floating island. Twelve floating islands were installed in each of the floating platforms.

The outside dimension of each floating platform is 122 feet (37.1m) in length and 26 feet (7.9m) wide, giving each of the floating platforms an area of 3,172 square feet. The main walkway, measured 122 feet in length by 4 feet wide, and had sufficient strength for the mounting of four winch stands and four anchoring winches, two at each end of each floating platform. To the main walkways are attached fourteen dock fingers each measuring 2 feet (0.6m) by 11 feet (2.1m); seven dock fingers were placed on each side of the main walkway. These fingers are spaced 18 feet apart, providing 12 slips per dock, in which are fastened 12 floating islands, as depicted in the enclosed drawing (Figure 4). Each slip area formed by two fingers and the main walkway was designed to have a load capability of five hundred pounds. This provides a total

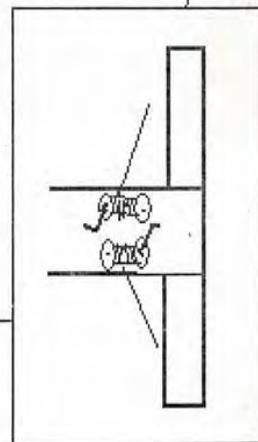
Two winches were fastened at each end of the floating platforms. Securing the floating platforms to the anchors below.

Four large winches were mounted on each floating platform. Each winch has a holding capacity of 4000 lbs (1814 kg). During strong winds and wave fetch caused by wind, movement can be felt but the platforms are still quite stable and walking is easily accomplished.

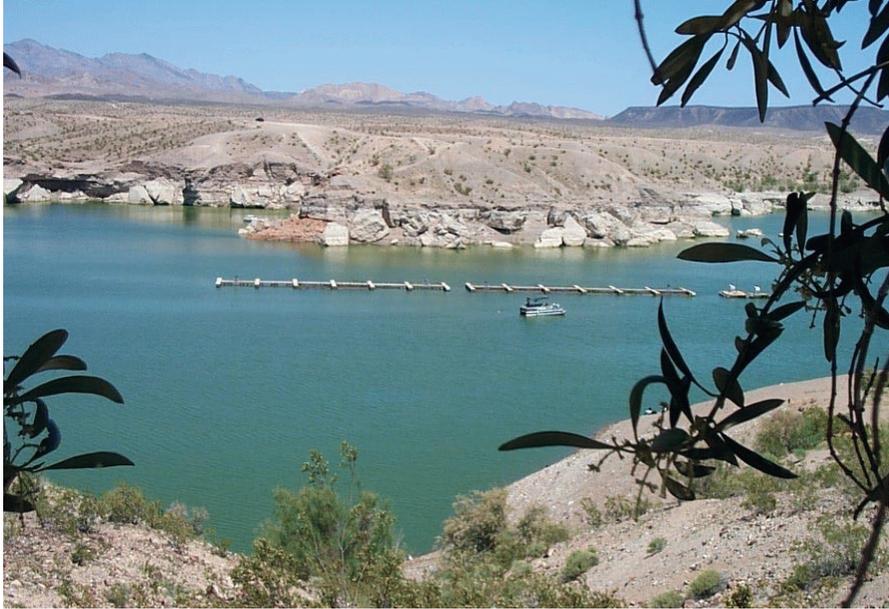
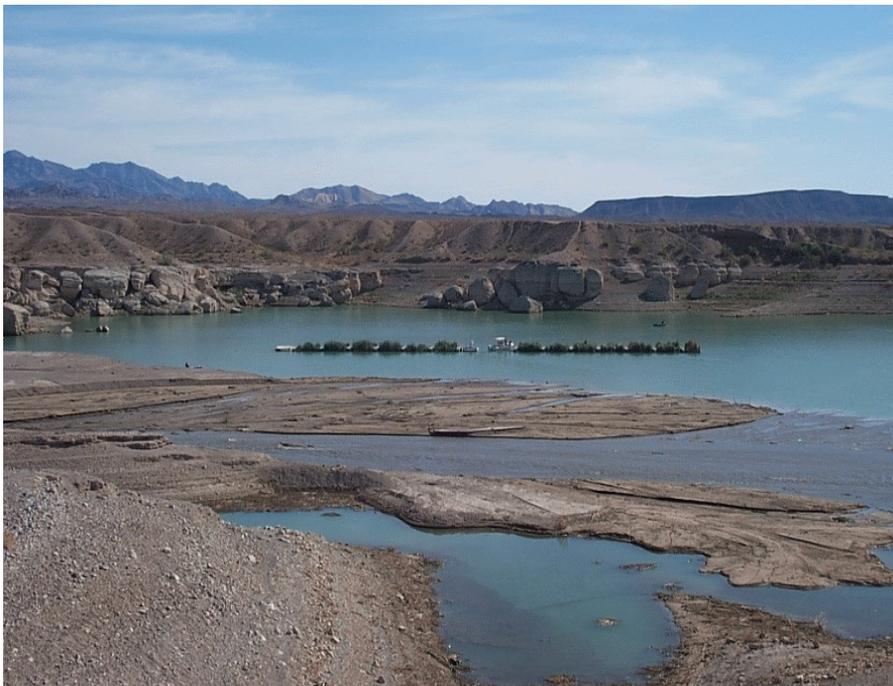
**Figure 5.**  
View of the floating platforms in Las Vegas Bay in the winter of 2001 before planting.

Summer of 2002 showing established cattails and bulrush.

load capacity of 6,000 pounds (2721.6 kg) per floating platform. Figure 5 shows a view of the floating platforms in Las Vegas Bay from the campground during the winter of 2001 before planting and a later view of the floating platforms with the established floating islands, summer, 2002.

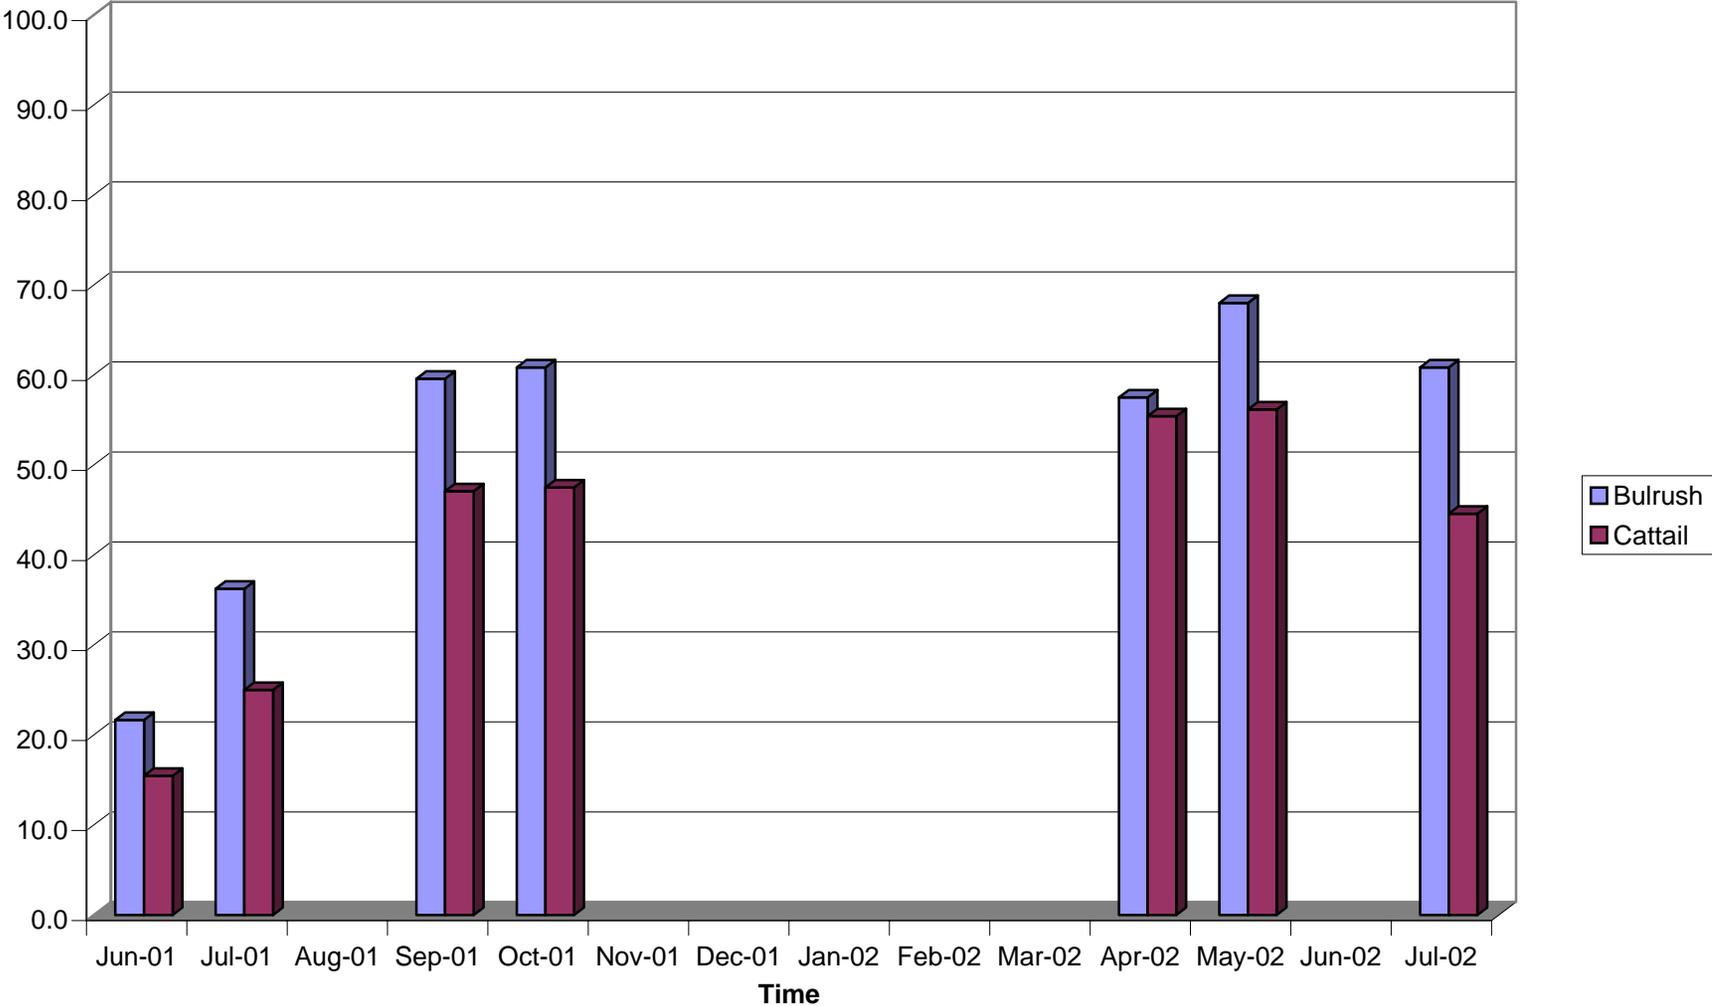
**Figure 6.**  
**Percent Coverage Evaluation**

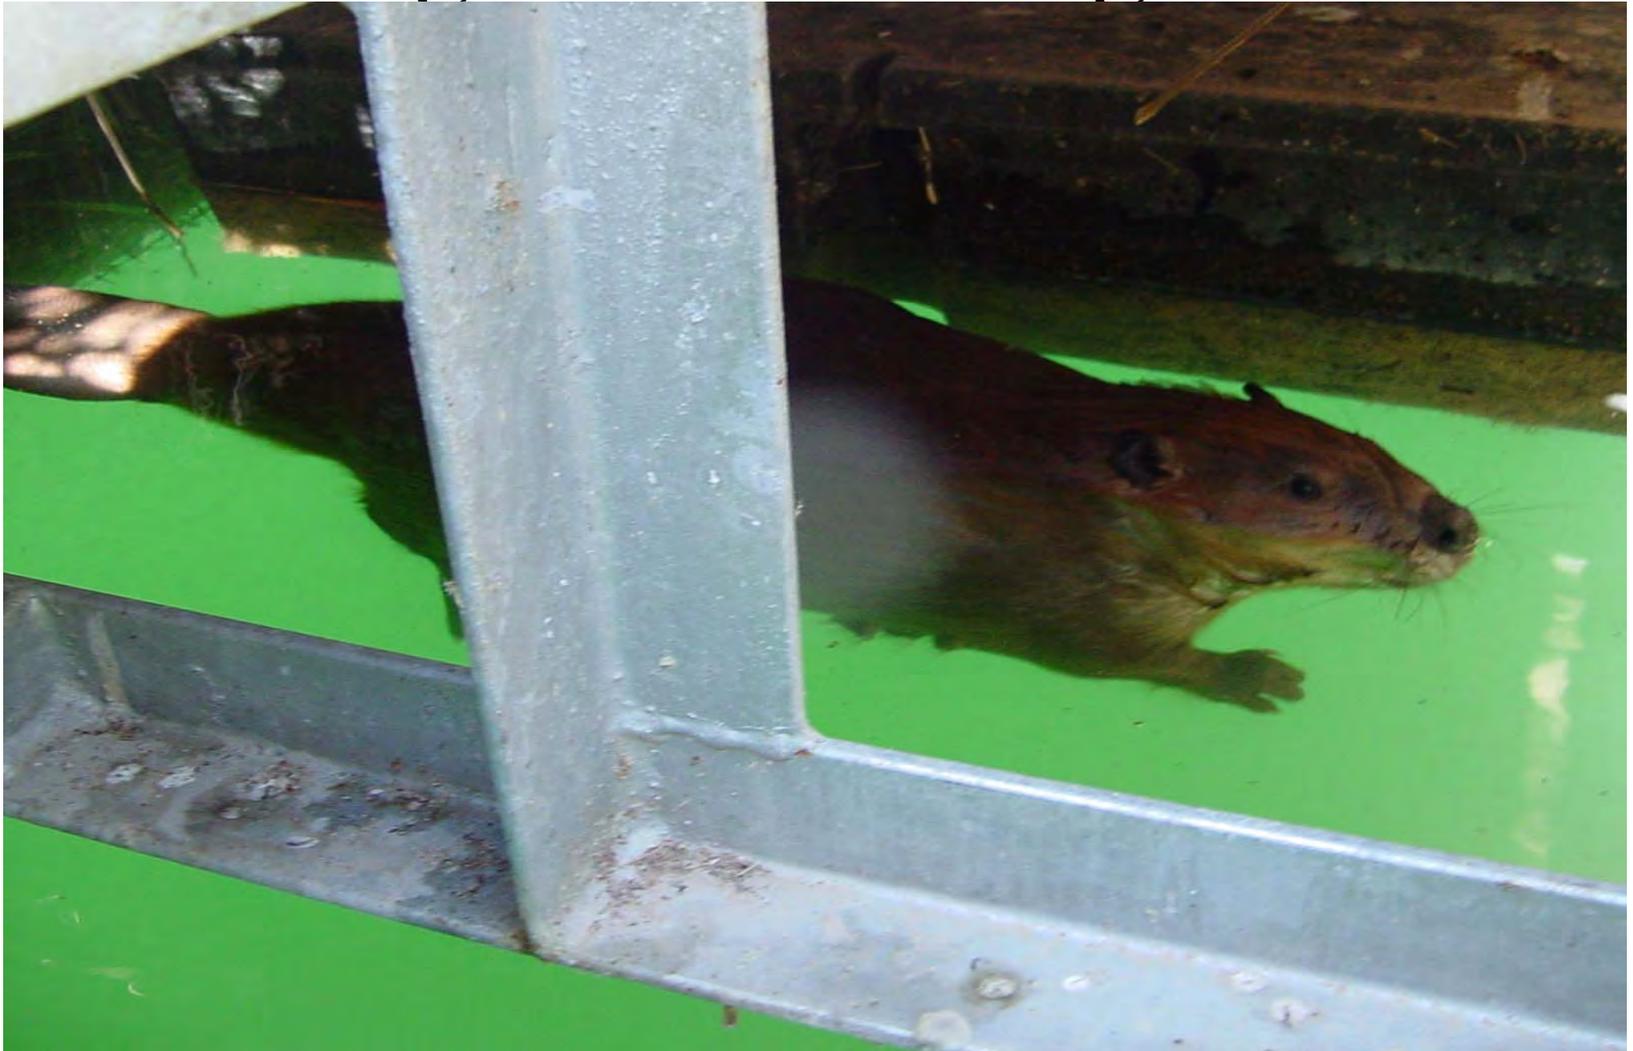
Figure 7. One of two beaver now residing at the floating islands.

- 4) Beaver have produced noticeable damage to the floating islands during the winter of 2001-2002. There is now a pair of beaver on the floating islands. If these beavers mate and produce offspring, the destruction to the vegetation and islands, as well as the structure of the floating platforms, will be to great and removal of the beavers will be necessary.

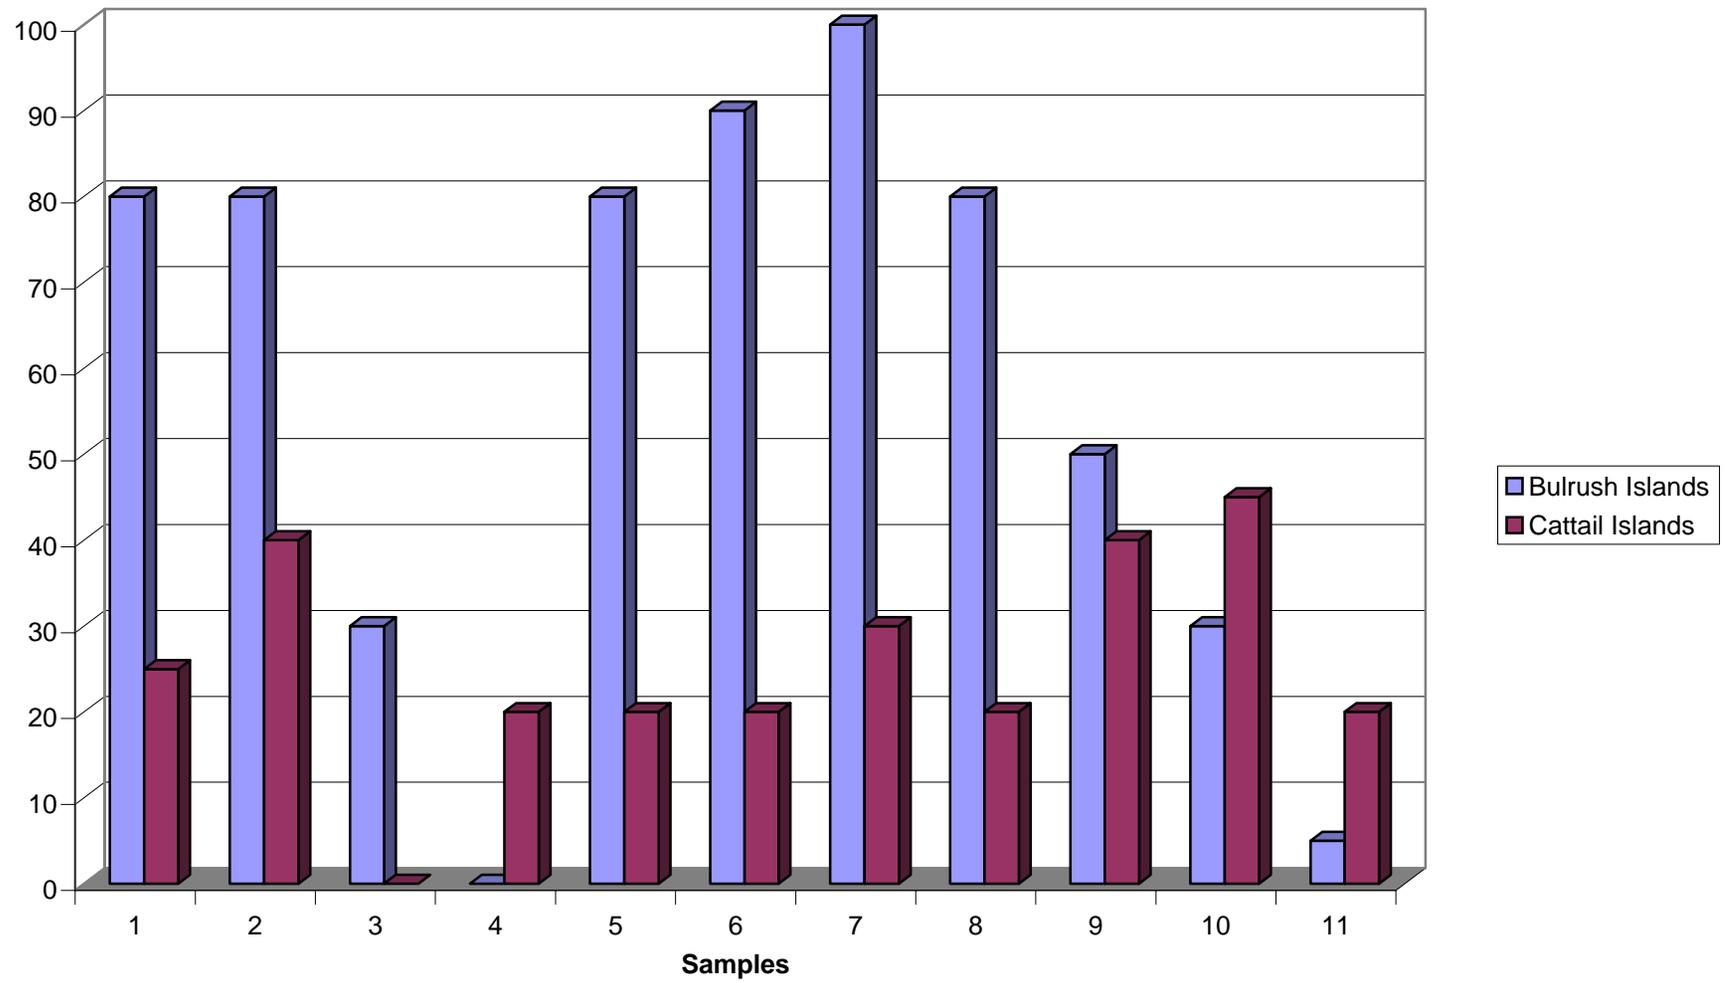
**Figure 8.**  
**Percent Coverage Quadrat Samples**  
**August 2002**

A quarter meter square quadrat was used to more carefully evaluate the percent coverage of the vegetation on the floating islands as well as, collect culm length and diameter, and biomass weight data. Twenty-two samples, one from each floating island was collected, minus the missing cattail island that sank on May 20, 2002 and the bulrush island (number 8) that was seeded rather than planted with vegetative sprigs or tubers. Because of the time involved in quadrat sampling, approximately six samples per day, and the destructiveness of the collection of the quadrat samples, only one sample per floating island was taken. The mean percent coverage using the quadrat to evaluate the eleven cattail and eleven bulrush islands, in July 2002, was 25 and 57 percent, respectively (Figure 8). This is similar to the visual percent coverage of 44 and 60 percent evaluated visually for the same July 2002 evaluation.

Although the two platforms were originally planted with either cattails or bulrush, some islands had a mix of both species. After two growing seasons the platforms are becoming more diverse in species composition, several quadrat samples had three to six species present. However, cattails are still the predominant species on the cattail platform and Olney's Bulrush is the dominant species on the bulrush platform. Olney's is much larger than the other bulrush species and therefore, produces the most biomass. Because of its size, Olney's is crowding and shading out more of the other smaller bulrushes with each subsequent growing seasons. Volunteer species have also become prevalent on some of the floating islands, with Phragmites leading the list of these species. Cattails make up the majority of the biomass on the floating islands. Cattails are the largest species on the floating islands both in height and culm base diameter (measured 15cm above the island base), followed by Olney's bulrush. Cattails in excess of 11 feet (340cm) high and with culm diameters as wide as 2.5 inches (6.7cm) and Olney's up to 8 feet (240cm) tall with half inch (13mm) culm widths were collected as part of quadrat samples. Fresh weight biomass measured from within the quarter meter square quadrats, ranged from two quadrats containing no biomass to one with 11.58 pounds (5,252 gm) of biomass. The mean fresh and dry weight biomass for the cattail islands was 5.24 pounds (2,376 gm) and 1.40 pounds (635 gm) respectively, and 3.90 pounds (1770 gm) and 0.65 pounds (297 gm), fresh and dry weight respectively for the bulrush islands.
