CHAPTER 3

EROSION IN THE LAS VEGAS WASH

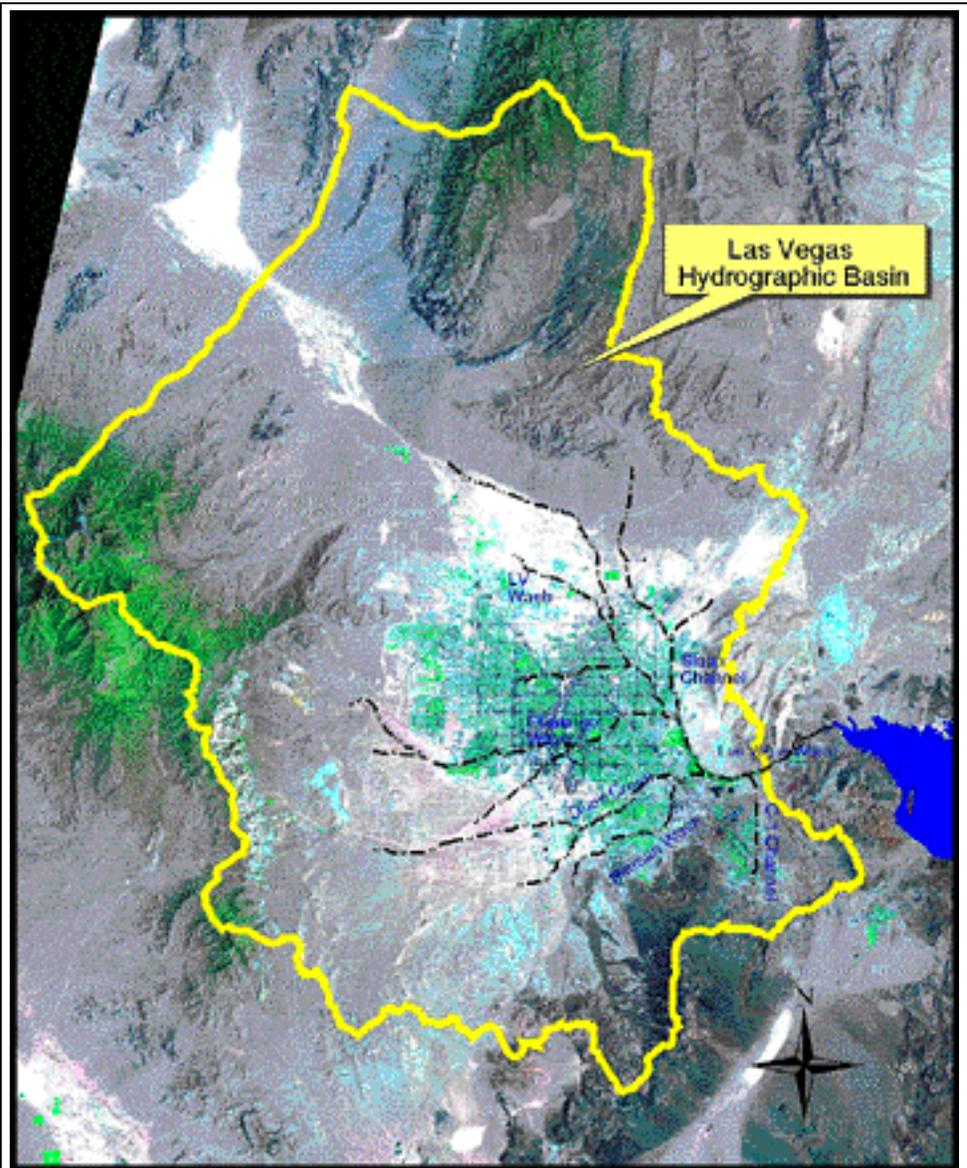
Figure 3.1 - Satellite image of Las Vegas Valley Hydrographic Basin depicting the Las Vegas Wash and associated tributaries.

The Wash is a natural channel that drains the entire 1,600-square-mile Valley. The Valley is about 50 miles long and is five to 25 miles wide. Figure 3.1 shows a satellite image of the Las Vegas Valley Hydrographic Basin and indicates the location of Las Vegas Wash and tributaries. The Wash discharges into Las Vegas Bay at Lake Mead.

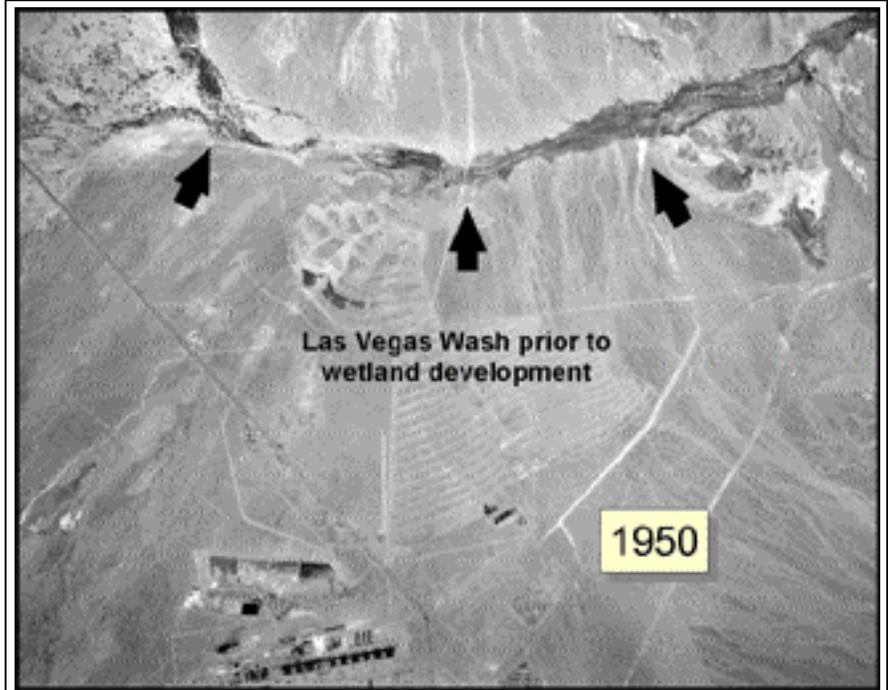
Figure 3.2 – Aerial photo of Las Vegas Wash, 1950.

The flow from the springs originally supported grassy meadows, mesquites and other phreatophytes along the small tributary washes. The plant growth entirely consumed the flow from the springs. Except for occasional flood flows there was no flow down the Wash (USBR, 1982). Prior to urbanization of the Valley, the Wash was defined by an evenly graded, stable flood plain typical of arid environments. Figure 3.2 shows an aerial photo of the Las Vegas Wash in 1950, prior to perennial flow and substantial wetland development.

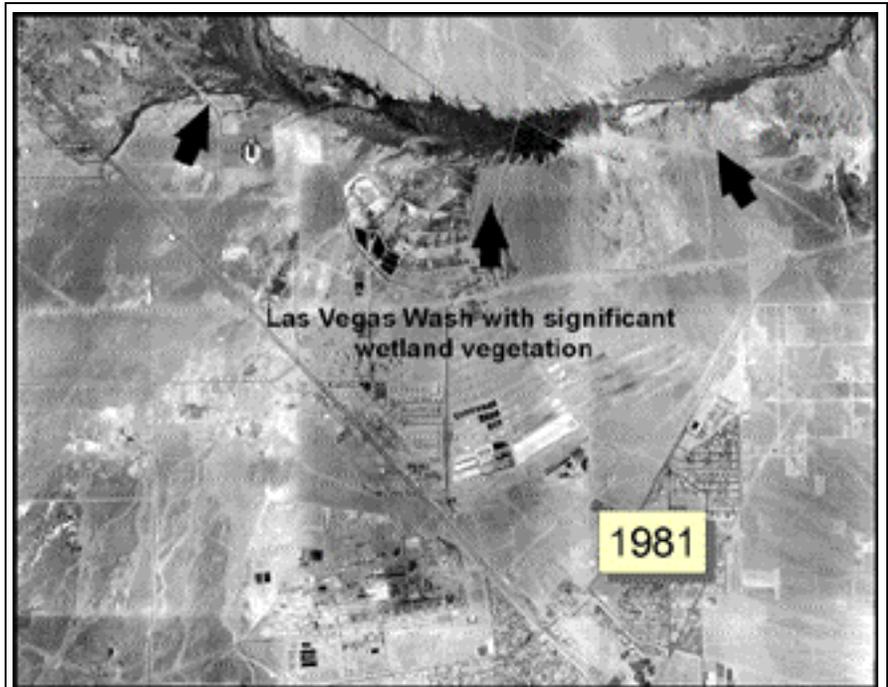
Figure 3.3 – Aerial photo of Las Vegas Wash, 1981.

Figure 3.3 shows an aerial photo of the Las Vegas Wash indicating a vast amount of wetland vegetation along the Wash channel.

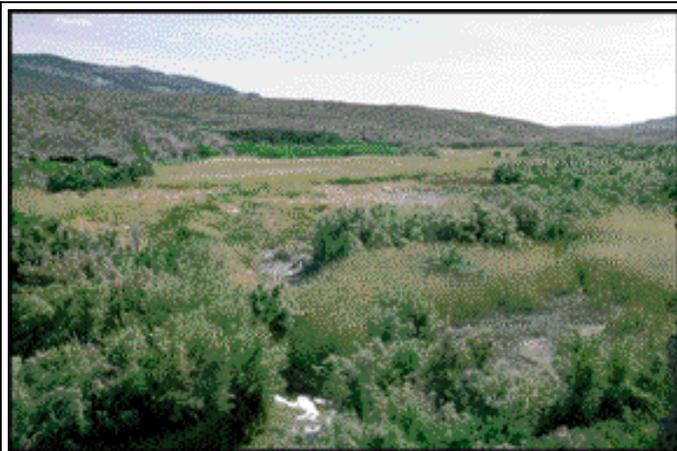
Figure 3.4 – Historic view of Las Vegas Wash from Northshore Road, 1975 (Pat A. Glancy, USGS).

During the early to mid 1970s, erosion became more evident in the lower reaches of the Wash (downstream from Three Kids Wash). The reaches above Three Kids continued to be dominated by wetlands habitat. The flood plain was still relatively flat and broad during this period and flourished with vegetation and wildlife fed by the gradually increasing flows from upstream. Figure 3.4 – 3.6 are a series of photos taken at Northshore Road in the lower reach of the Wash. These photos show conditions in 1975, 1985, and 1999.

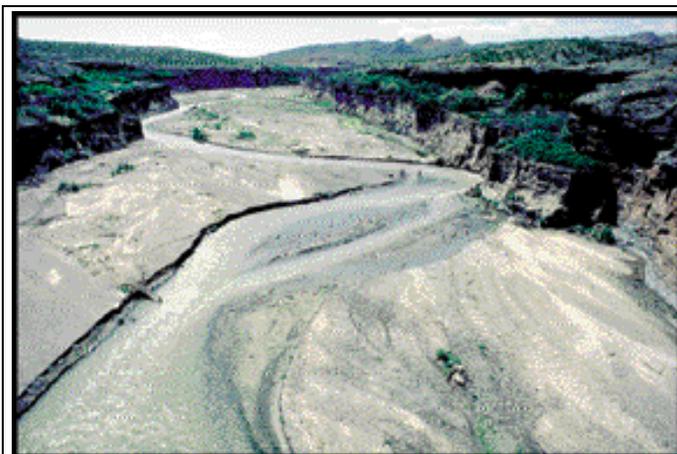
Figure 3.5 – Historic view of Las Vegas Wash from Northshore Road, 1985 (Pat A. Glancy, USGS).

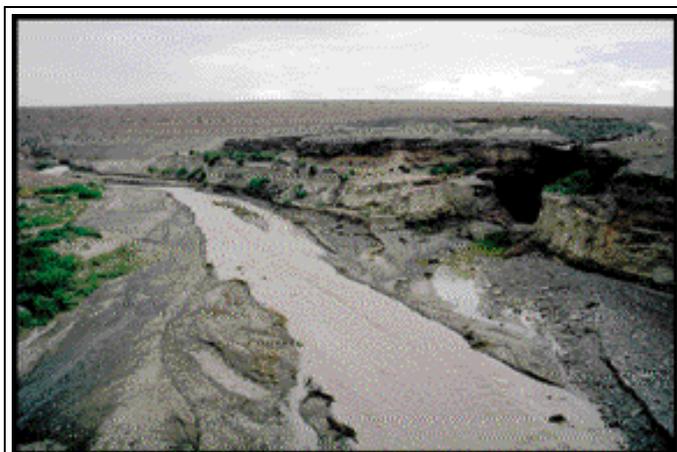
Figure 3.6 – View of Las Vegas Wash from Northshore Road, 1999 (Pat. A. Glancy, USGS).

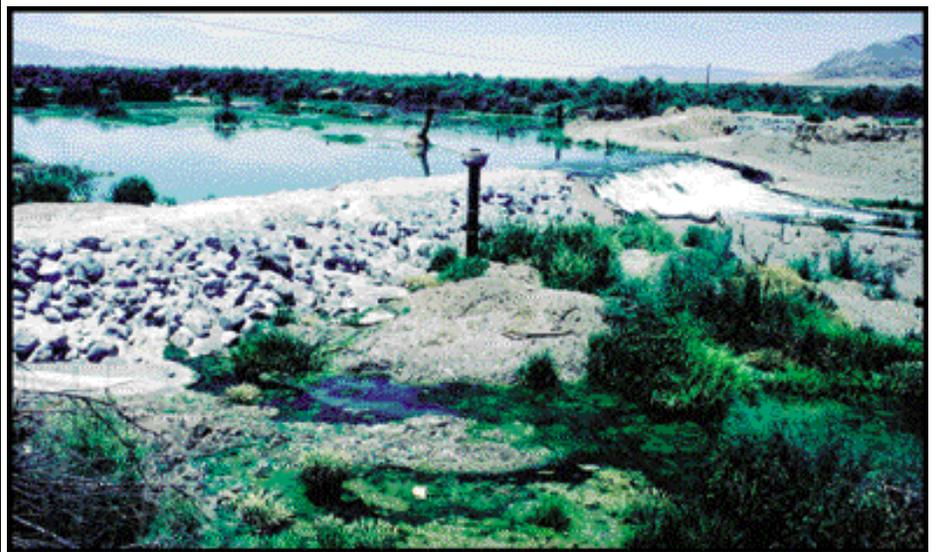
Figure 3.8 – Grade Control Structure at Las Vegas Lateral, 1985 (Pat A. Glancy, USGS).

During design, a series of flood events further threatened the Lateral, prompting the construction of a temporary Grace Control Structure (GCS) by the Colorado River Commission. The GCS, constructed in 1984, was a rip rap grouted structure approximately 7 feet high by 450 feet in length and was designed to last about two years. Photos taken after completion of the GCS show extensive wetlands development in areas behind the structure (Figure 3.8).

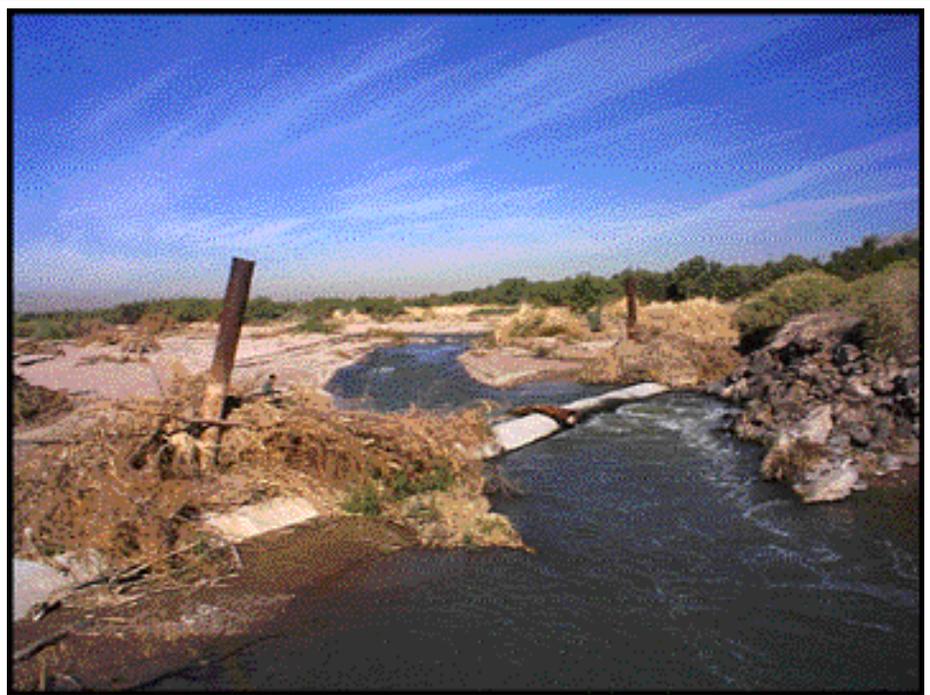
Figure 3.9 – Las Vegas Wash flowing under abandoned Lateral, October 1998 (Southern Nevada Water Authority).

In July 1998, the Southern Nevada Water Authority (SNWA) and Clark County Parks & Recreation entered into a cooperative agreement to permanently repair the GCS site. During this process, a flood event in September 1998 caused extensive erosion in the Wash and resulted in the entire Wash flow passing under the abandoned Lateral by early October (Figure 3.9). Realizing that continued erosion may result in loss of the abandoned Lateral and the remaining GCS, the

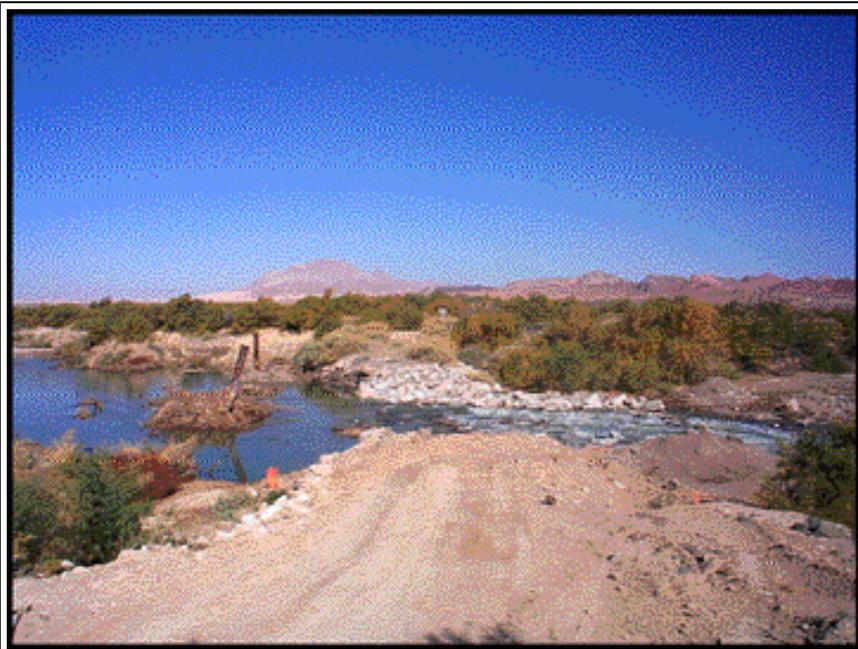
Figure 3.10 – Grade control structure site after emergency repairs completed, November 1998 (Southern Nevada Water Authority).

SNWA’s general manager declared an emergency action. Within four weeks emergency repairs were completed resulting in stabilization of the GCS. The emergency repair involved placing approximately 2,000 tons of rock rip rap below the abandoned lateral. Rock rip rap was granitic in composition and size ranged from approximately 2 to 4 feet in diameter. Design included a weir section adjacent to the abandoned lateral, a stilling basin and counterweir for energy dissipation. The upstream weir section keyed into the remaining abutments of the original GCS, constructed of rock rip rap with concrete grout. Upon completion, the emergency repair was approximately 100 feet wide and 90 feet long (Figure 3.10).

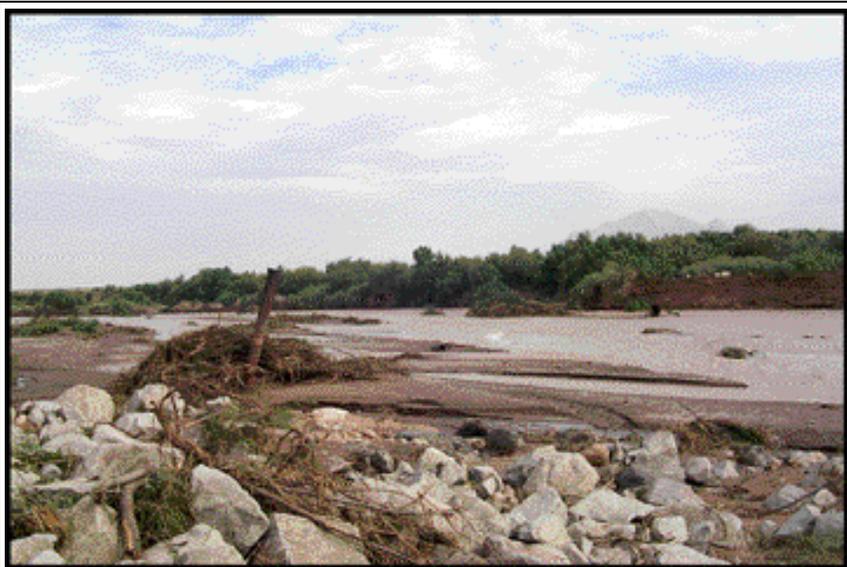
Figure 3.11 – Grade control structure site after July 1999 storm event (Southern Nevada Water Authority).

The July 8, 1999, flood event took place during the bidding process for permanent repairs to the GCS. Observation during the flood showed that the emergency repairs withstood greater than design flows prior to failure. Failure originated at the concrete grouted rock rip

rap abutments, from the original GCS, then progressively removed materials placed during emergency repairs. Floodwaters extensively altered the site resulting in postponement of the repairs and total redesign of the structure (Figure 3.11). The Las Vegas Lateral GCS is currently being redesigned and is planned for construction late- to mid-2000.
